# Property Inspection Report

## Toilet - Property Inspection Report

### Toilet #1

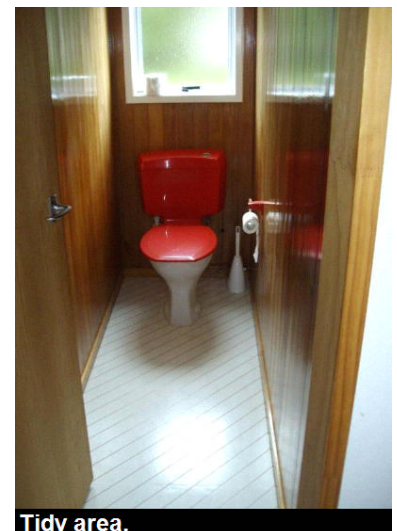
Image 1:

<i>Orientation:</i>	Faces West.
<i>General:</i>	Separate room.
<i>Internal ceiling and wall linings:</i>	Base linings intact, Reasonable Condition.
<i>Window sash and function:</i>	Single glazed, Aluminium frame, Awning, Functions as designed, Remedial attention suggested, Easing required.
<i>Window Reveals &amp; Sills</i>	Base materials are in, Reasonable Condition, Painted.
<i>Door types and function standards for this room:</i>	Hinged door, Function as designed, Reasonable Condition.
<i>Door panels and door reveals:</i>	Base materials are in, Reasonable Condition.
<i>Door Hardware:</i>	Door stop fitted.
<i>Lighting:</i>	Installed.
<i>Tested:</i>	Tested, working.
<i>Floor Covering:</i>	Vinyl fitted, Reasonable Condition.
<i>Toilet Cistern:</i>	Single flush plastic cistern, Reasonable Condition.
<i>Toilet Seat:</i>	Plastic seat.
<i>Toilet Pan:</i>	Fixed firmly to floor.
<i>General Summary, and comments from the inspector on this area:</i>	Reasonably well presented room. Minor remedial tasks as listed, generally cosmetic, the linings are intact, superficial ageing or wear evident.
