# HOME STRUCTURE REPORT

568 DANFORTH AVE., TORONTO.

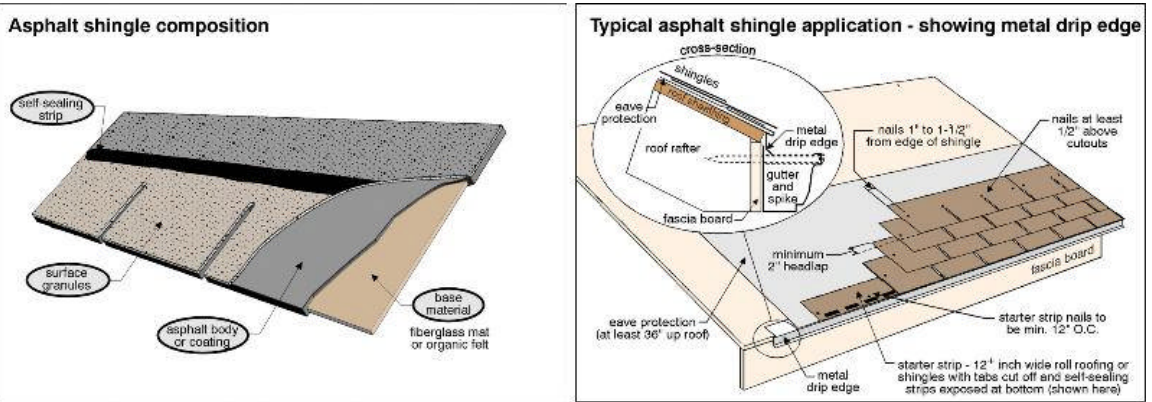
*Slope - Hip, Surface Material - Asphalt Shingle.*

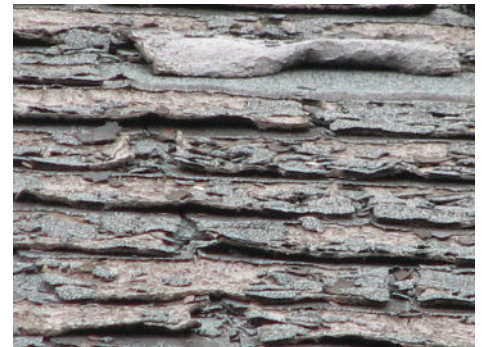
**Roof Surface Age:** Approximately 15-20 Years.

**Roof Life Expectancy:** The roof surface appears to be at or very near the end of its useful life and will subsequently fail to protect the building from water damage.

- Replace missing shingles
- Secure and reseal loose flashing
- Repair ridge caps
