# Home Inspection Report

**456 Castle Avenue  
West Simsbury, CT 06092  
Prepared exclusively for:  
Mary Brown**

**Prepared by: Cedar Hill Home Inspection  
PO Box 537  
West Simsbury, CT 06092  
860-217-0060  
Web: [www.CedarHillInspect.com](http://www.CedarHillInspect.com)**

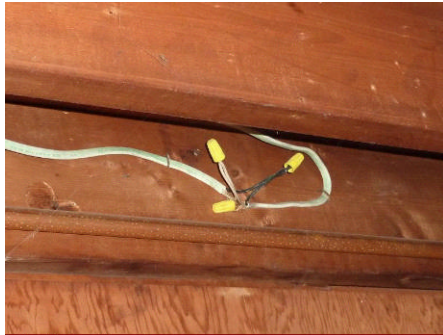
*The following electrical system device and/or distribution wiring safety deficiencies were noted:  
Missing, loose or broken safety covers on switches, outlets and/or open junction boxes noted,*

*loose and/or hanging wire(s) and/or other dangerous wiring condition, splices, connections, and/or repairs not in junction box(s) (poses fire safety and/or shock hazard), and bare bulb fixtures noted in closets .*

No junction box

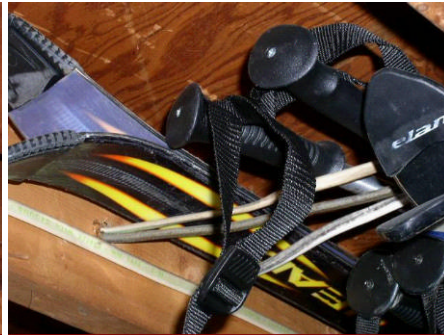
Dangerous wiring

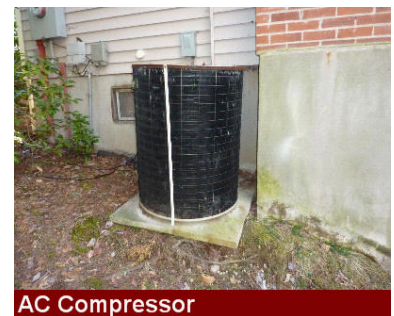
**AC Compressor**

**The compressor unit on the exterior was noted to be out of level.**  
This condition can effect the operation and efficiency of the air conditioning system.

- Recommendations and Comments:** It is recommended that the cooling system be inspected and evaluated by a licensed cooling contractor before the cooling season begins. Do to ambient conditions cooling system was only visually inspected, no determination can be made to operation and effectiveness of system.

Have all cooling system(s) deficiencies repaired by a licensed air conditioning contractor as necessary.

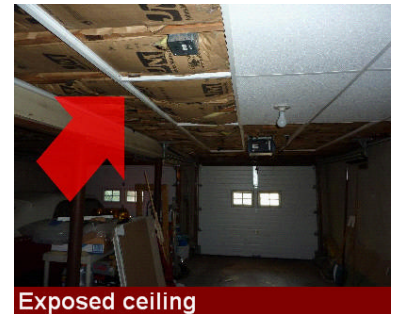
**Walls:** Wood framed with drywall covering and Masonry (concrete, block or brick).  
**Holes and/or other deficiency noted in drywall.**  
 Garage walls attached to homes have drywall covering to protect the home. Any breach or hole can allow fire extension or CO gas from the garage into the home. Have any garage drywall deficiency repaired by a home improvement contractor.

Exposed ceiling

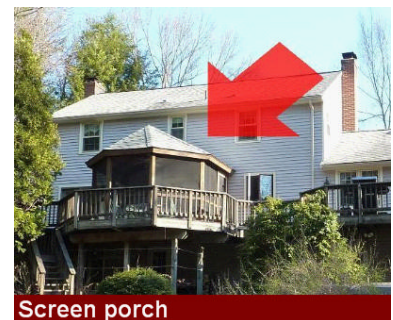
Entry Porch:	Entry located: front/center. Entry Construction: Porch of slate or slate and concrete. Porch deck surface appears to be generally in good condition. Entry porch balusters and guardrails: No porch guardrails observed. <i>Recommend adding guard rail(s) for safety.</i> Number of steps to grade: 1. Stairs appear to be in generally good condition.
Landing:	Landing located: rear/right. Deck surface appears to be generally in good condition.
Enclosed Porch:	Enclosed porch style: Enclosed deck located rear. Enclosed porch construction: Deck style framing, built on columns. Roof over porch: With wood support columns. Walls: Screened in porch or sliding doors.
Windows:	No windows, screens only, <b>screens torn, missing and/or generally in poor condition.</b>

Screen porch

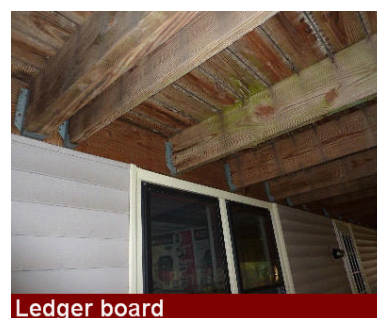
The following deck framing conditions were noted:  
Ledger board: Ledger board noted to be in serviceable condition.  
**Ledger board lag bolts: No bolts noted attaching ledger board to home.** This poses a safety hazard.  
Flashing at ledger board: flashing observed  
Joist hangers: were noted.  
Framing noted to be in serviceable condition.  
Deck support columns material noted: Wood  
Support columns condition: support columns appear to be in serviceable condition  
Support column footings: Footings noted at columns with good mechanical connection

Recommendation and Comment: Recommend all deficiencies be repaired by a carpenter, masonry contractor and/or home improvement contractor as necessary.

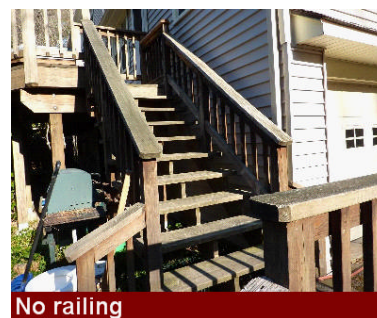
Deck Stairs: Steps to grade from deck: 10.  
Multiple access to grade observed.  
Stair(s) condition: Stairs are in serviceable condition.  
Stair(s) balusters & guardrails: Stair guardrail secure.  
**Stair(s) handrail: No stair handrail observed.**  
*Hand rails are recommended to be small enough to place hand around, dimensional lumber is not considered a handrail. Hand rails are recommended for all stair applications for safety. Recommend adding handrails for safety.*

No railing

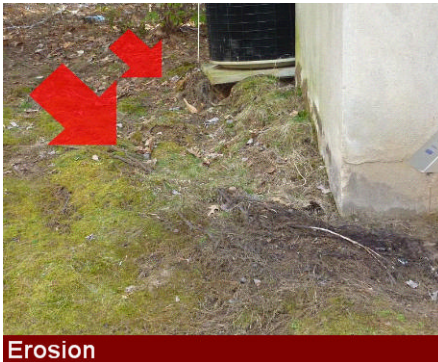
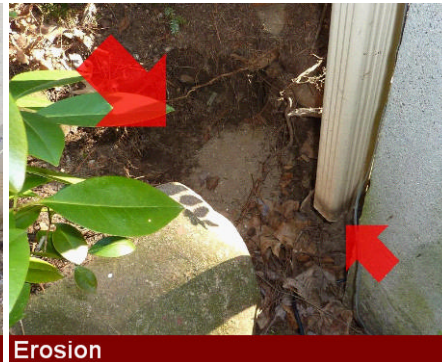
**Indications of poor drainage was noted - extensive erosion and/or areas indicating erosion near home and/or foundation.** Recommend contacting a landscape contractor to improve drainage as necessary.

Erosion

Recommendations Changing soil grade near house to pitch away and divert water away from foundation, is recommended.  
and Comments:

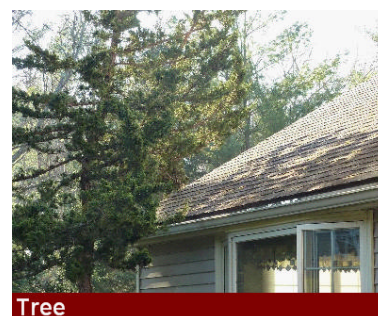
Tree

Trees Near Home: Trees overhanging and/or threatening home.

Recommendations Recommend having tree surgeon remove trees and/or branches as necessary.  
and Comments:
