# Home Inspection Report

456 Castle Avenue  
West Simsbury, CT 06092  
Prepared exclusively for:  
Mary Brown

Prepared by: Cedar Hill Home Inspection  
PO Box 537  
West Simsbury, CT 06092  
860-217-0060  
Web: [www.CedarHillInspect.com](http://www.CedarHillInspect.com)

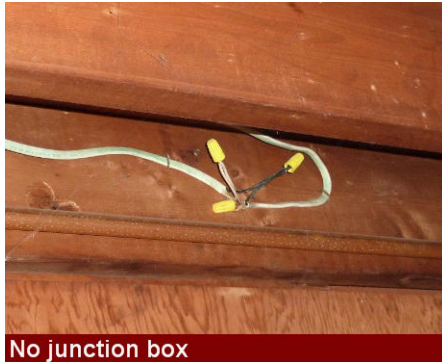
*The following electrical system device and/or distribution wiring safety deficiencies were noted:  
 Missing, loose or broken safety covers on switches, outlets and/or open junction boxes noted,*

*loose and/or hanging wire(s) and/or other dangerous wiring condition, splices, connections, and/or repairs not in junction box(s) (poses fire safety and/or shock hazard), and bare bulb fixtures noted in closets .*

No junction box

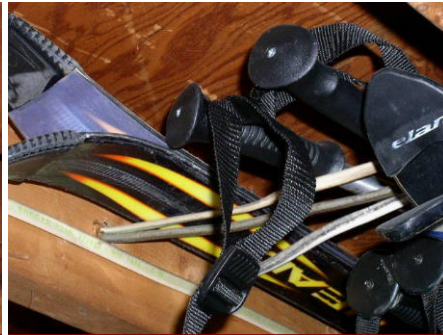
Dangerous wiring

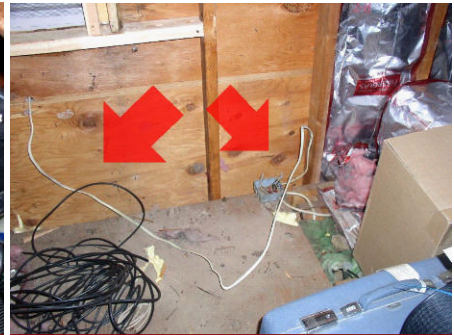
Unsafe wiring

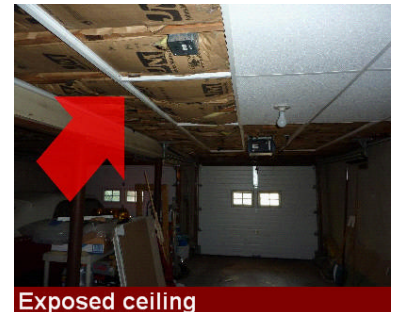
**Walls:** Wood framed with drywall covering and Masonry (concrete, block or brick).  
*Holes and/or other deficiency noted in drywall.*  
 Garage walls attached to homes have drywall covering to protect the home. Any breach or hole can allow fire extension or CO gas from the garage into the home. Have any garage drywall deficiency repaired by a home improvement contractor.

Exposed ceiling

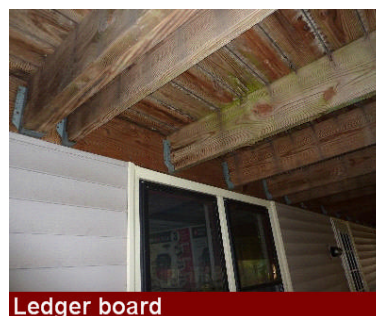
The following deck framing conditions were noted:  
Ledger board: Ledger board noted to be in serviceable condition.  
**Ledger board lag bolts: No bolts noted attaching ledger board to home.** This poses a safety hazard.  
Flashing at ledger board: flashing observed  
Joist hangers: were noted.  
Framing noted to be in serviceable condition.  
Deck support columns material noted: Wood  
Support columns condition: support columns appear to be in serviceable condition  
Support column footings: Footings noted at columns with good mechanical connection

Ledger board

**Recommendation and Comment:** Recommend all deficiencies be repaired by a carpenter, masonry contractor and/or home improvement contractor as necessary.

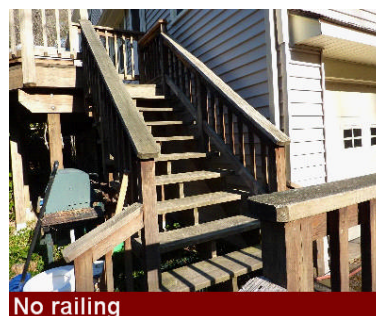
**Deck Stairs:** Steps to grade from deck: 10.  
Multiple access to grade observed.  
Stair(s) condition: Stairs are in serviceable condition.  
Stair(s) balusters & guardrails: Stair guardrail secure.  
**Stair(s) handrail: No stair handrail observed.**  
*Hand rails are recommended to be small enough to place hand around, dimensional lumber is not considered a handrail. Hand rails are recommended for all stair applications for safety. Recommend adding handrails for safety.*

No railing

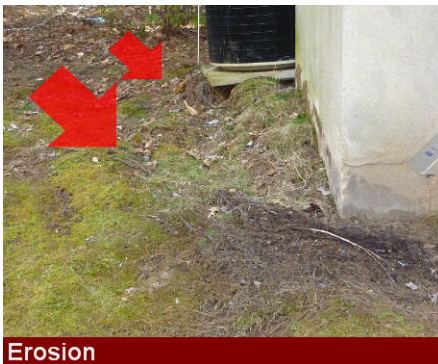
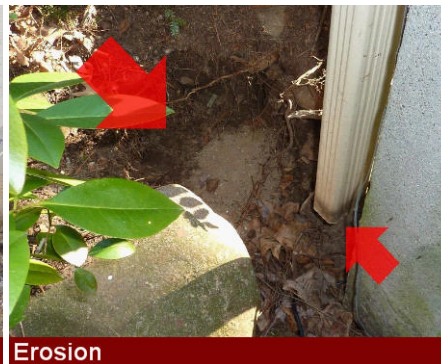
Within 5 - 10 feet of foundation generally grading slopes is about level and should be graded away.

**Indications of poor drainage was noted - extensive erosion and/or areas indicating erosion near home and/or foundation.** Recommend contacting a landscape contractor to improve drainage as necessary.

**Recommendations and Comments:** Changing soil grade near house to pitch away and divert water away from foundation, is recommended.

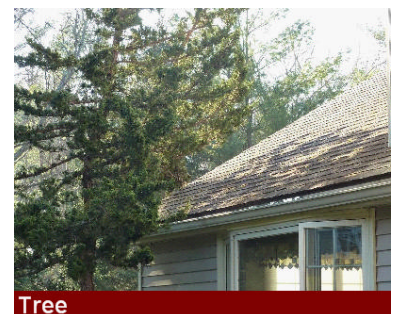
Tree

**Trees Near Home:** Trees overhanging and/or threatening home.

**Recommendations and Comments:** Recommend having tree surgeon remove trees and/or branches as necessary.
