Report: 0200; 3d sample **Address:** 123 Anystreet

Confidential Inspection Report

123 Anystreet
Anytown, PA 12345

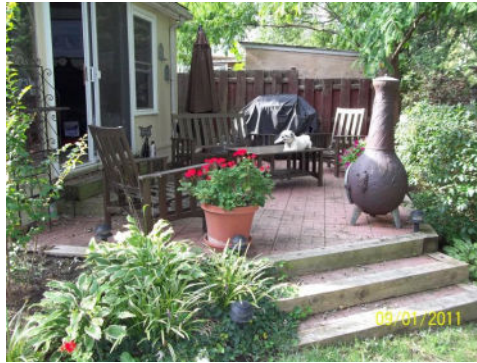
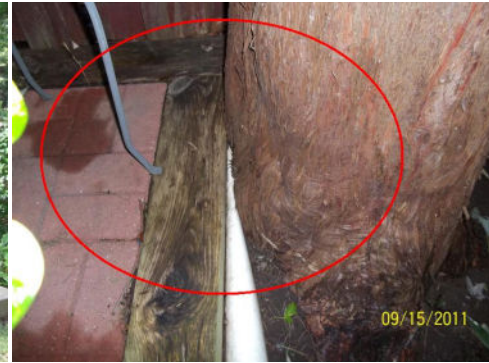
Slab Condition:

OK [MR] RR SC NI Patio was in a serviceable condition. Some repairs are recommended to maintain the patio in a satisfactory condition and extend its useful life. The patio slab exhibited normal wear and tear from exposure to the elements. *The raised area of the patio appears to be caused by the tree growing near the patio. Removal of the tree is recommended to prevent continued damage of patio area. Redesign of the patio surface should be considered if tree is not removed to allow for the future growth of the trunk to prevent further damage to the patio surface. Evaluation by a qualified contractor to obtain repair recommendations and costs is advised.*

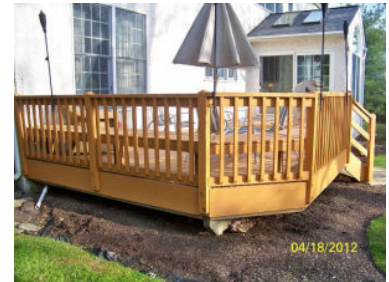
Condition:

Areas that were accessible and able to be visually inspected were in a serviceable condition. Some improvements are recommended to maintain the deck in a satisfactory condition and extend its useful life. Deck components exhibited normal weathering conditions at the time of the inspection. *Conditions observed at the time of inspection included several loose deck boards that will need to be better secured and a few deteriorated/damaged deck boards; replacement is needed. It is recommended that maintenance repairs are done to maintain and extend the useful life of the deck structure. A quality sealant should be applied to the wood surfaces on a regular basis to preserve and protect the wood materials from weathering and extend their useful life. Low elevation of deck prevents access to and viewing under the deck structure. No comment is made on components not able to be accessed and inspected.*

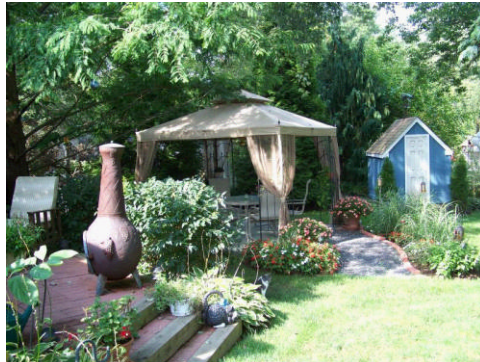
Gazebo and shed

A shed was located on the property in the rear yard area. The shed was not included in the home inspection and no comment is made on its condition. There is an in-ground pool located on the property. The pool was not included with the home inspection and was not inspected. No comment is made on its condition. Recommend that a qualified pool contractor further evaluates the pool facility to determine its condition and if any repairs or upgrades are needed.

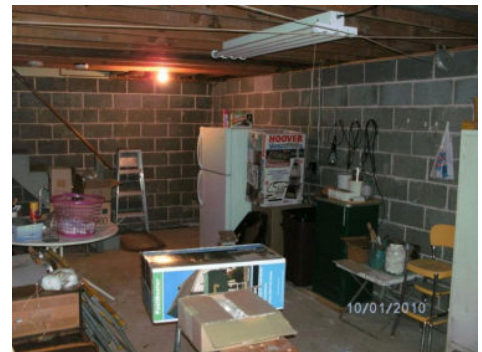
[OK] MR RR SC NI **Walls:**
Walls are constructed with concrete block. Exposed visible portions of the interior foundation walls appear to be satisfactory. *Minor cracking was noted at one or more locations. No displacement was observed and walls appeared plumb. The cracks do not appear to be a structural problem at this time. Some minor cracking is normal for a structure with this age and type of construction. Should any of these cracks begin to grow, then further evaluation and attention would be recommended.* Visibility was limited in some areas due to stored contents blocking access to portions of the wall areas.

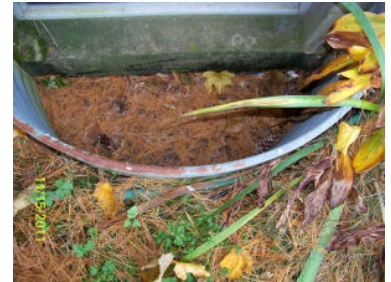
Windows Wells:

Attention Needed. *Debris has accumulated in the wells and needs to be removed to prevent deterioration/ damage to the basement windows. Plastic window well covers are not installed. Recommend installation of covers to help keep rain and debris away from the basement windows and prevent seepage into the basement.*

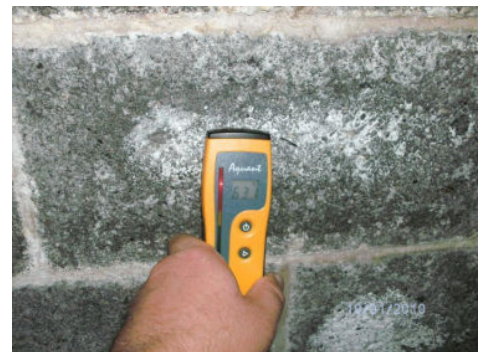
Moisture:

Efflorescence was noted at several locations. Efflorescence is a white powder like substance that is typically located on an interior foundation wall where moisture is migrating from the outside to the interior surface through the concrete block or concrete. It is a salt residue that occurs when the moisture dries from the surface. Water seepage may recur in the future. The best defense against water seepage is good drainage of soils near the foundation wall.

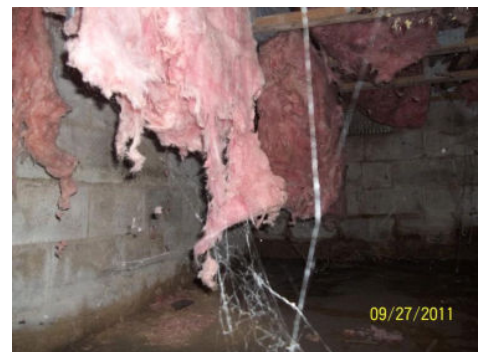
There is insulation installed in the crawlspace area. The joists have insulation installed between them insulating the living space above. *Some insulation was loose/hanging down and needs to be reinstalled. Some of the insulation is damaged and replacement of these sections with new is recommended. The heating distribution lines in the unheated crawlspace are not properly insulated. Lines need to be insulated to protect them from freezing damage and leaks.*

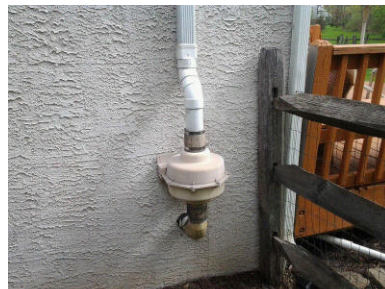
Exterior unit

Radon System - A radon reduction system was installed in the basement. These systems are installed to reduce the level radon gas detected to a safe level below the EPA threshold of 4.0 pCi/l . Inspection of the system is not included in the home inspection and no comment is offered on its function and condition. Recommend that you consult with a qualified and licensed contractor that specializes in the installation of these systems to further evaluate the installation to obtain information as to its condition and function to insure it is in a safe and satisfactory operating condition. Also recommend that you inquire with the owners about any service agreements in place and/or maintenance requirements. More information about radon is available at <http://www.epa.gov/radon/pubs/consquid.html>.

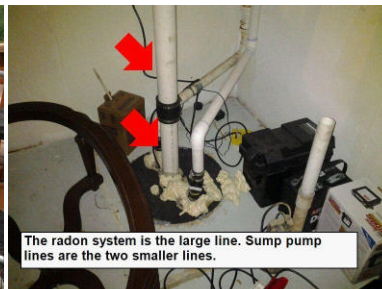
Interior installation

The radon system is the large line. Sump pump lines are the two smaller lines.

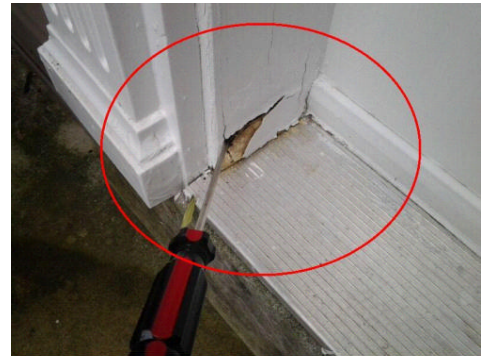
Lower exterior trim/frame

Attention Needed. *Caulking between trim components and the siding needs improved/replaced. Improper or missing weather stripping noted at one or more locations that will need repaired or replaced. The door is difficult to operate, some adjustment/minor repair is needed for the door to properly operate. Some deterioration noted at the bottom of the door frame that needs to be repaired. Additional repairs may be needed due to underlying conditions that may be uncovered when the initial repair work is completed.*

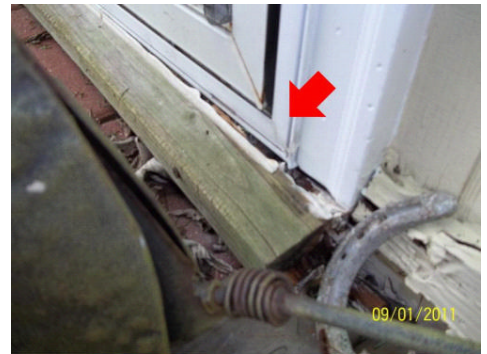
Attention Needed. *The door appeared to be in a functional condition, some adjustment/repair is needed to maintain the door in a satisfactory condition. Recommend that the caulking between trim components and the siding is improved as a preventative measure. Door is difficult to operate (door rubs/sticks), some adjustment or repair is needed. Screening is damaged, repair or replacement is needed. The door sill was loose/deteriorated and will need to be repaired or replaced. Additional repairs may be needed due to underlying conditions that may be uncovered when the initial repair work is completed. This is a sliding glass door.*

Door still needs repaired.

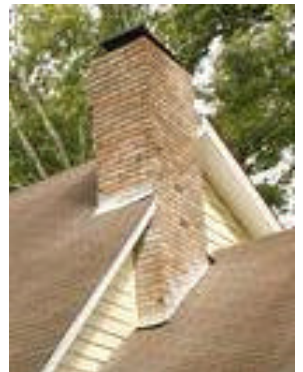
The flue is lined. Two flues are installed within the chimney structure. *I was unable to determine the condition of the flue due to limited visibility. A rain cap is installed that prevented access to inspect the flue. The inspection is limited to the visible portions of the flue only. Further evaluation by a qualified professional chimney sweep is needed.*

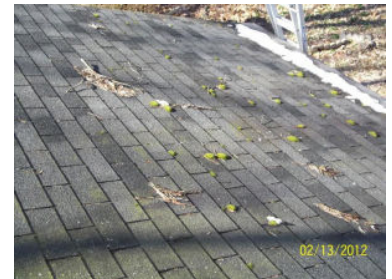
The roofing materials appear to be in a satisfactory condition, no significant concerns were noted. Within useful lifespan. Roofing materials show signs of normal weathering and aging. Some debris has accumulated on the roof surfaces that should be removed. Moss/algae growth noted on roof surface that will accelerate material deterioration; removal is recommended. Normal maintenance is recommended to maintain the roofing materials in a satisfactory and functional condition. This usually consists of inspection of the roofing system and repair/replacement of damaged/missing shingles, flashing, removal of leaves and other debris that accumulates. Regular

maintenance should help insure the weather tightness of the building and extend the useful life of the roofing materials.

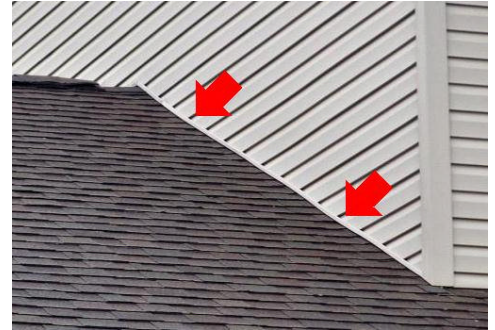
The visible flashings at the time of inspection were found to be functional. *Some siding was installed on top of the roofing material at one or more locations. The flashing was not visible and not able to be inspected at these locations. Typically siding should be kept off the roof surface 1/2" to 1" to prevent water from wicking up behind the siding. I was unable to inspect and determine the condition of the step flashing at these locations and no comment is made on their condition. It is common practice for builders of similar constructed homes in the area to install siding and flashing components in the manner noted. No interior problems were observed that may have been related to the installation of the siding and flashing noted at the time of inspection. These areas should be monitored in the future; over time maintenance repairs may be needed.*

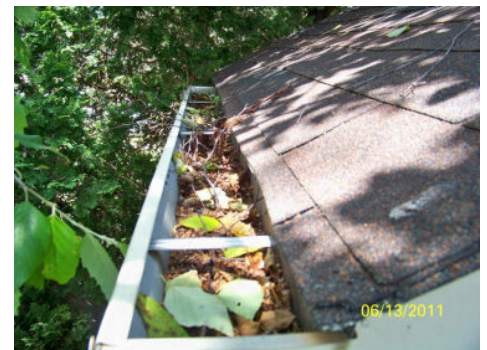
Gutters and downspouts were in satisfactory condition. *Downspout discharge needs to be directed away from the building (extensions recommended) to prevent water damage to the foundation walls. Some debris was observed in the gutters. Recommend that gutters are cleaned as a preventative measure to prevent blockage from occurring that can prevent proper flow. Due to the close proximity of large trees to the structure, it is recommended that you consider installation of gutter guards to prevent debris from clogging the gutters and downspouts.*

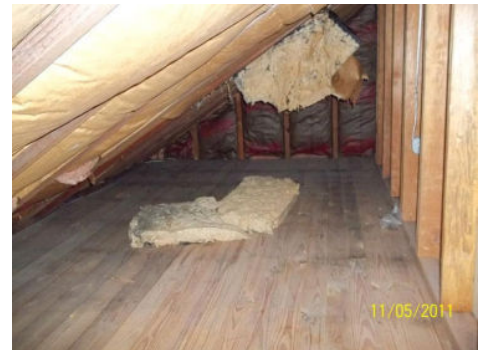
OK [MR] RR SC NI Type of insulation installed is fiberglass batts. Insulation is installed between the studs of the finished walls. Insulation is installed between roof rafters. *Some insulation is installed unevenly or has been disturbed and should be corrected to maintain a satisfactory coverage to properly insulate the living space below. Further evaluation and improvement of the insulation installation by a qualified contractor is advised.*

Average depth installed was 5-6 inches. Insulation is compacted and the true R-value at this point in time may be substantially less than that originally installed. Installation of additional insulation is recommended to help reduce the cost to heat and cool the house. The recommended insulation in the attic area is R-38, approximately 12". If insulation is added, it is important that the ventilation is proper. Recommend consulting with a qualified contractor to obtain recommendations for improving the insulation R-value and cost.

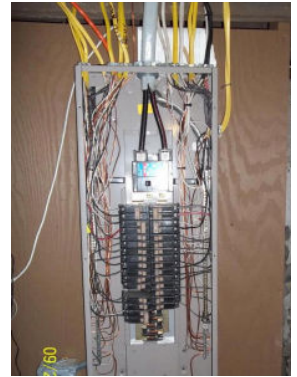
[OK] MR RR SC NI Panel appeared functional and in a satisfactory condition. Circuit and wire sizing correct so far as visible. *Panel is without the benefit of complete labeling. Recommend that the circuits are located and labeled for convenience and safety purposes.*

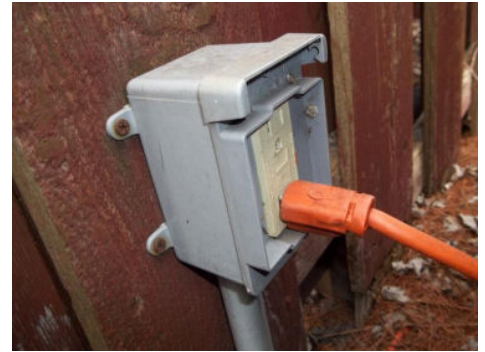
Exterior Walls:

Weather protection was missing/improper and needs to be corrected.

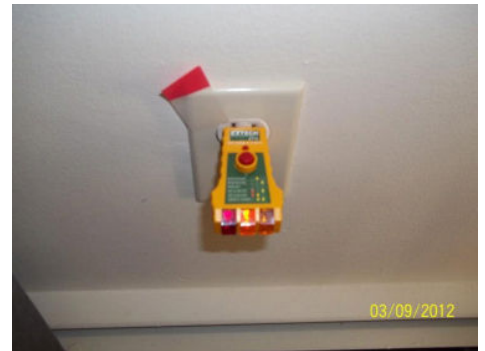
Breakfast Area:

Loose outlet noted; repair needed.

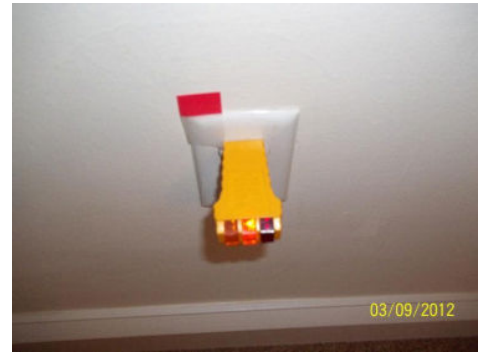
Bedroom #3:

Loose outlet noted; repair needed.

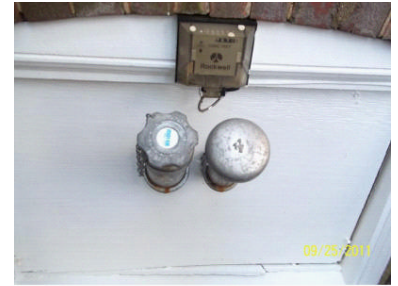
Fuel tank fill pipes

[OK] MR RR SC NI Oil. There is an interior tank installed to store the fuel oil. The fill and vent pipes are located on the left hand facing exterior wall . *This installation needs to be monitored for any leakage that may develop. Fuel oil leakage will contaminate the area which will be very costly to remediate.*

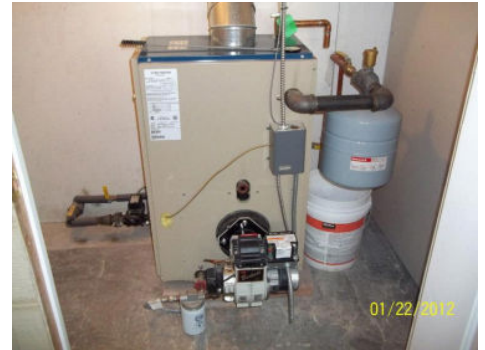
[OK] MR RR SC NI **Condition/General Operation:**
The general condition of the heating unit was functional and in a satisfactory condition at the time of inspection. The unit shows normal wear from use. *Recommend that the boiler unit is serviced to maintain it in a satisfactory condition and to extend its useful life.*

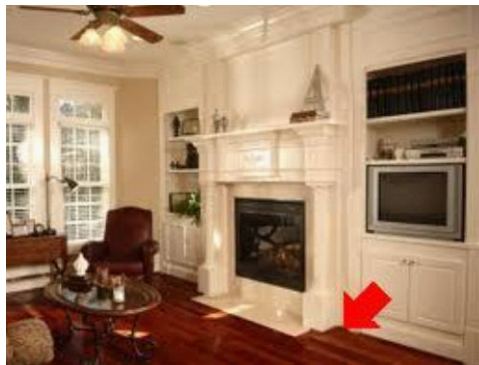
Location of gas valve

[OK] MR RR SC NI **Family Room:**
A masonry fireplace was installed. There is a gas log set installed. Mortar joints are intact. Damper is operational. There is a mantle installed, and it meets the 12" minimum clearance above the firebox. The hearth extends at least 18 inches in front of the firebox and extends at least 8 inches to either side. There is a set of glass doors installed. (Used correctly, these will help minimize heat loss when the fireplace is not in use and reduce the volume of room air sucked up the chimney). Room air is used for combustion (*It would be best to have a window open while using since a roaring fire consumes approximately 300 to 400 cubic feet of air per minute*). Recommend evaluation by a qualified professional chimney sweep each year prior to use as a regular maintenance practice. A gas valve was installed. It is located to the right hand side of the fireplace at the floor. The National Fire Protection Association recommends an NFPA 211, Level 2 inspection of any fireplace when a home is sold. Such an inspection, performed by a Certified or otherwise qualified chimney sweep, may reveal problems not apparent to this inspector and is strongly recommended.

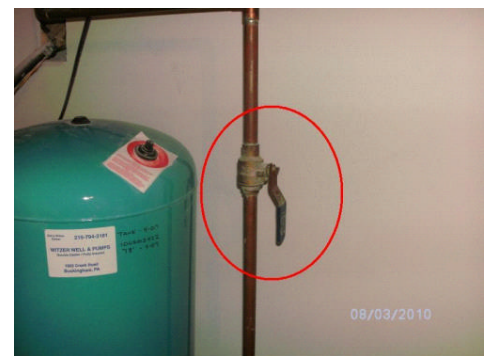
Water main shutoff valve

Main shutoff valve is located at the pressure tank. Valve is operational.

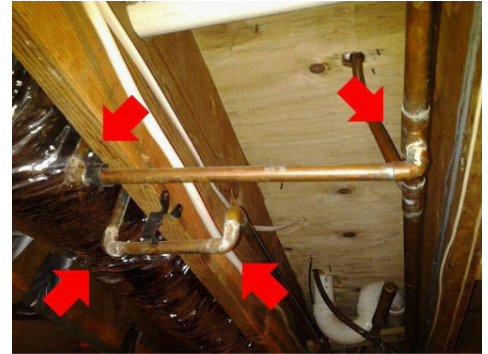
Example locations

[OK] MR RR SC NI Accessible supply lines that were able to be visually inspected appeared to be in a serviceable condition. *Some minor corrosion was noted at some locations where pipe unions and valves were installed that should be monitored; corrosion can be the precursor for leaks. No leakage was noted at the time of inspection. Some corrosion can typically occur as a result of residual flux material that can remain on the pipe/fitting from the original soldering process. Unable to fully view all installed lines. No comment is made on those portions of the lines that are not accessible and able to be visually inspected.*

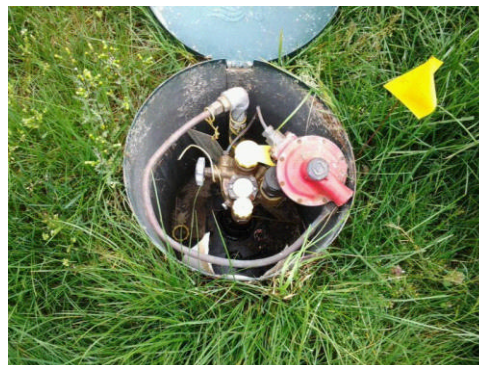
Buried propane tank

LPG tank is located rear side of house. It is a buried tank. This tank provides fuel for the fire place, stove top and gaslight located at the front walkway. *Recommend that you inquire with the present owner about ownership of the tank and maintenance responsibilities.*

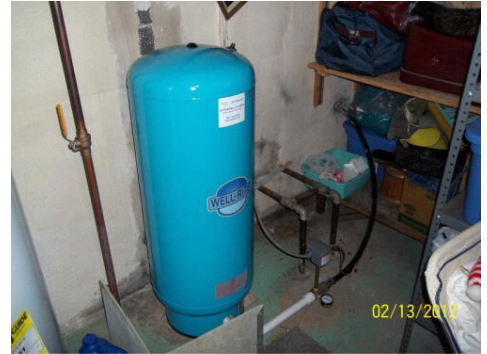
Tank & pump control switch

System was in a functional condition at the time of inspection. Pump was functional at the time of inspection. Pressure tank appears to be serviceable. *Recommend inquiring with owner about operation and service requirements.*

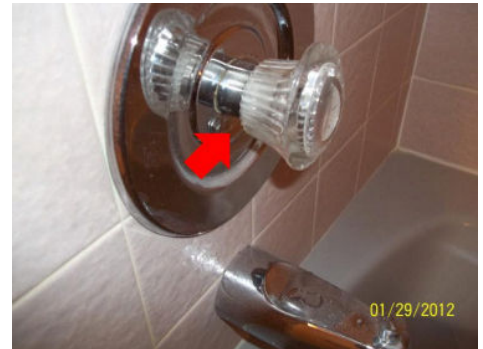
Tub Fixtures:

OK MR [RR] SC NI *Minor leakage is noted at faucet handle, repair needed.*

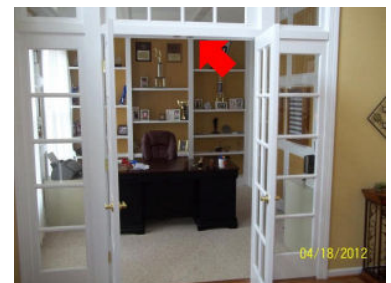
Office:

Door rubs/binds; some adjustment/repair needed to properly operate.

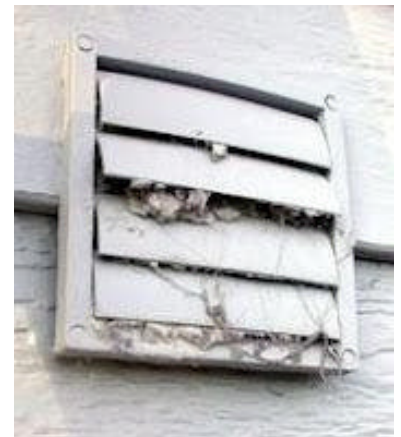
OK [MR] RR SC NI *The dryer vent appears to need attention. Cleaning is needed. A vent clogged with lint can create a fire hazard.*

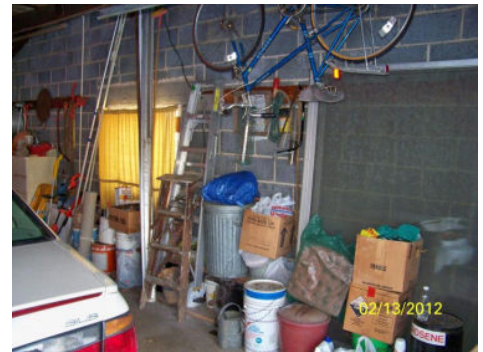
[OK] MR RR SC NI **Condition:**
Garage floor is concrete. Satisfactory condition. Typical cracks were observed. Sealing the cracks is recommend to prevent further damage. Floor was not fully visible, due to stored contents and vehicle(s) in the garage.
