REPORT OF MARINE SURVEY

PRE-PURCHASE CONDITION & VALUE
of the vessel

1998 Sea Ray 33' Sundancer 330

Bob Ptak, AMS #842 - S.A.M.S.
Society of Accredited Marine Surveyors
on
8/26/2010

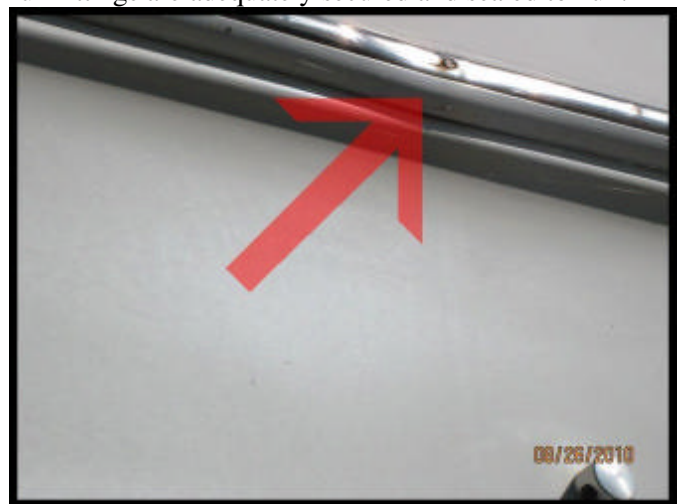
Rub rail: Rub rail is stainless steel with backing of white plastic. Well secured in good condition with only minor scrapes. An area on the starboard side shows a flattened portion of stainless steel rail but all remain serviceable.

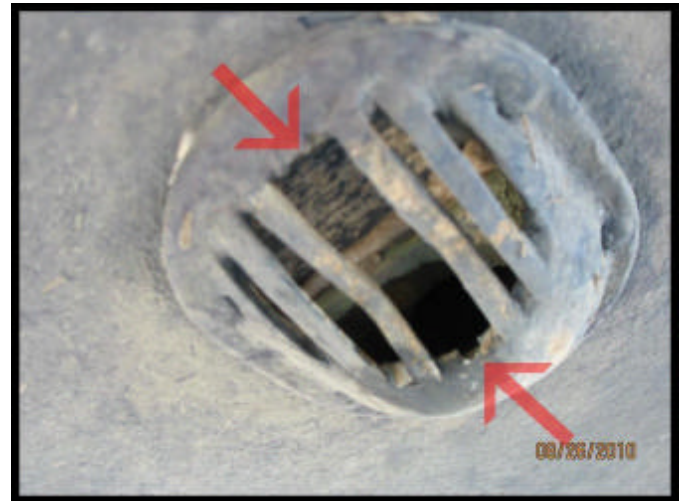
All strainers/screens are well secured to hull bottom. Clear of debris & zebra mussels. **Port side strainer is bent and one vane is missing but remains serviceable. Replace as desired.**

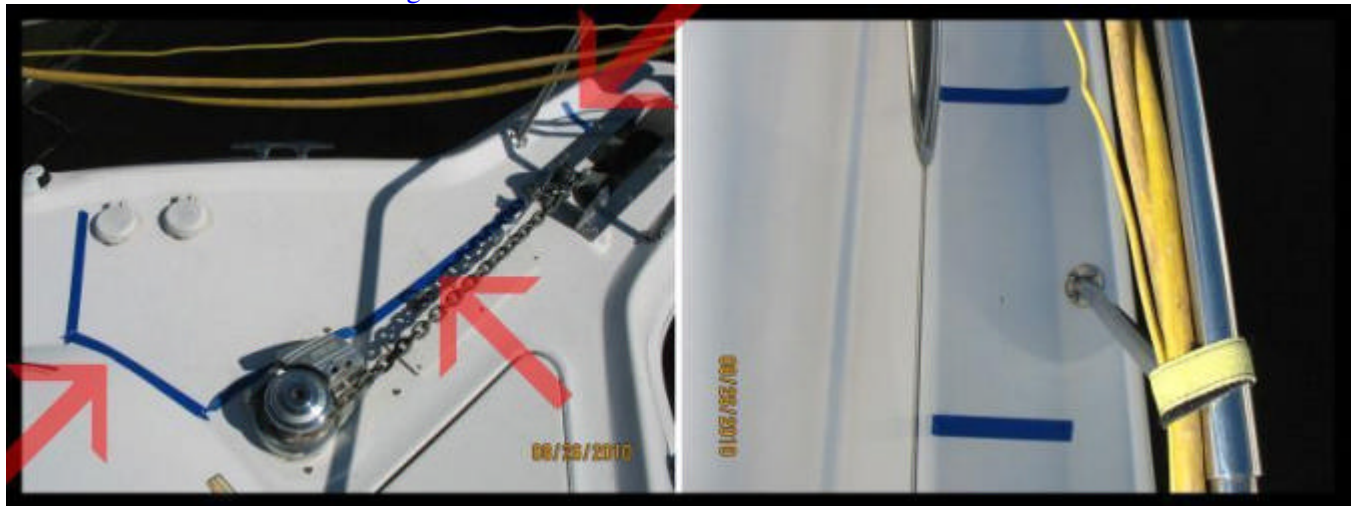
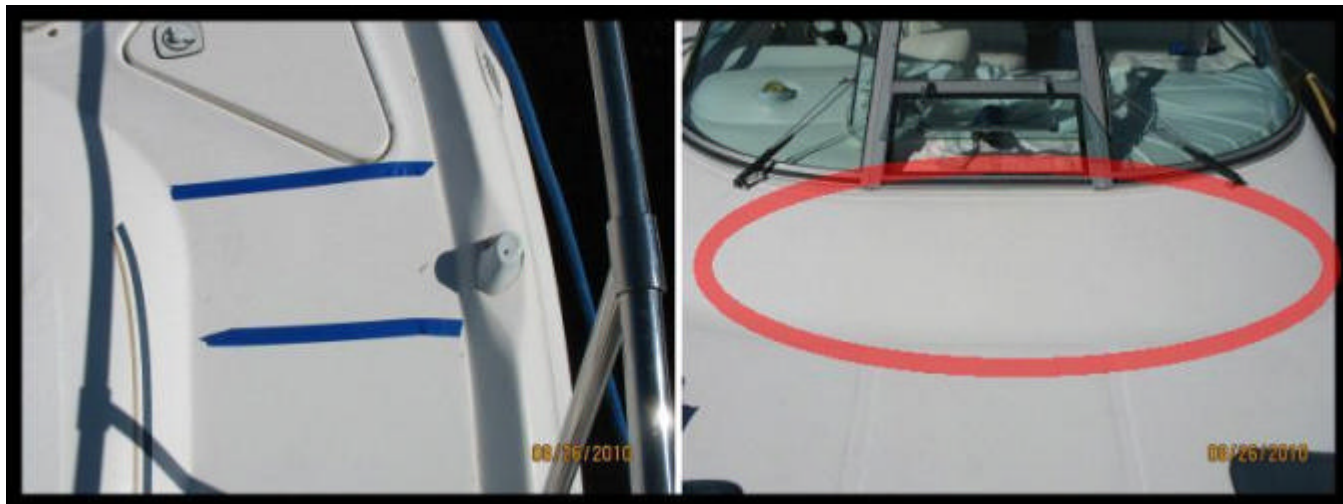
Most of the top deck had normal relatively Dry moisture meter readings. Higher than normal moisture readings found in deck surface as follows: (Most marked with tape for clarity or use of arrows/circles on photo)

- 1) Foredeck area near windlass
- 2) Near anchor locker
- 3) Port side near port light and stainless steel rail support
- 4) Slanted area in front of windshield.

Percussion hammer used to test deck surface and no apparent delamination was found in any high moisture areas. Deck is not spongy or soft and is solid under foot. It is not unusual to discover some deck moisture in older vessels.

RECOMMENDATION: To seal off deck from further moisture penetration, deck fittings near elevated moisture areas should be removed and resealed.

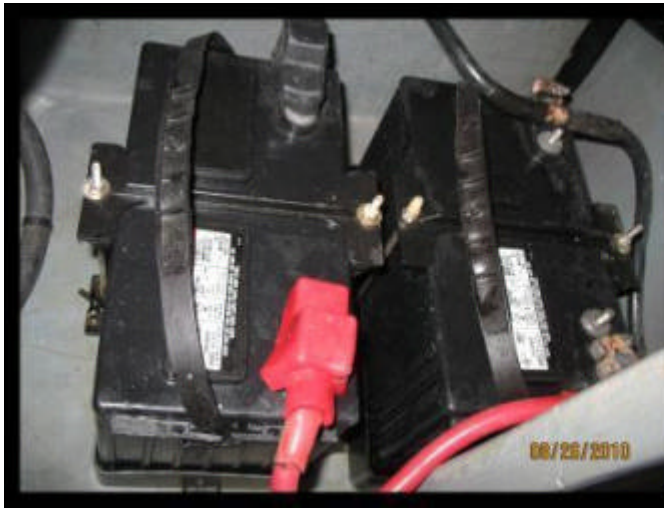
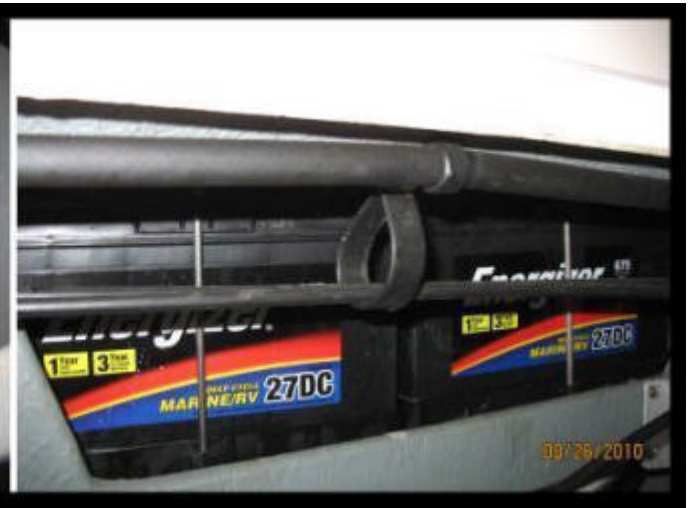
Primary batteries: There are four batteries (two sets of two) located in the engine compartment that are Group 27 Lead acid which provide service to the main engines, generator and house. Each set of two are wired in parallel producing 12 volts. Batteries are well secured in boxes with straps or hold down brackets. Cables are properly color coded and positive terminals are properly covered with boots or box covers.

Battery selector switch: Not equipped. RECOMMENDATION: ABYC E-11.7 recommends a battery switch be installed for each battery or bank with a CCA rating of 800 Amps. Recommend compliance for safety reasons.

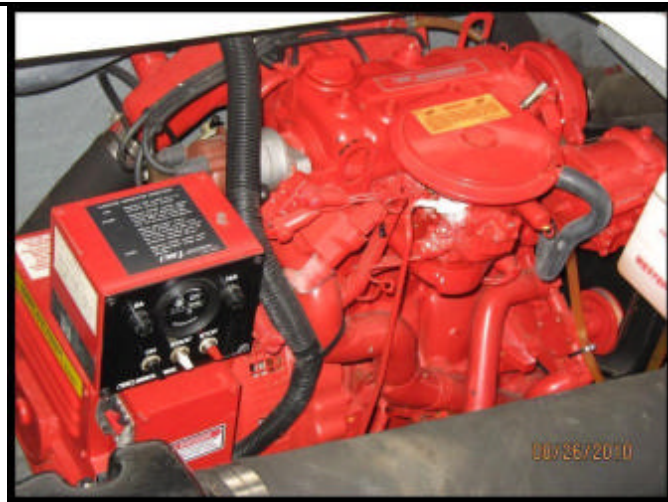
Type & Size:	Gasoline powered, Three cylinders.
Serial number:	Tag not readable.
Kilowatt/Voltage rating:	120 Volts AC, Kilowatt rating could not be read off label.
Hour meter:	Meter reads 41.5 hrs.
Generator test:	The generator started without any excess cranking and rapidly came up to speed. Generator maintained voltage when loaded with all AC units running as well as other AC electrical components.
Type of installation:	On tray.
Hoses and clamps:	Properly double clamped.
Belts and pulleys:	Belts condition are serviceable. No cracks or splits sighted. Pulleys/belts appear to be in line.
Cooling system(s):	Fresh water / heat exchanger cooled with water intake through lever action seacock.

Coolant level low in tank for generator. ----- Top off coolant reservoir and monitor frequently for leaks.
