Inspection Report Compiled For:

Tuesday February 21, 2012

Report 8654

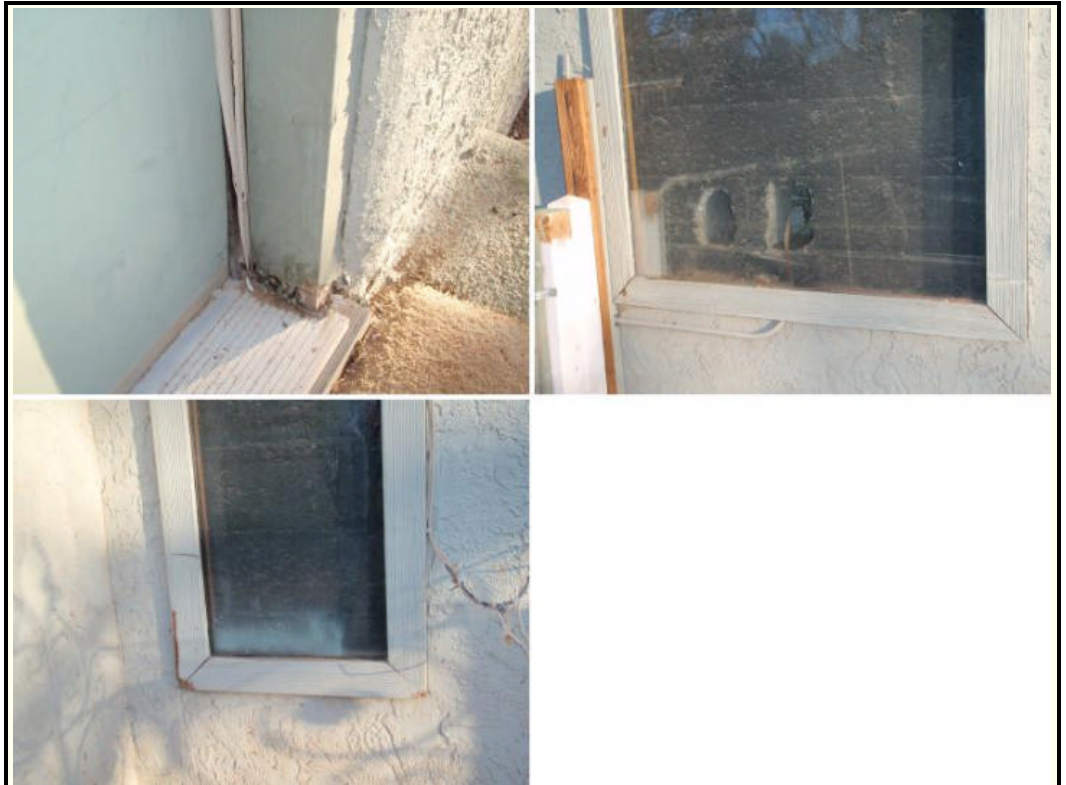
Refinish trim on the south side.

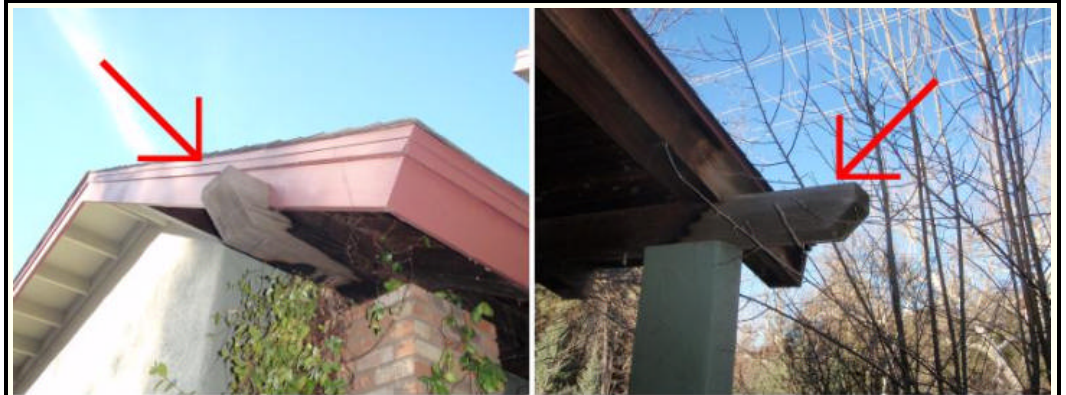
Consider flashing caps on the exposed beam ends.

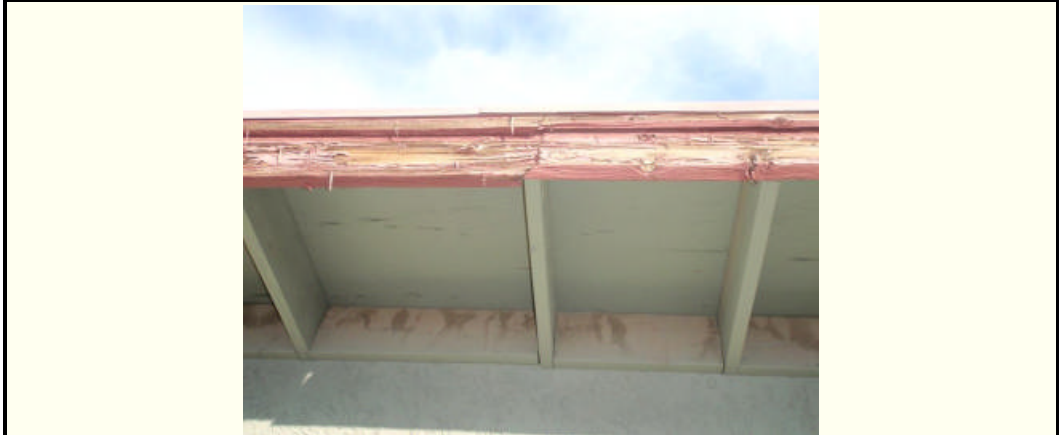
Fascia is in good condition, paint is in good condition with the exception of the upper south fascia (accessed from the roof). This fascia is heavily weathered and dryrotted in some areas. I recommend replacing this portion of the fascia.

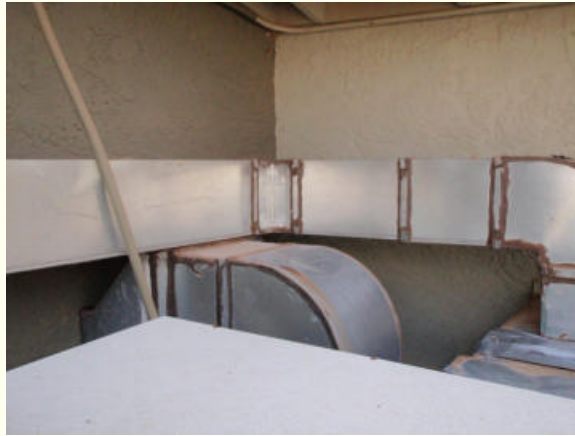
There is exposed ductwork on the deck roof. Be sure to keep all duct joints and the penetration through the house wall well sealed.

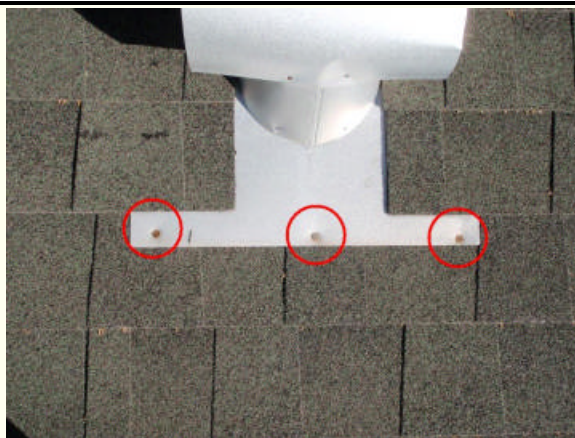
There is a row of exposed nail heads below each vent pipe roof jack. These are areas that may eventually leak. I recommend sealing or caulking all exposed nails.

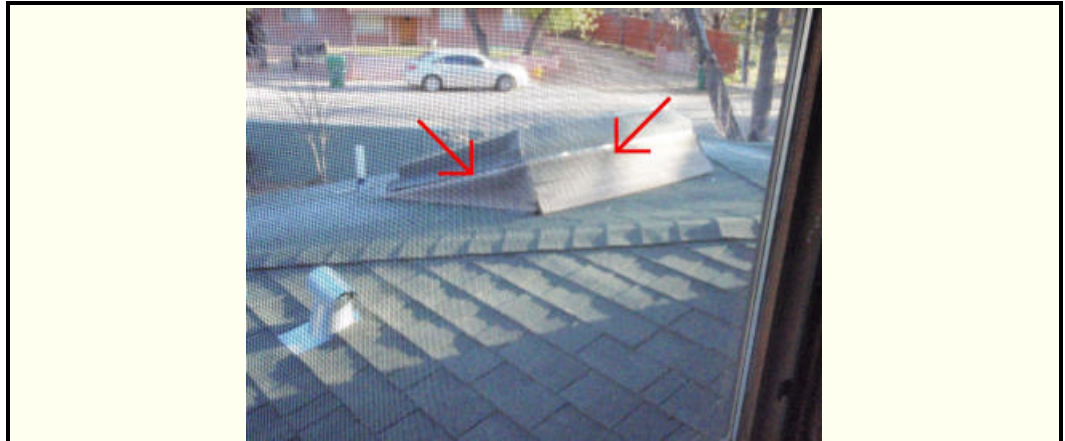
The master bathroom skylight curb is constructed of wood and is weathered and warped. I recommend having a contractor replace the curb and install proper metal flashing.

The kitchen skylight flashing is loose and not well sealed. Have a roofer repair the skylight flashing.

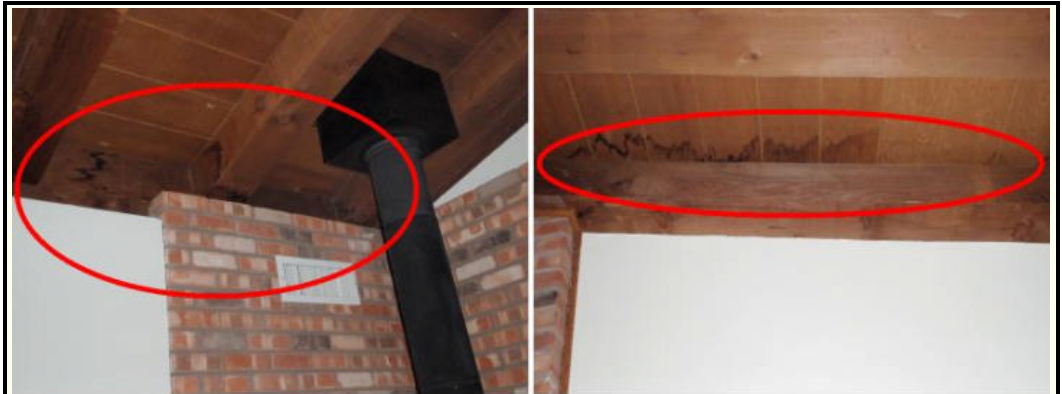
Some staining can be seen below the chimney penetration in the living room and the woodstove vent in the family room. Have a roofer reseal all chimney flashings as part of regular roof maintenance.

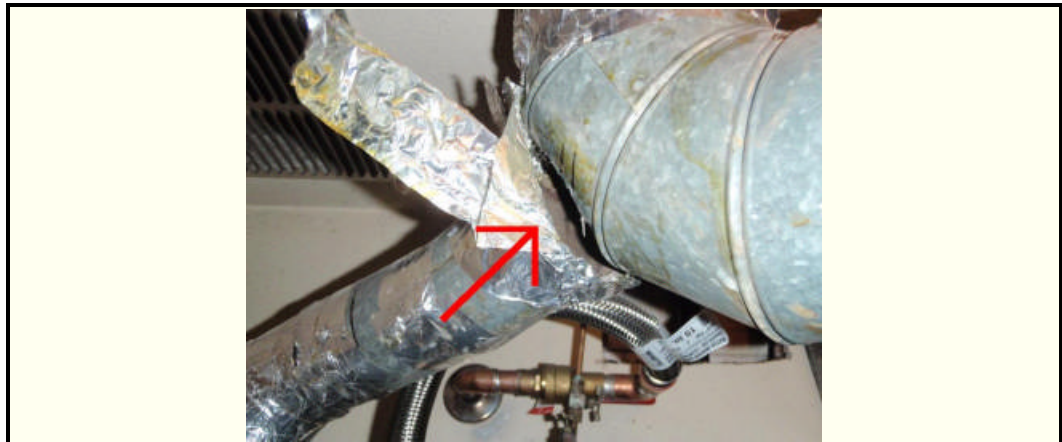
The vent does not have a proper wye fitting where it connects to the furnace vent. The vent is loose at the fitting, a carbon monoxide hazard. I recommend having a plumber or heating contractor install the proper fitting and secure the vent pipe.

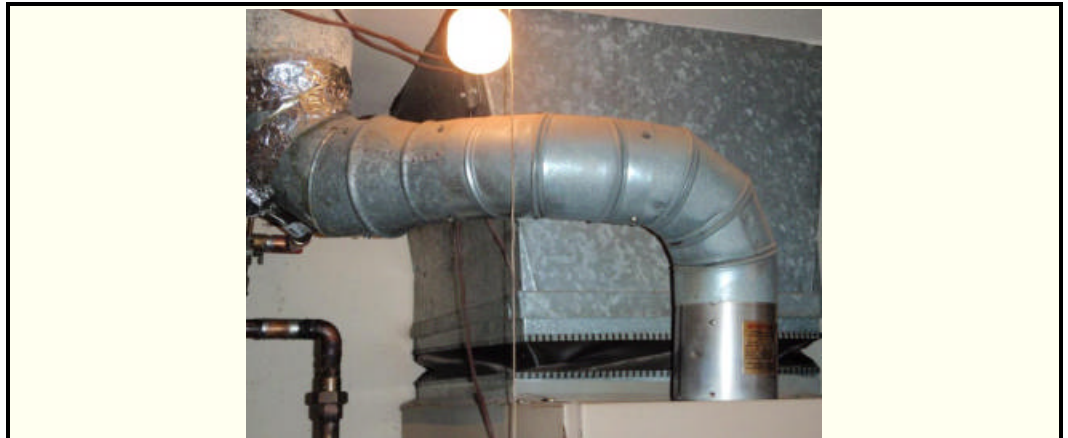
Single wall vent pipe does not appear to have proper clearance to the wood closet door (6 inches required). I recommend having the single wall pipe replaced with double wall type B vent that only requires 1 inch of clearance.

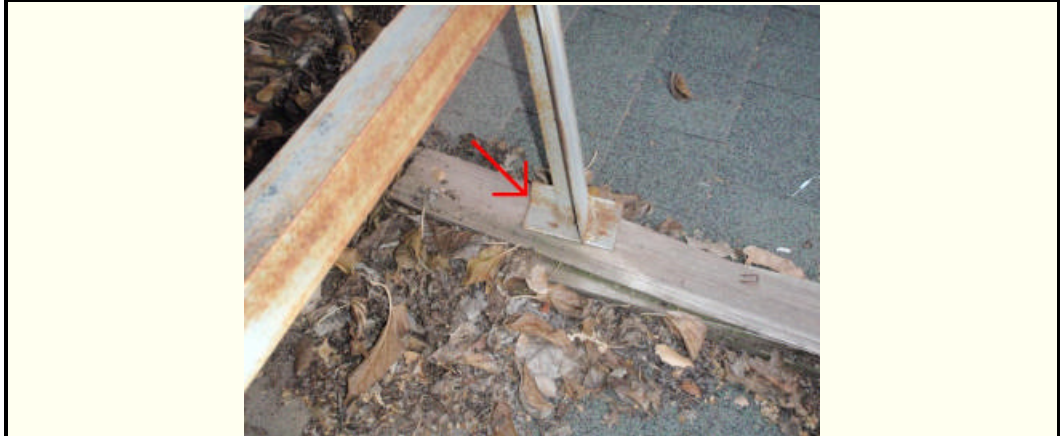
CONCERN(S) AND RECOMMENDATION(S):
The unit does not appear to be properly secured to the roof or properly shimmed. I recommend evaluation and repair by a heating contractor.

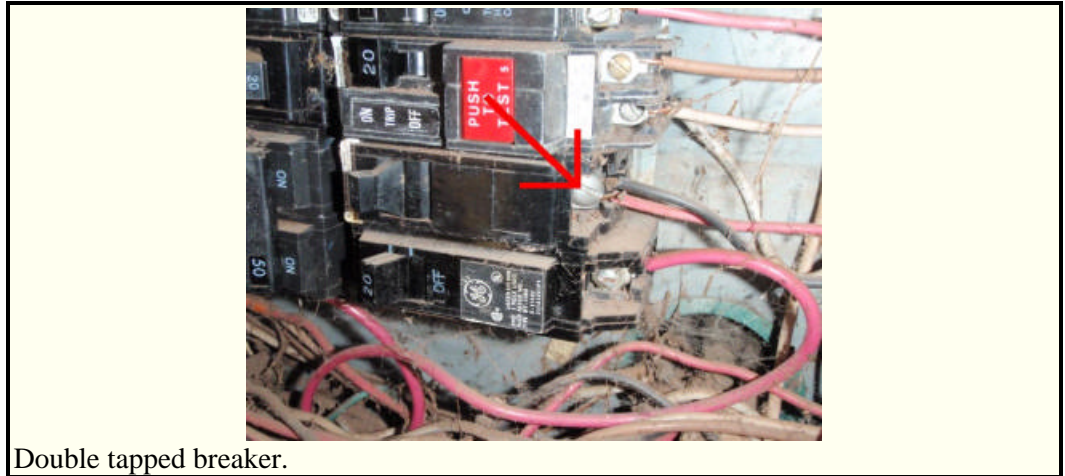
Two circuits are connected to one breaker. This brand of breaker is intended for a single circuit. Because the breaker lugs are not designed for 2 conductors, loosening and arcing can occur. Have an electrician make modifications made so that each circuit has its own circuit breaker.

Double tapped breaker.

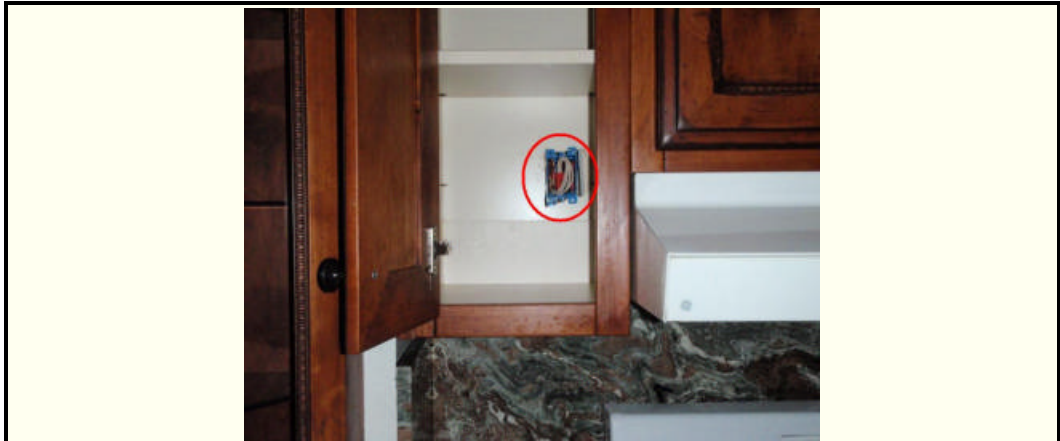
Junction boxes in the upper kitchen cabinet left of the stove and 2 in the garage attic are missing the covers. Have a handyman or electrician install covers on the open junction boxes for safety.

Open junction box in the kitchen.

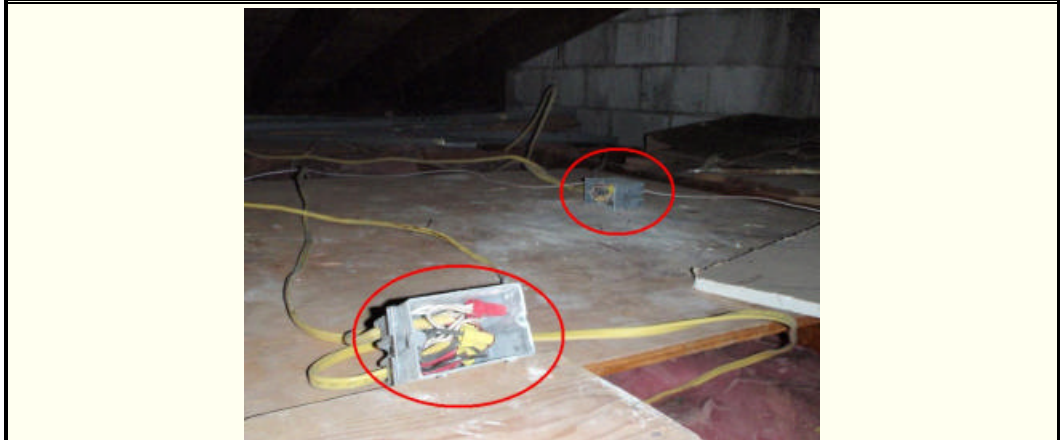
Open junction boxes in the attic.

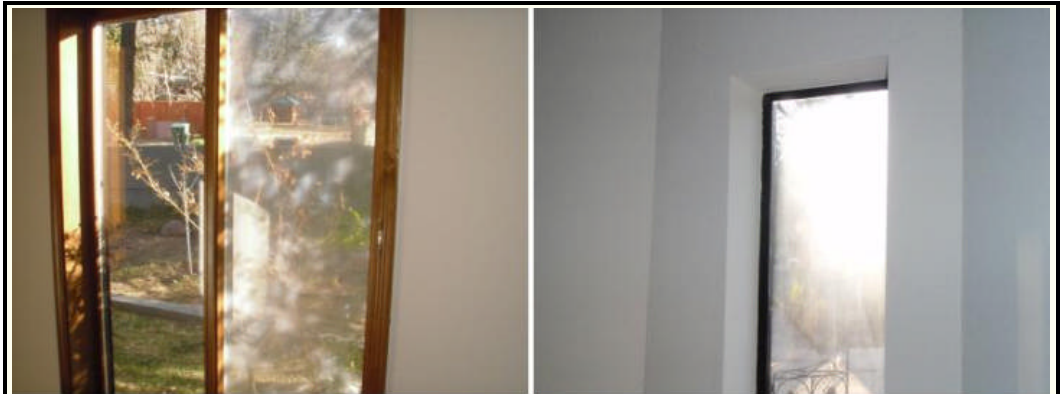
2 clerestory windows, 1 living room bay window (southeast corner) and 1 northeast corner bedroom window show the presence of condensation and streaking between the double panes. This is an indication that the seal is leaking. Although this does not measurably affect the insulating value on this type of window, it is a fairly significant aesthetic issue. The only fix is glass replacement. Other windows may be affected but not discovered due to weather or lighting conditions. If more than one or two broken seals are found, I generally suggest further evaluation by a glass company to determine if other windows are affected.

Fogged windows.

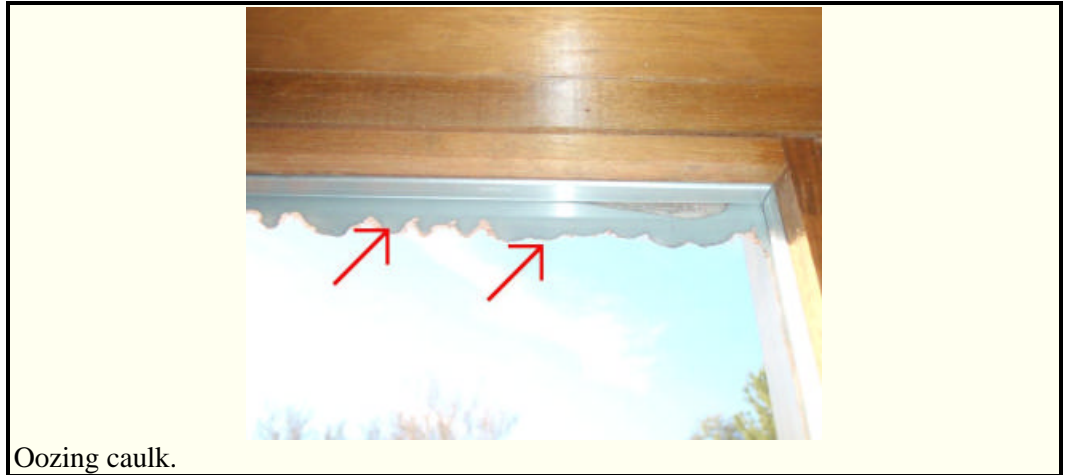
Caulk is oozing from the window frames in a few areas. This can usually be cleaned off.

Oozing caulk.

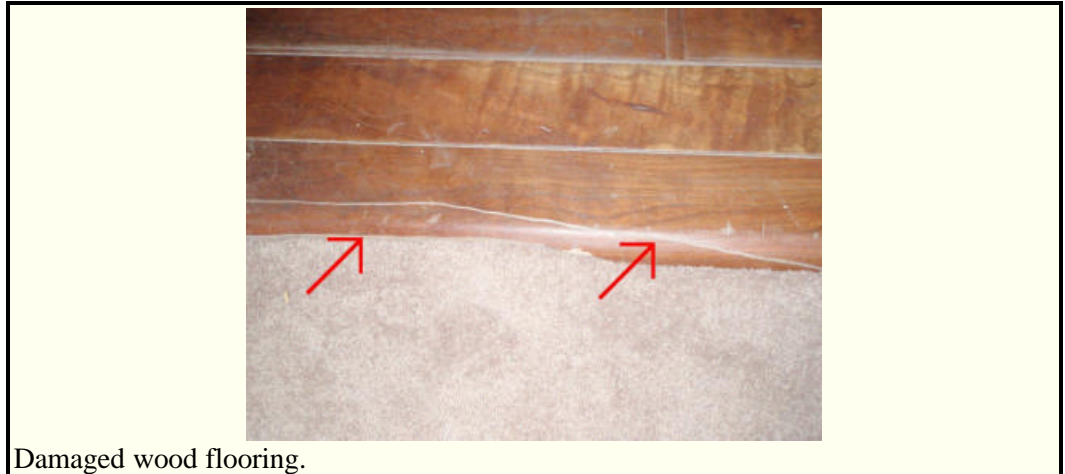
Wood floors: Heavy wear noted. Refinishing is recommended. Wood is split or damaged at the top family room step and at the master bedroom threshold, suggest repair of damaged or split boards.

Damaged wood flooring.

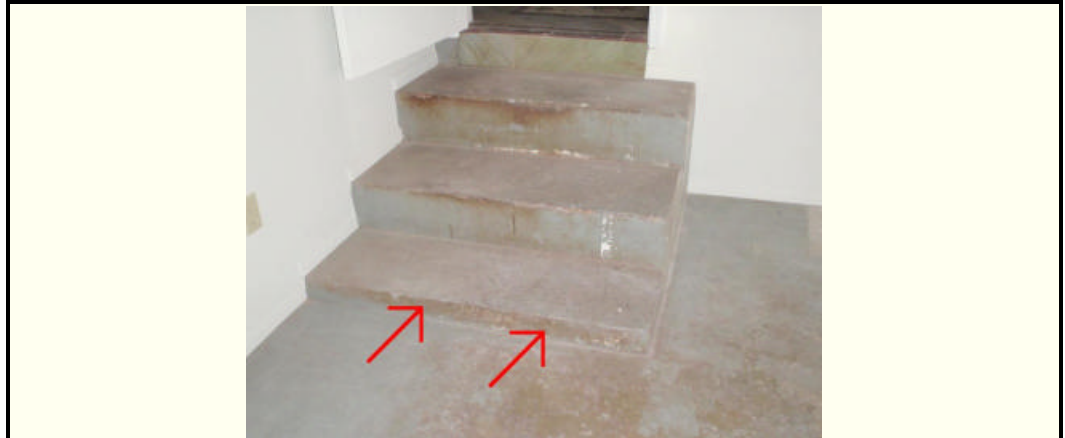
The garage steps have varying riser height, a trip hazard. Installation of a handrail may make the steps safer.

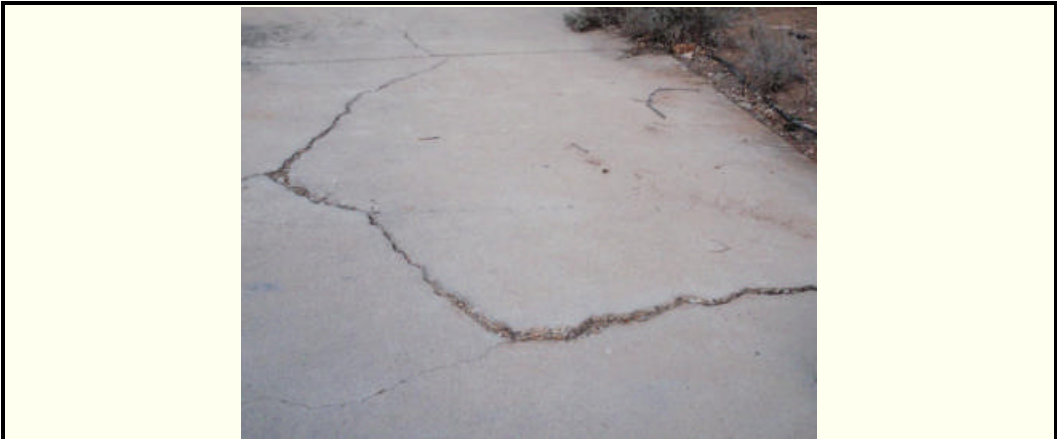
Large cracks noted.
Concrete driveway cracks are common in this area and repairs are generally unsatisfactory. Consult with a concrete contractor to determine if repairs or resurfacing are possible or cost effective.

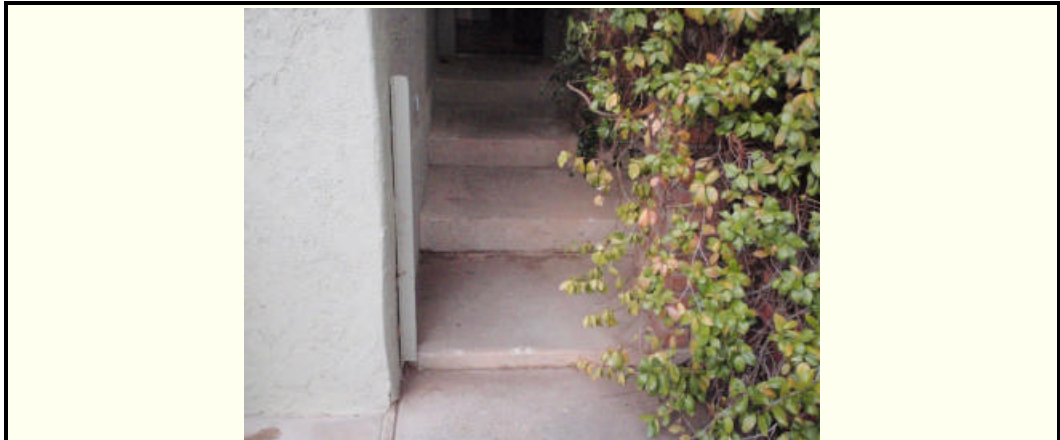
Front entry steps have varying riser height, a trip hazard. Installation of a handrail is recommended.

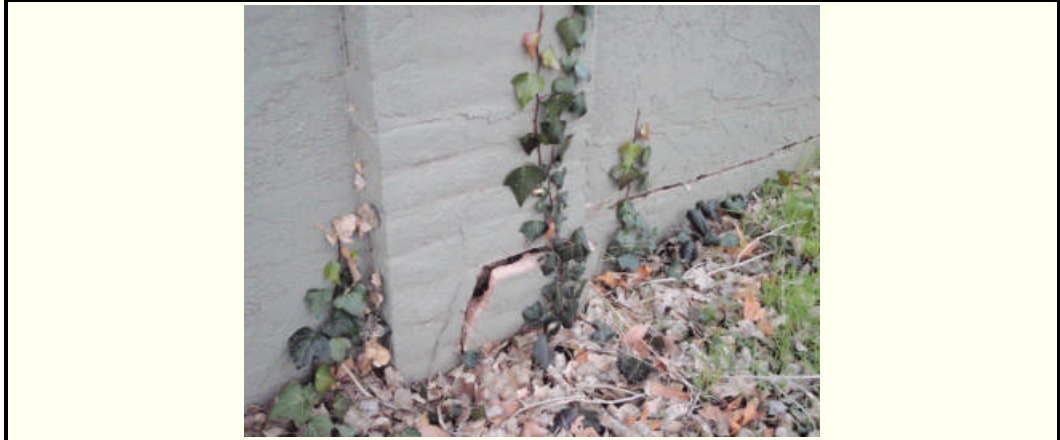
Large cracks are noted, probably from tree root growth. I recommend having the cracks repaired. If the cracking continues, trees may need to be removed.
