Inspection Report Compiled For:

Tuesday February 21, 2012

Report 8654

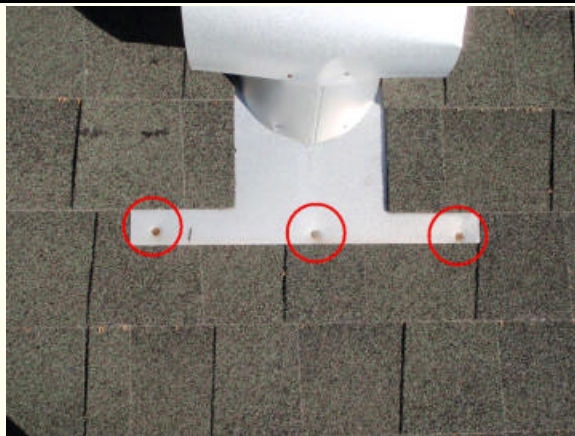
There is a row of exposed nail heads below each vent pipe roof jack. These are areas that may eventually leak. I recommend sealing or caulking all exposed nails.

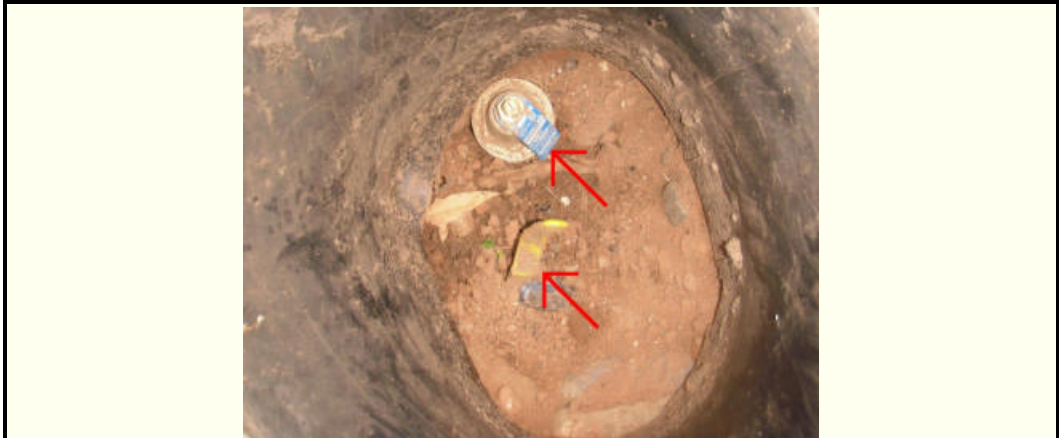
Main water valve and pressure regulator.

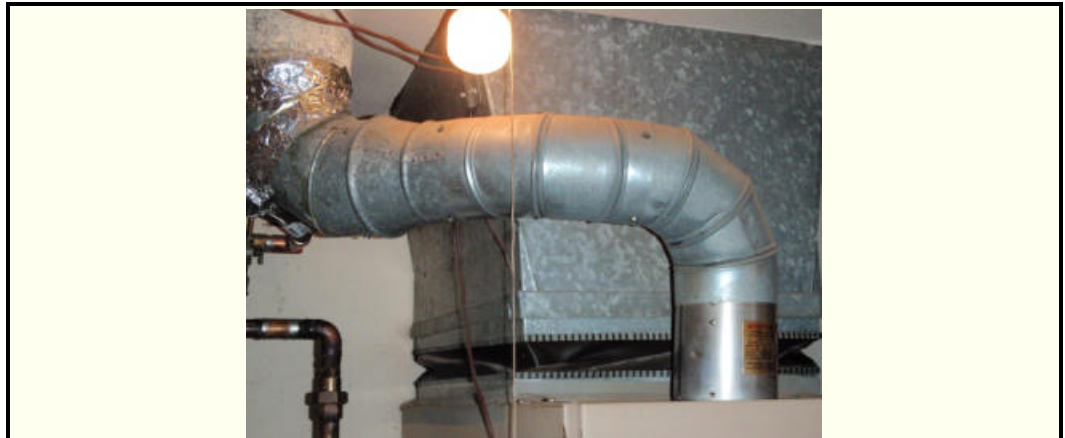
Single wall vent pipe does not appear to have proper clearance to the wood closet door (6 inches required). I recommend having the single wall pipe replaced with double wall type B vent that only requires 1 inch of clearance.

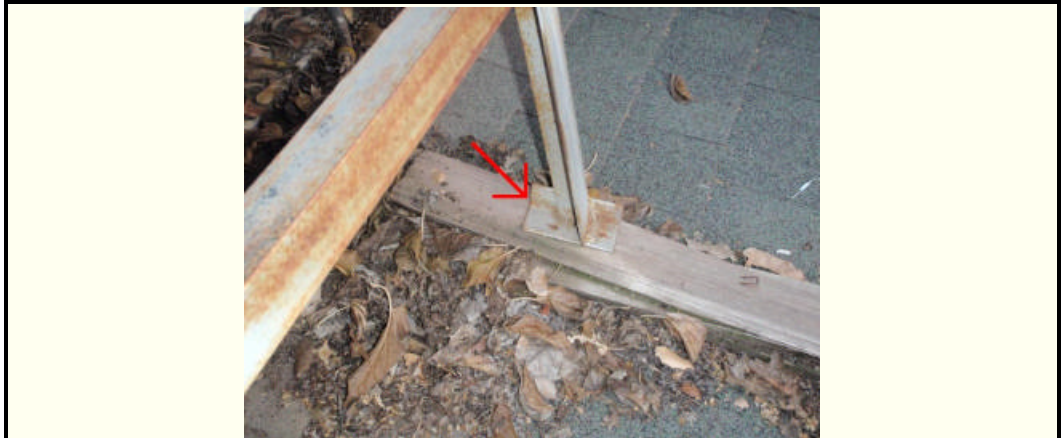
CONCERN(S) AND RECOMMENDATION(S):
The unit does not appear to be properly secured to the roof or properly shimmed. I recommend evaluation and repair by a heating contractor.

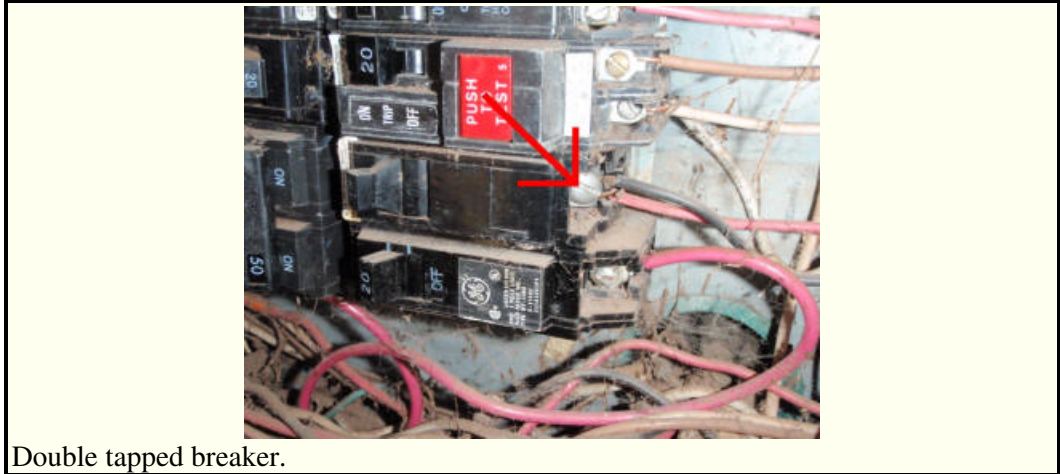
Two circuits are connected to one breaker. This brand of breaker is intended for a single circuit. Because the breaker lugs are not designed for 2 conductors, loosening and arcing can occur. Have an electrician make modifications made so that each circuit has its own circuit breaker.

Double tapped breaker.

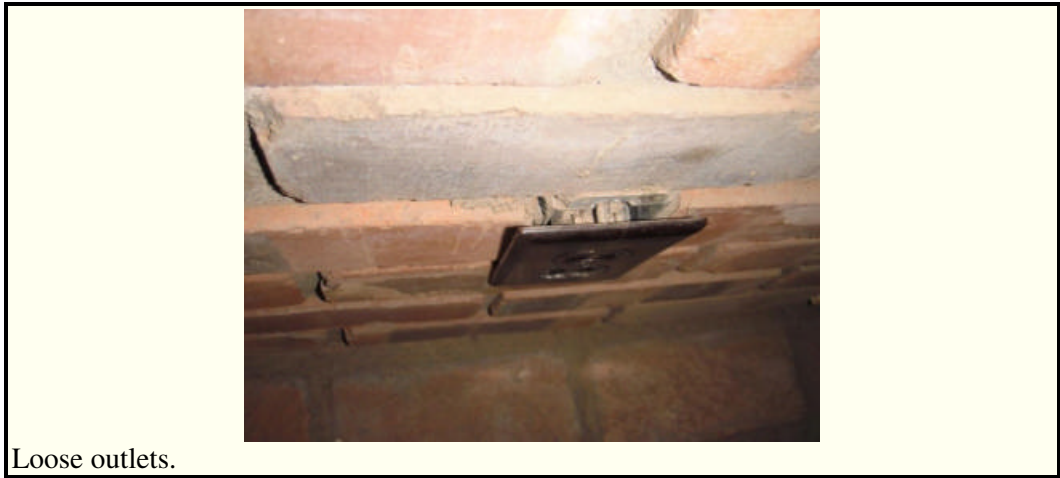
Outlets by the woodstove and by the fireplace are loose in the wall or hearth. Have an electrician repair any loose outlets.

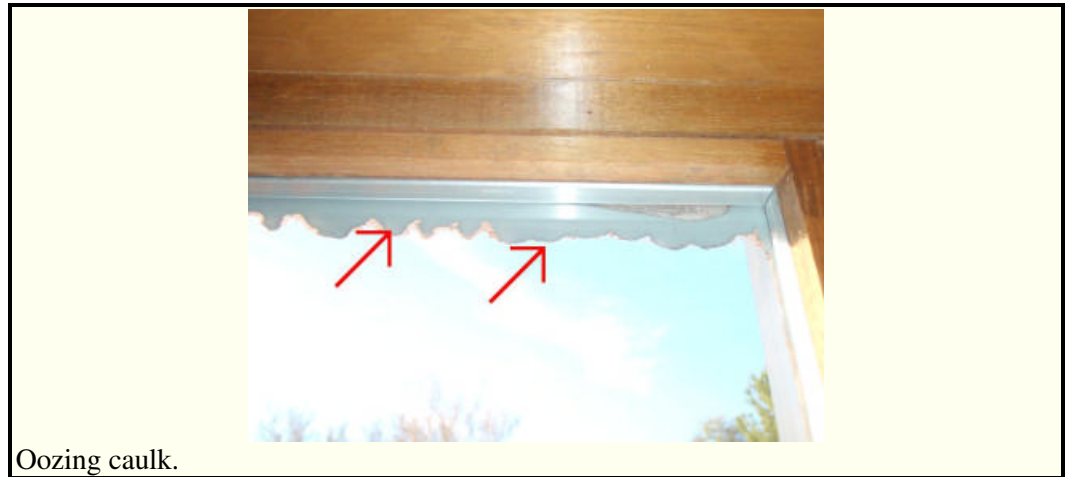
Caulk is oozing from the window frames in a few areas. This can usually be cleaned off.

Oozing caulk.

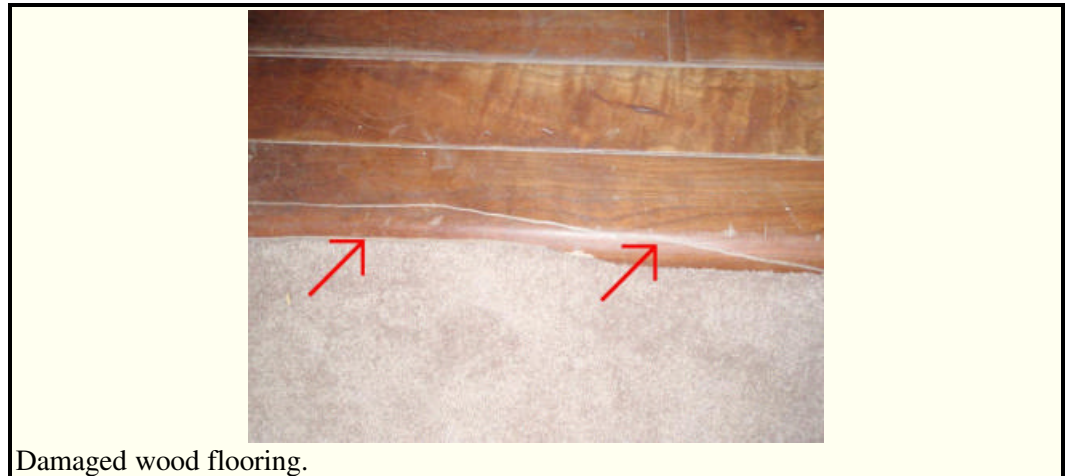
Wood floors: Heavy wear noted. Refinishing is recommended. Wood is split or damaged at the top family room step and at the master bedroom threshold, suggest repair of damaged or split boards.

Damaged wood flooring.

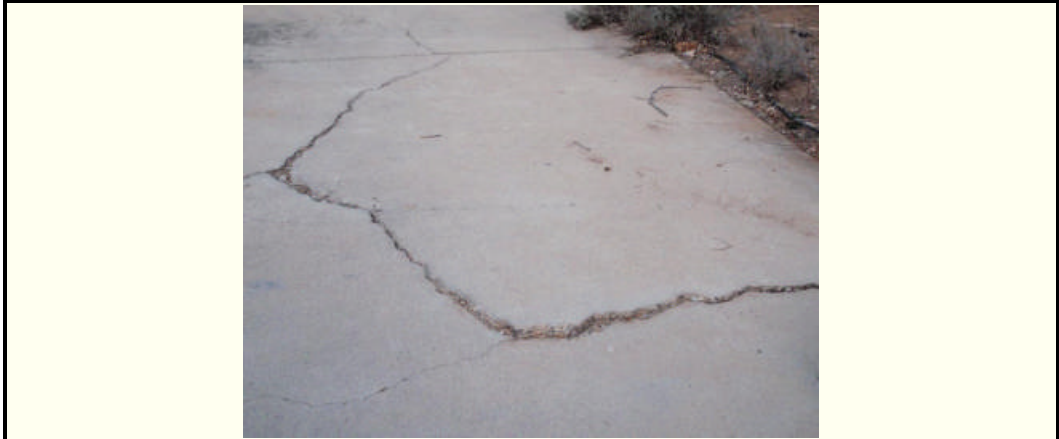
Large cracks noted.
Concrete driveway cracks are common in this area and repairs are generally unsatisfactory. Consult with a concrete contractor to determine if repairs or resurfacing are possible or cost effective.

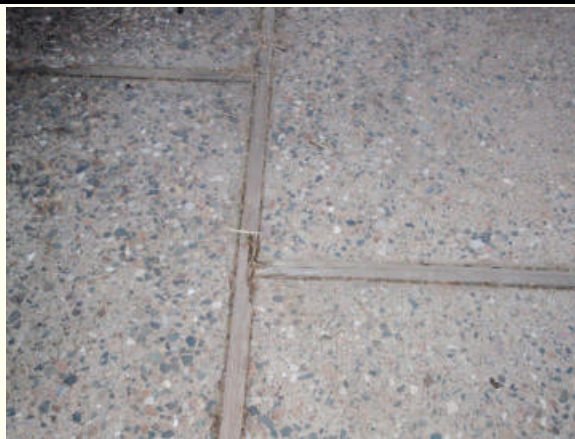
Wood patio dividers are deteriorated in some areas (typical), remove or replace as needed. One solution is to remove the wood dividers and mortar or grout the gaps.

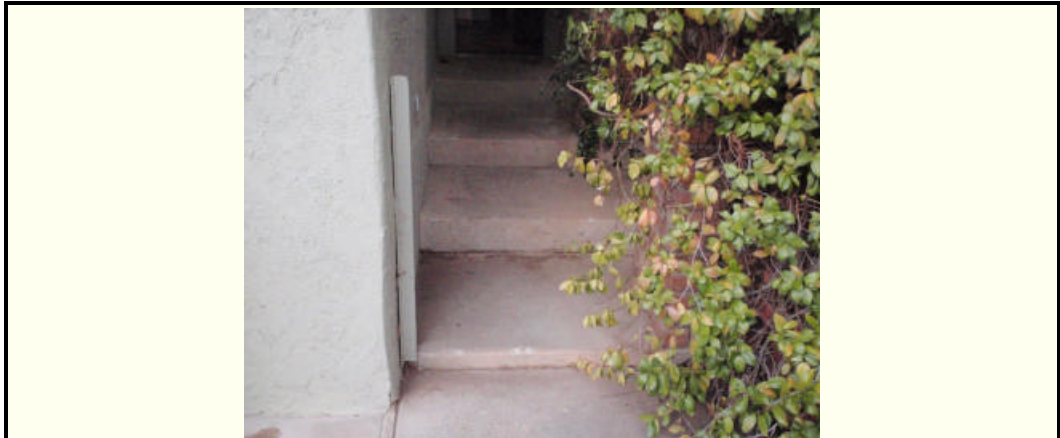
CONCERN(S) AND RECOMMENDATION(S):
Front entry steps have varying riser height, a trip hazard. Installation of a handrail is recommended.

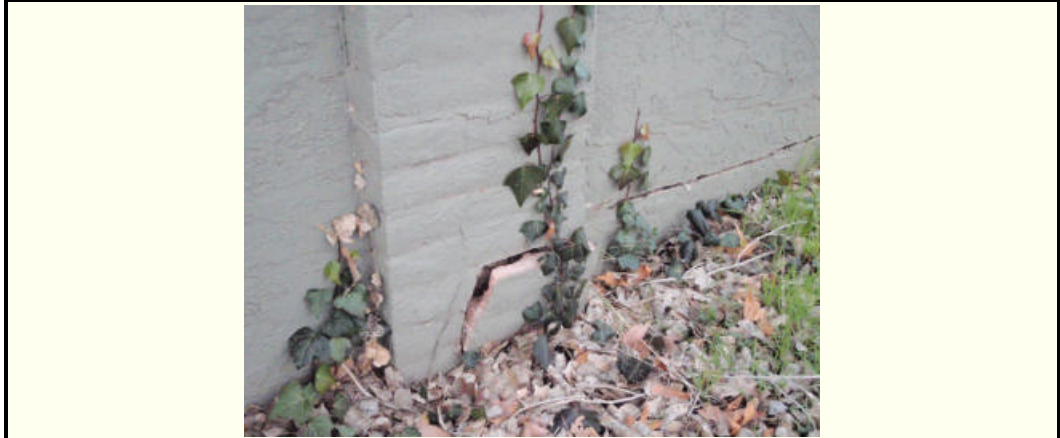
Large cracks are noted, probably from tree root growth. I recommend having the cracks repaired. If the cracking continues, trees may need to be removed.
