# PROPERTY INSPECTION

Property inspection performed on for property address: 1234 Champagne Lane Paulden, AZ. Report prepared by Roger Skaggs exclusively for My Report Rocks on 04/30/2012. Use of this report by third parties without purchaser's or inspector's permission is strictly prohibited, this report is the property of the inspector and client named herein. Information shall be disclosed to other interested parties with discretion and in compliance with recognized codes of professional conduct. Report summary will not contain all inspection details, reliance on the full report is essential for all items to be addressed. Reproduction, modification in any manner is prohibited. No liability is assumed If this report is used by any other parties. Copyright © 2012 Inspect-It 1st ® Property Inspection All Rights Reserved. Phone: 877-392-6278 File:() Form:112ResAlpha

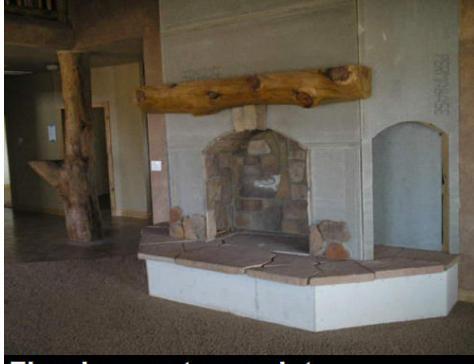
**Deficiencies** - No chimney installed. A qualified fireplace technician should be called to further evaluate and perform corrections as needed.

**Deficiencies** - Fireplace is not complete. A qualified fireplace technician should be called to further evaluate and perform corrections as needed. Decorative stone on the exterior of the chimney chase is not installed. A qualified repair person should be called to further evaluate and perform corrections as needed.

Fireplace not complete

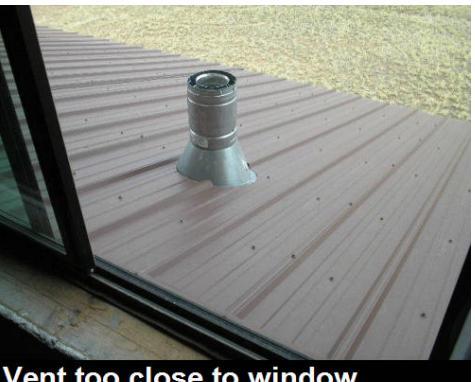
Safety Concern - Observed at the upstairs bedroom: A gas vent is installed too close to an opening window. This vent is not being used at this time. If this vent is to be used, modifying the vent is needed for safety. The vent cap is not installed.

ent too close to window

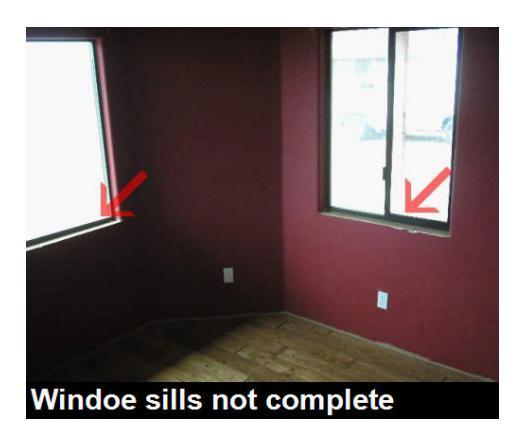
Maintenance Advised - Observed at many windows throughout the house: Widow sills are not complete. Wood framing is exposed. A qualified contractor should be called to further evaluate and perform corrections as needed.
