FOUNDATION

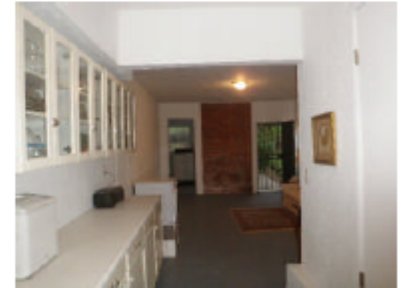
1. SLAB

Type/Condition: Basement painted concrete Appears Serviceable.

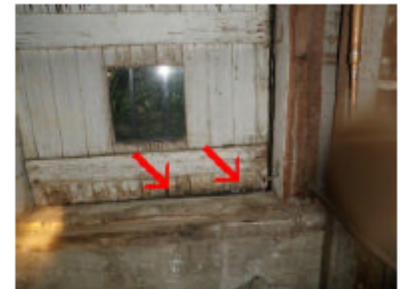
3. VENTILATION

Vent Screens: torn, bent areas **CORRECTION RECOMMENDED.**

Access Cover: Door present Appears Serviceable / **Gaps present at bypassed gas meter access door recommend corrections.**
