GARAGE - CARPORT

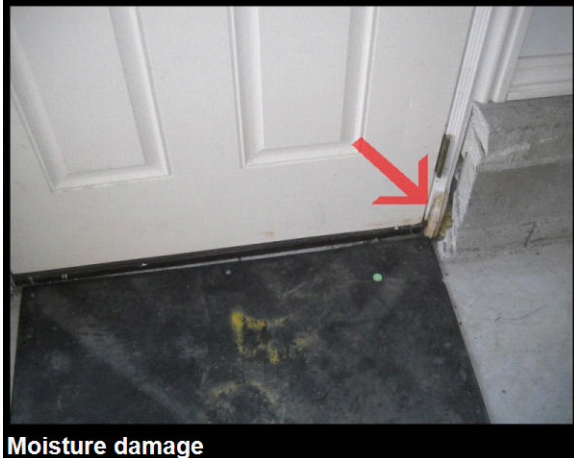
Service Doors:

Hardware operational, **Damage noted** at the lower trim of door opening. Water seepage appears to be occurring.
