Confidential Inspection Report
999 Main St.
Fort Myers, FL 33903

Prepared by: 3D Inspection Systems, Inc.
3D Inspection Systems
Fort Myers, FL 33907
800-745-6126 info@3dinspection.com

GENERAL INFORMATION

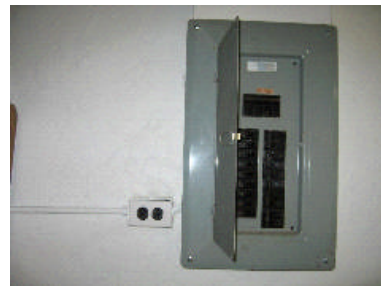
p	<i>Main Panel Location:</i> Garage, Appears serviceable.
			<i>Main Panel Observations:</i> Circuit and wire sizing correct so far as visible, Grounding system is present, Multiple wires are connected to a single lug on a circuit breaker where only one wire should be connected, Missing strain relief at panel, Have a licensed electrician make further evaluation and corrections as needed.
			<i>110 Volt Circuits:</i> 12.
			<i>220 Volt Circuits:</i> 6.
p	<i>Subpanel #1:</i> Located in the Air conditioner.
p	<i>Subpanel #2:</i> Located in the Utility room.

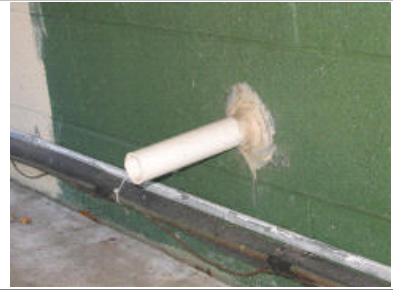
There is no trap on the drain line. Drain line empties into the rear yard and is considered a sanitary nuisance by local officials. Consider connecting this drain lin to the main drain system serving the house.

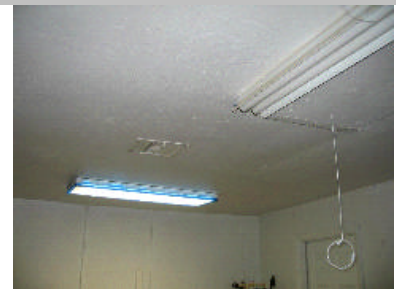
Condition: Blemishes noted. Cosmetic repairs and trim needed to improve appearance.

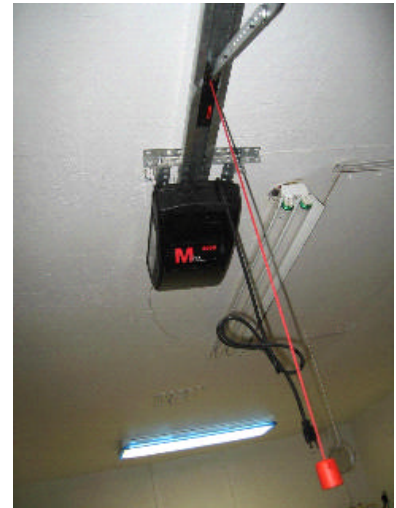
Door Operator: Automatic door opener(s)- not operational, due to a lack of power. An electrical outlet should be installed in the ceiling.
