BASEMENT

456 Castle Avenue Hamilton, OH 45013

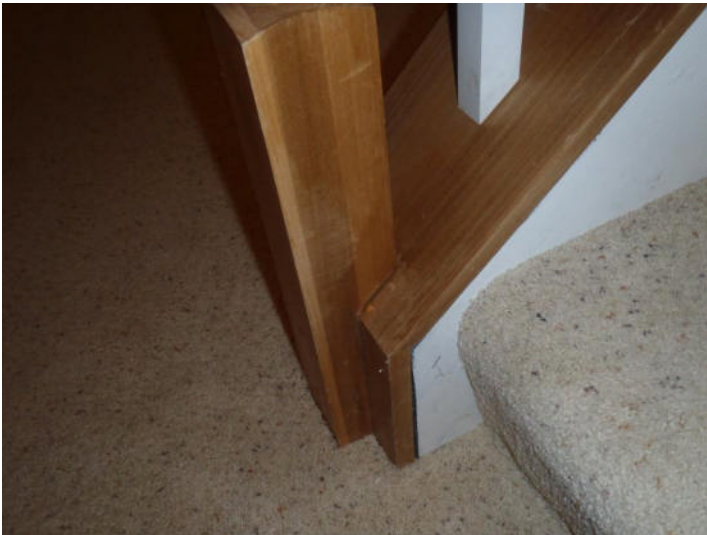
Stairs performed their designed & intended function with no defects viewed. Handrails performed their designed & intended function except for the following. The following defects were viewed - Handrail is loose. A qualified Contractor should be called to make corrections as needed.
