LOCATION: Hall.

A- 2. Tub Faucet

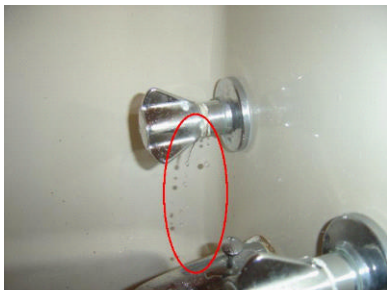
The faucet was leaking. If excessive, this can cause damage to the wall cavity behind the faucet. Correction by a qualified contractor is recommended.

Droplets from a leaking faucet control.

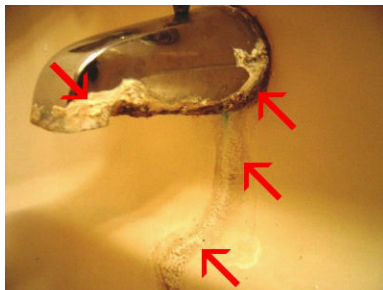
The faucet handle(s) was difficult to operate. This may be due to age or an accumulation of mineral deposits. Correction by a qualified contractor is recommended. (Lot of mineral deposits.)

Heavy mineral deposits from chronic leaks.
