## EXTERIOR - PART A

### **PART A: EXTERIOR COMPONENT OBSERVATIONS**

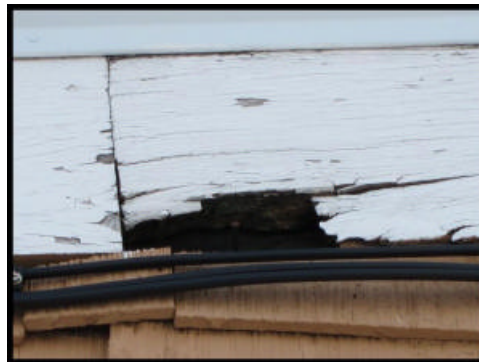
#### 4.1 Wood Siding:

Moisture has penetrated the siding in areas causing rot. All rotted siding should be replaced or repaired with a patching material designed for wood repair (1C.06).
