FIREPLACE OR SOLID FUEL HEATING

FIREPLACE

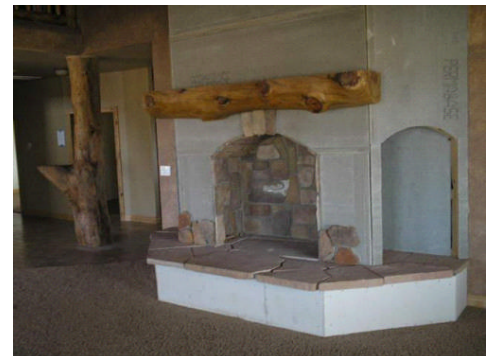
8.3 Firebox

Deficiencies - Fireplace is not complete. A qualified fireplace technician should be called to further evaluate and perform corrections as needed. Decorative stone on the exterior of the chimney chase is not installed. A qualified repair person should be called to further evaluate and perform corrections as needed.

Fireplace not complete

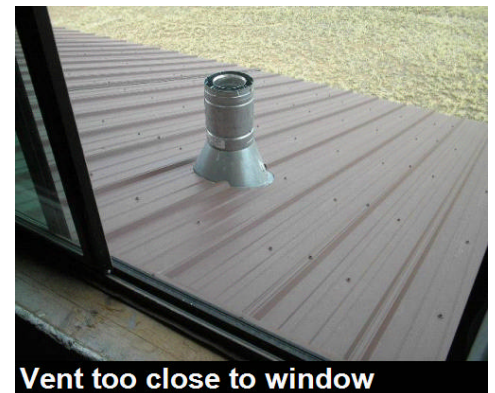
9.4 Window Overview

Safety Concern - Observed at the upstairs bedroom: A gas vent is installed too close to an opening window. This vent is not being used at this time. If this vent is to be used, modifying the vent is needed for safety. The vent cap is not installed.

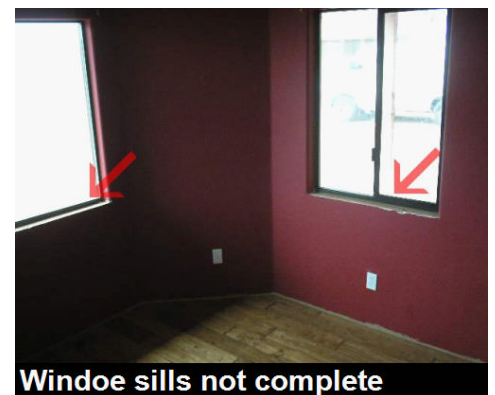
9.5 Window Sills

Maintenance Advised - Observed at many windows throughout the house: Window sills are not complete. Wood framing is exposed. A qualified contractor should be called to further evaluate and perform corrections as needed.
