Property Inspection Report
456 Castle Avenue
Warminster, PA 18974

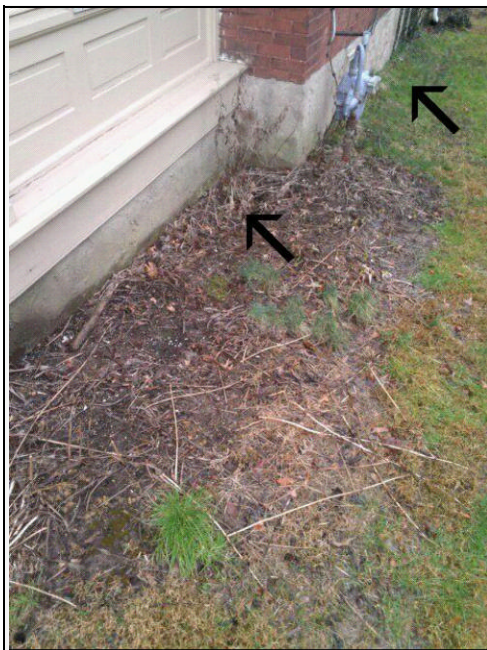
Grade needs correction or adjustment at the following locations: Front, left and right side. Negative pitch increases the risk of water seepage into the foundation area. Correction is recommended by a qualified landscape contractor or qualified individual. Pitch slope of soils away from foundation. Slope should fall away from the foundation at a minimum of 1/4 inch per foot and extend at least 10 feet away from the foundation if possible. A good fill soil is recommended that contains some clay. Avoid using permeable soil such as topsoil and sandy materials.

Negative pitch towards foundation walls

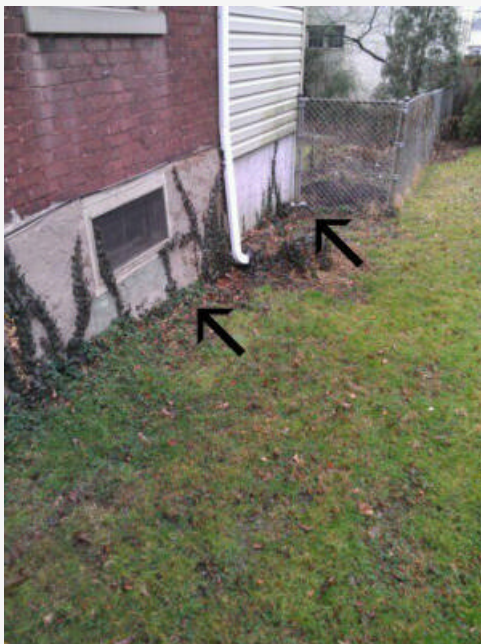
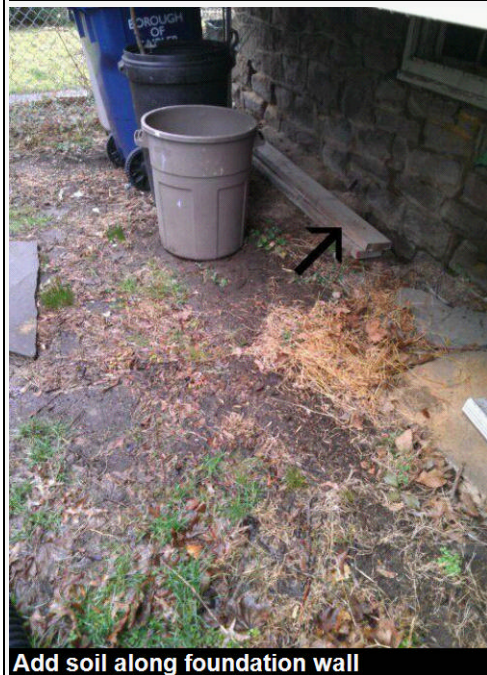
Add soil along foundation wall

Keep in mind in the future to add soil in any areas of settlement or erosion around foundation to promote drainage away from the foundation. It is a good practice to have at least 1/4 inch per foot sloping away for the first 10 feet if possible.

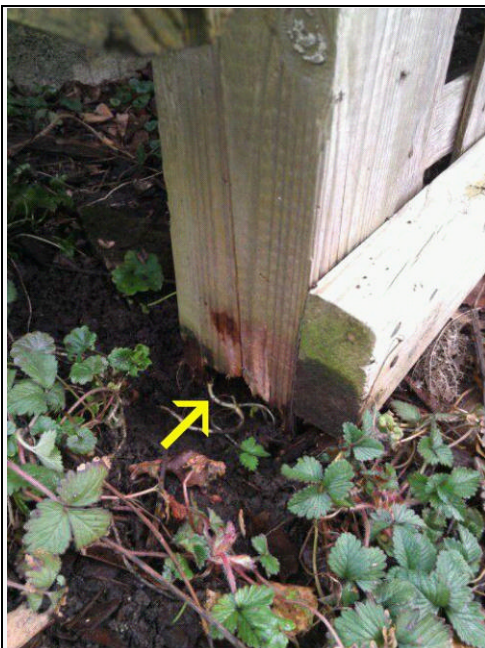
Improper conditions are present which need attention/repair by a qualified contractor. Support post on the left side of the deck is almost completely rotted and lacks adequate support. Improvements to post size is recommended as well.

Base of post is rotted.

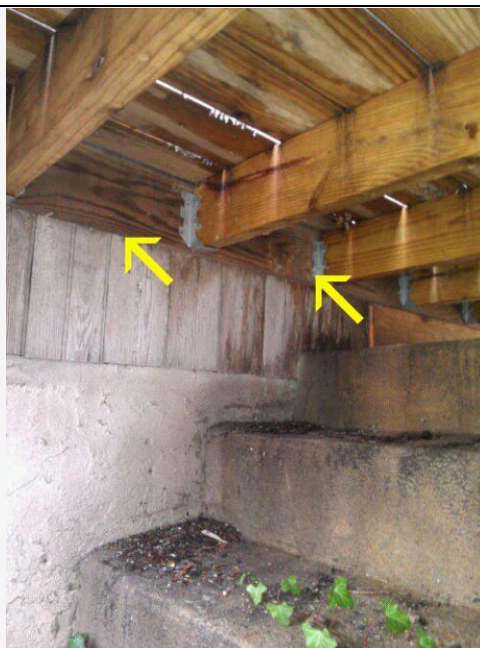
Deck improperly supported

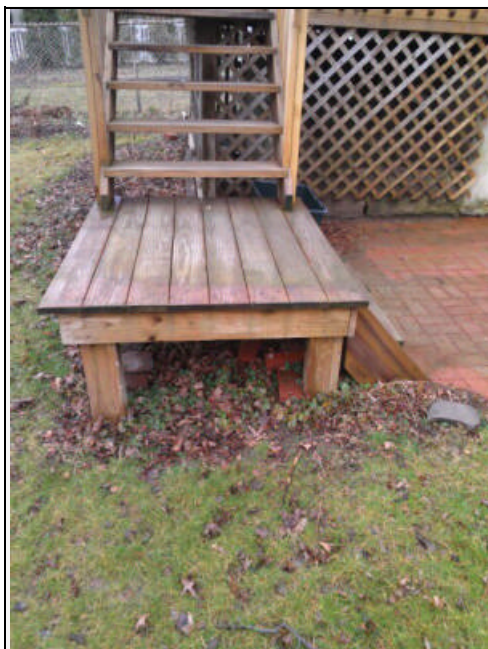
Steps are in fair overall condition. **A handrail is recommended for safety at the lower landing and steps. Steps with greater than two steps should have a railing for safety. Check local jurisdiction for local requirements.**

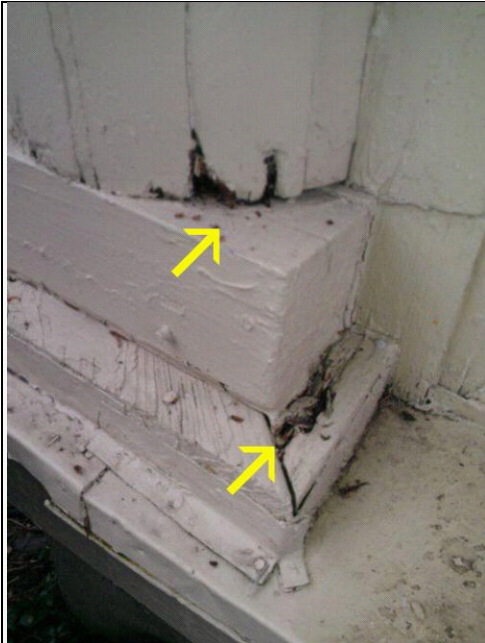
Wood post and surrounding trim is rotted at the front left corner of the porch. Repairs are recommended by a qualified contractor to prevent additional deterioration.

Wood rot present

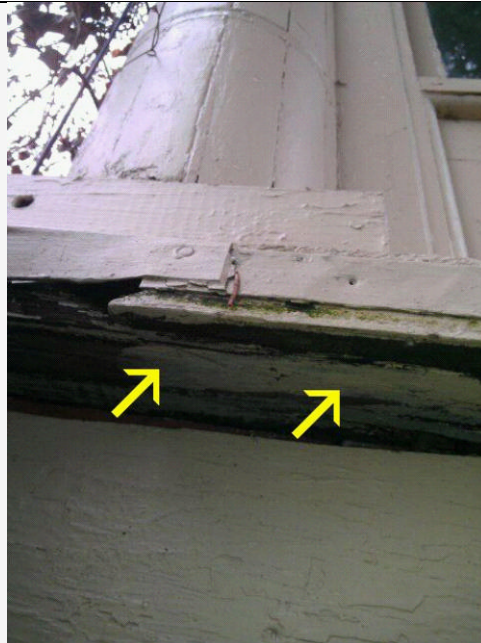
Rot present under capping

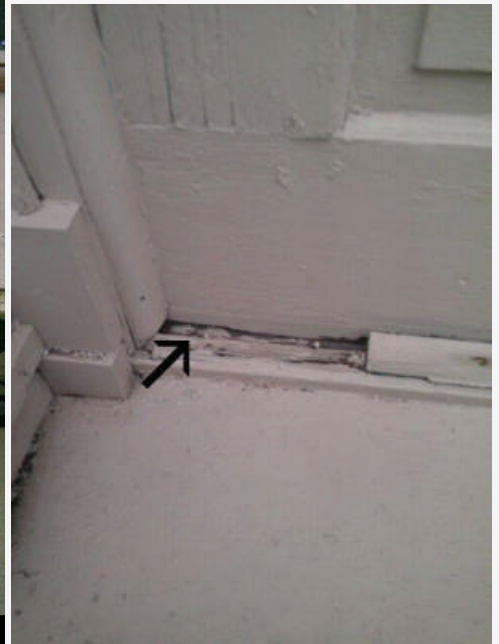
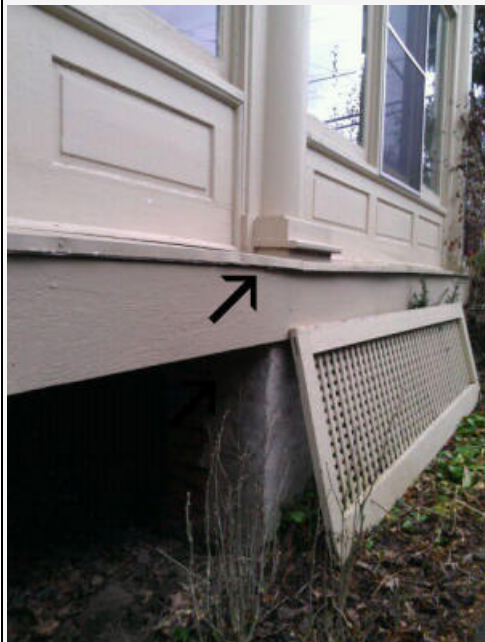
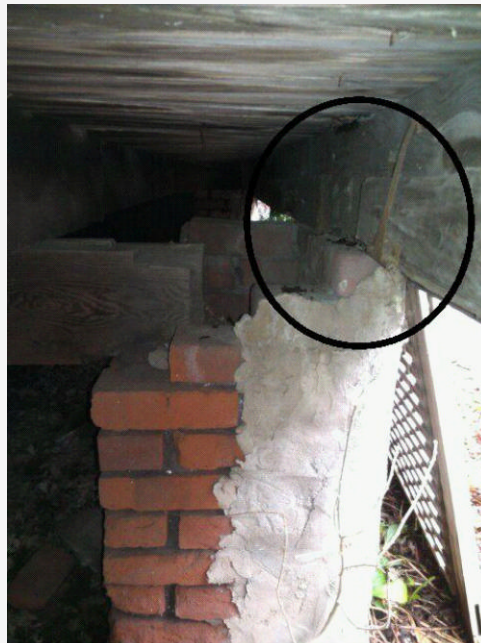
Several of the support posts lack adequate support. The brick piers located below the support posts are not centered and have loose bricks at more than one location. There are some locations where the support posts are barely supported and the piers are leaning. Further

Wood and posts hardly supported.

evaluation and structural repairs are needed by a qualified contractor.

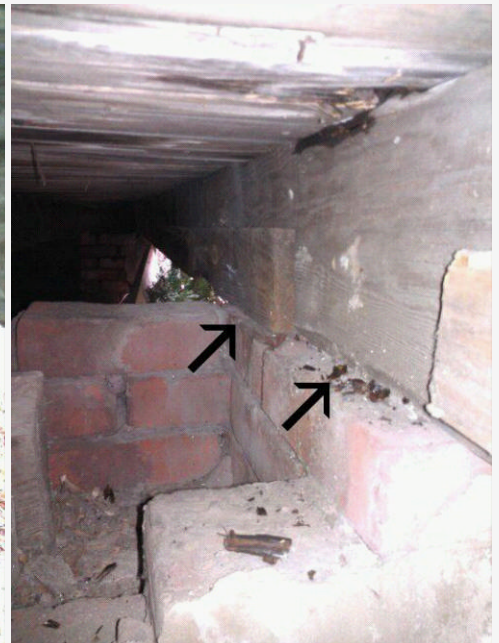
Improperly supported joist

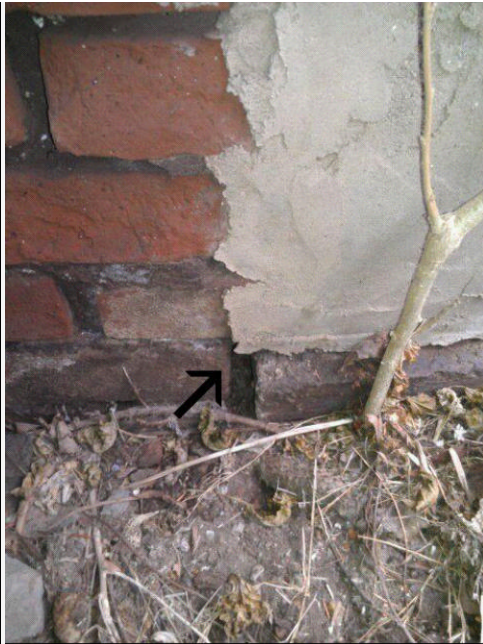
Loose brick at pier

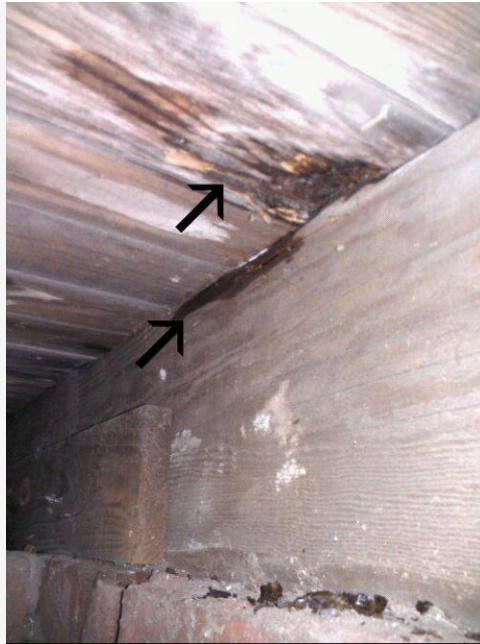
Water leakage is taking place which is damaging the framing at this location. Further evaluation and repairs are recommended by a qualified and licensed contractor.

Water damage /rot

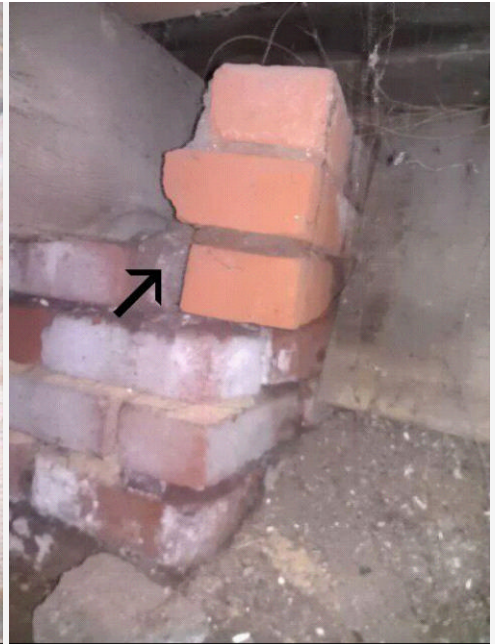
The brick are loose at front support posts as well. Further evaluation and repairs are recommended by a qualified and licensed masonry contractor.

Loose brick along front columns

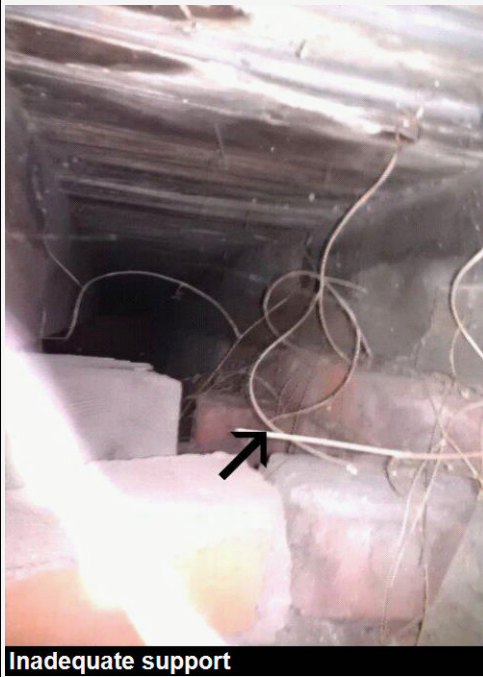
Inadequate support

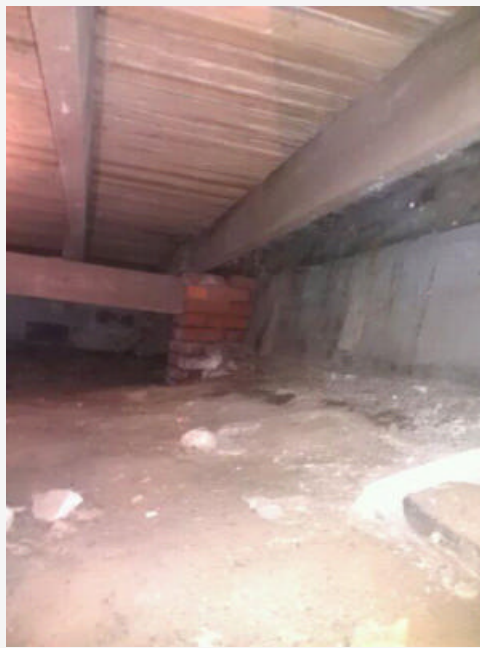
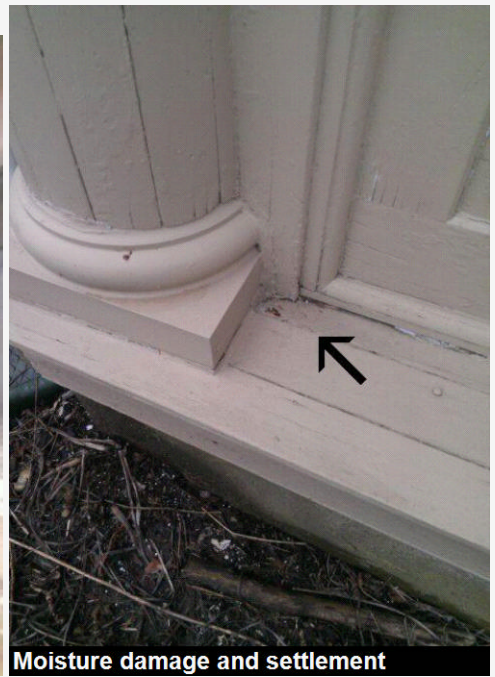
Settlement and moisture damage is also present the left side of the porch where post is located. Repairs should be made as needed by a qualified contractor. .

Moisture damage and settlement

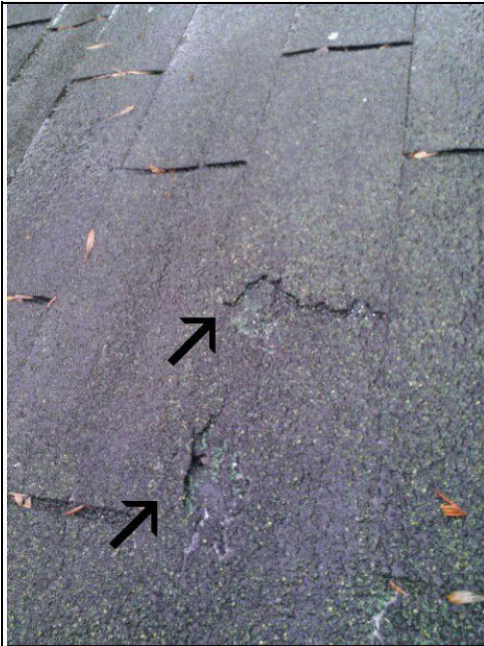
Asphalt composition shingles show signs of moderate weathering and aging. Deterioration to shingles is present along the left side of the porch. Evidence of leakage was viewed at interior of porch at this location. Recommend contacting a licensed roofer for further evaluation and repair or replace roof as needed.

Deteriorated shingles

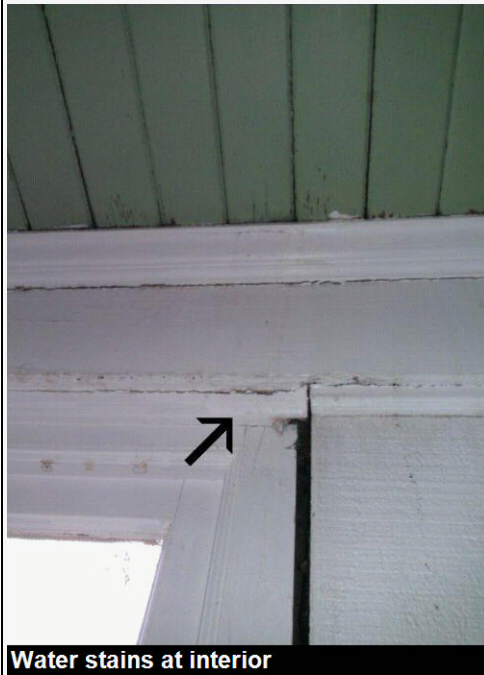
Water stains at interior

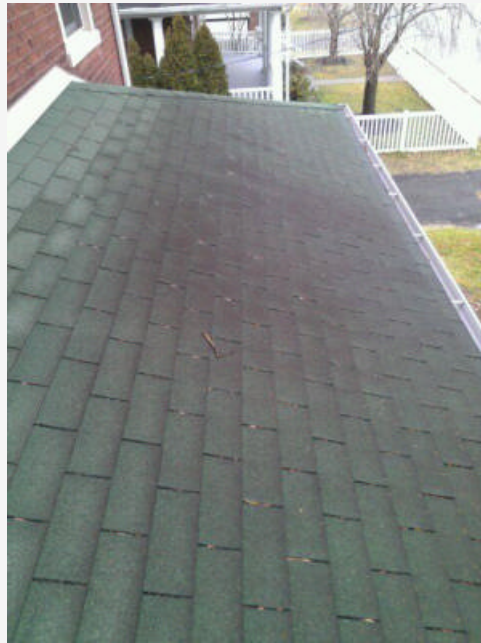
Damaged shingle

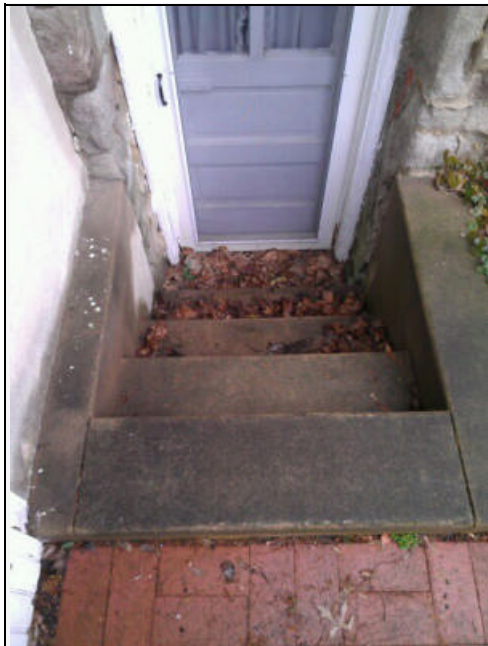
Handrail recommended at rear steps. Any stairs with greater than two steps should have a railing for safety. Check local jurisdiction for local requirements.

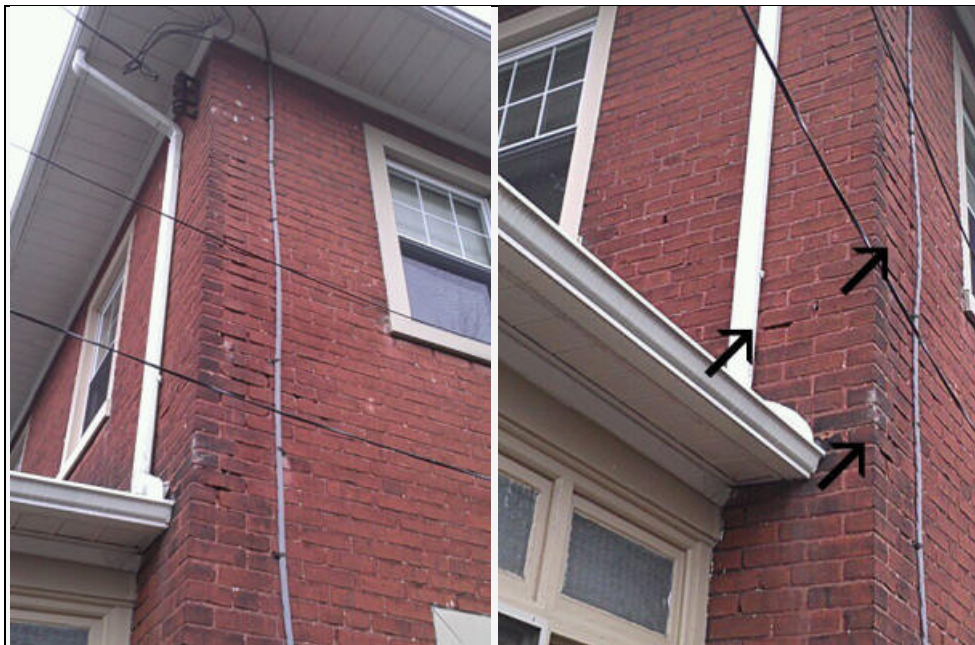
Re pointing of the masonry is recommended at this time by a qualified masonry contractor at several locations at the front and side of the house.

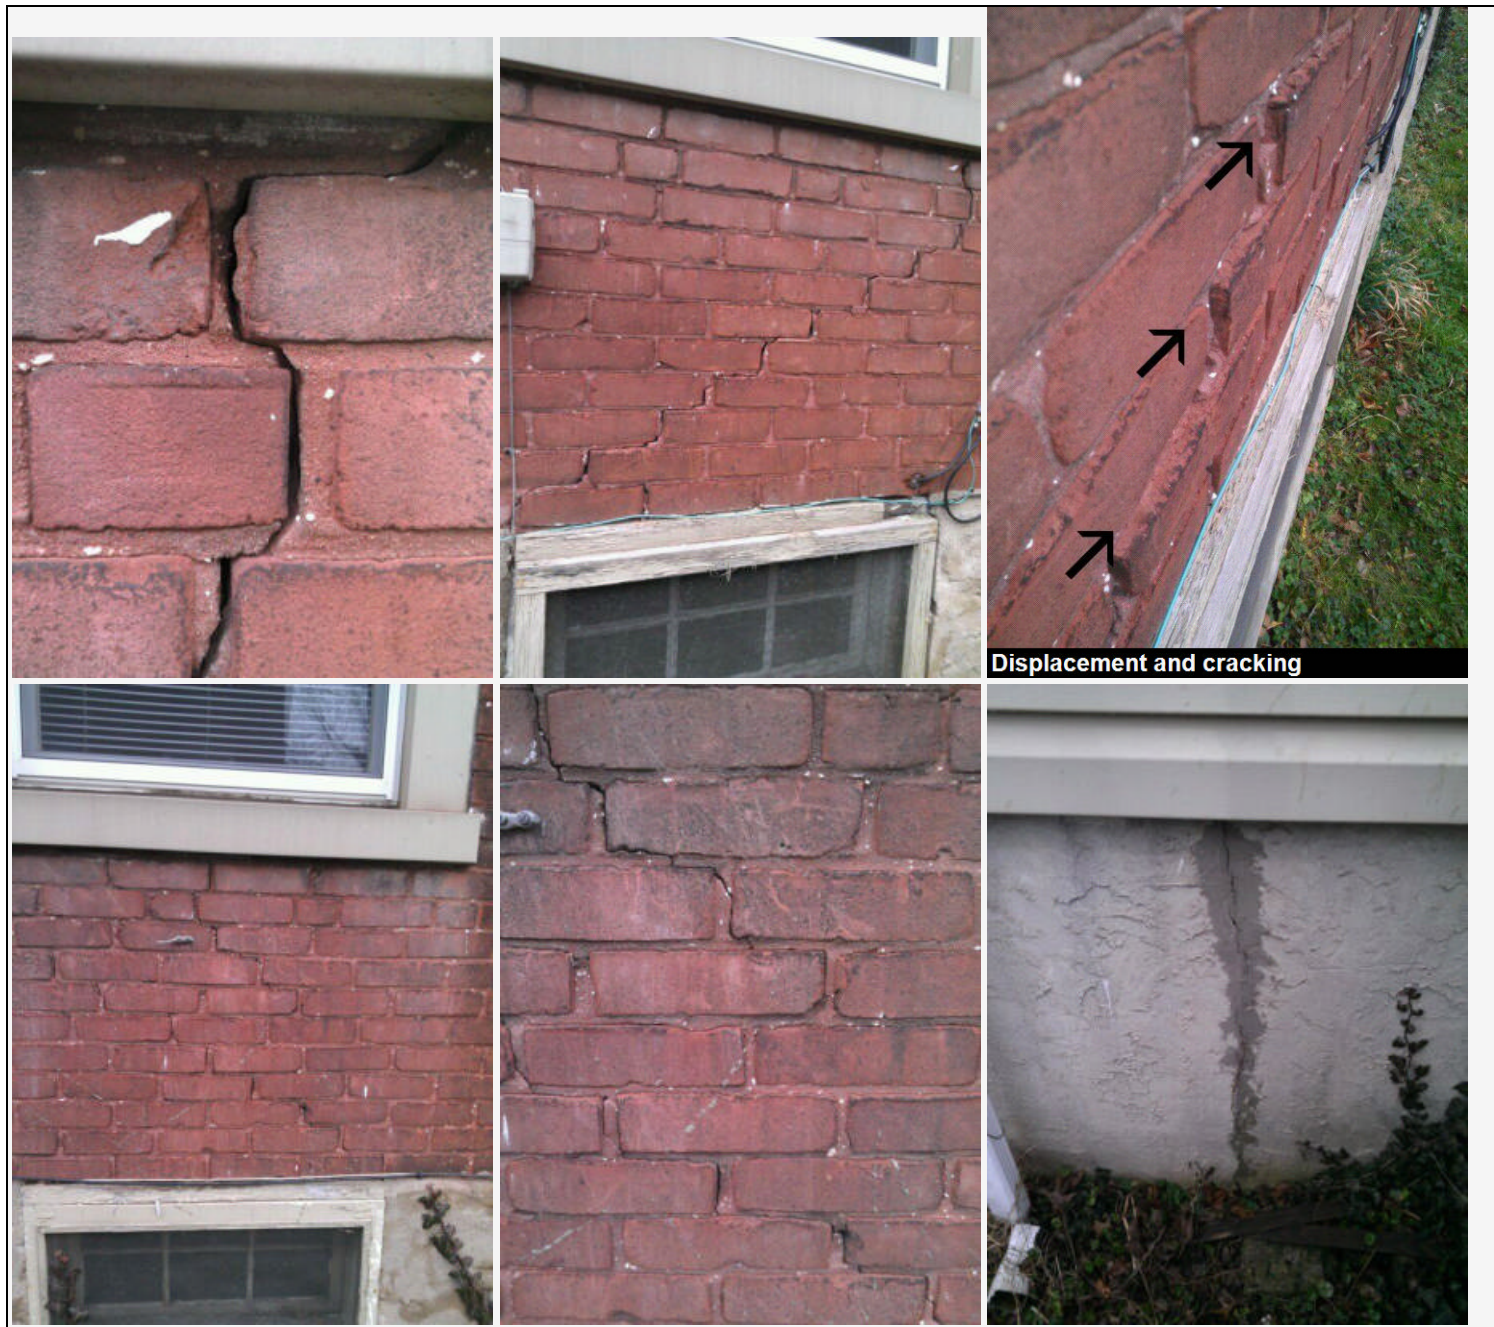
Structural repairs needed at the right side of the house. There are several stair stepped cracks in the structure and displacement present. This may be an indication of foundation defects or ongoing settlement. Further evaluation of structure is recommended by a licensed structural engineer to determine repairs needed.

The large crack at rear foundation wall has been patched in the past and has continued to crack which indicates that ongoing movement is present. Structural evaluation is needed by a structural engineer.

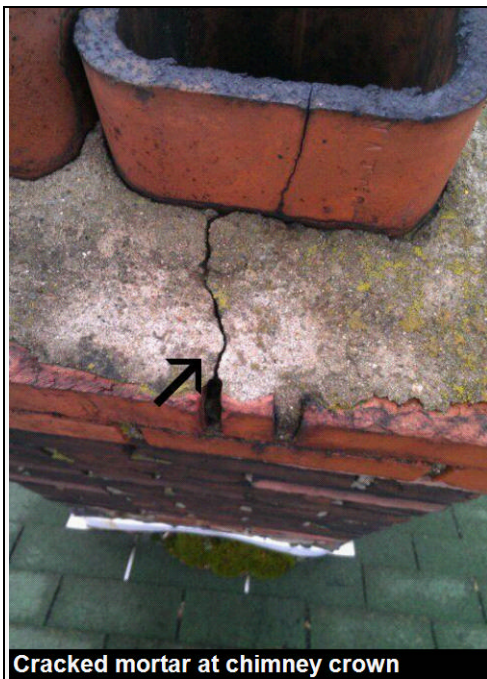
There is deterioration/cracking present to the mortar and pointing at the top of the chimney. Loose pointing is typically associated with entry points for moisture in the chimney crown. Repairs recommended to prevent damage to the integrity of the chimney and potential leakage.

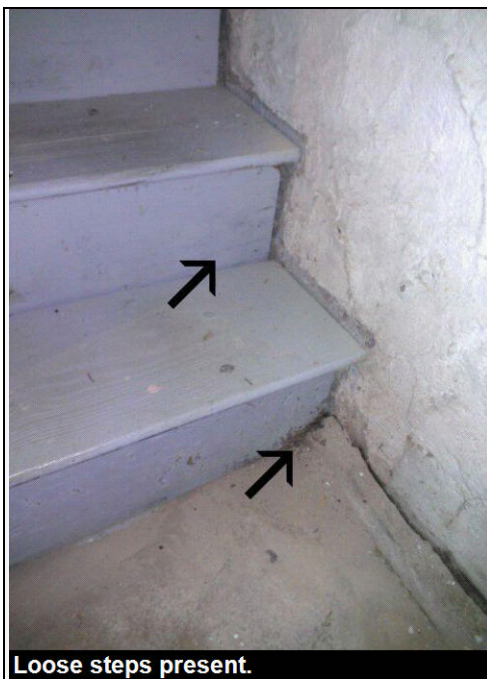
Steps are loose at the base of the steps which create a potential safety hazard. Further evaluation and repairs are recommended by a qualified and licensed contractor.

Loose steps present.

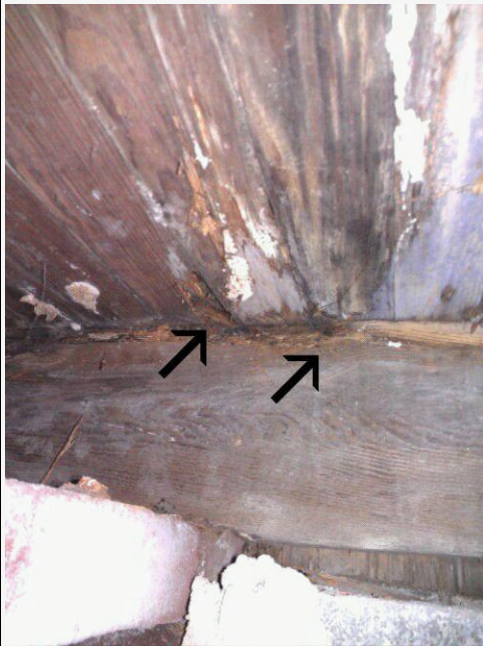
Joists rotted in some locations

Cracked floor joist is present at right side of house. Damaged joists can typically be repaired by sistering a new joist next to the damaged joist. Repaired joists should be bolted together with carriage bolts or lag screws. Repairs are recommended by a qualified contractor.

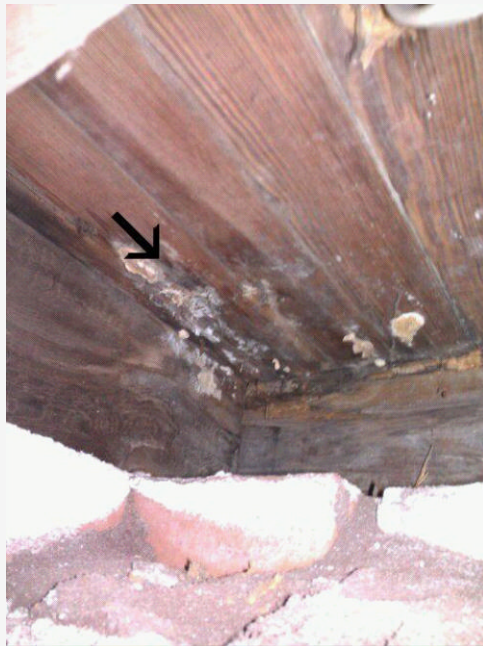
Fungus / mold-like material

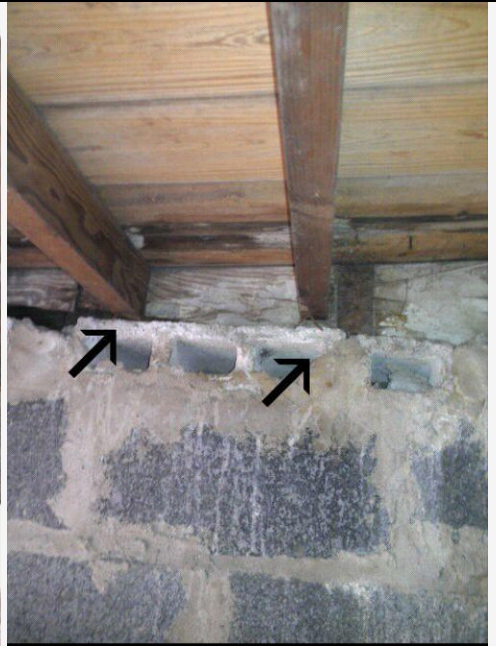
substandard floor framing below kitchen

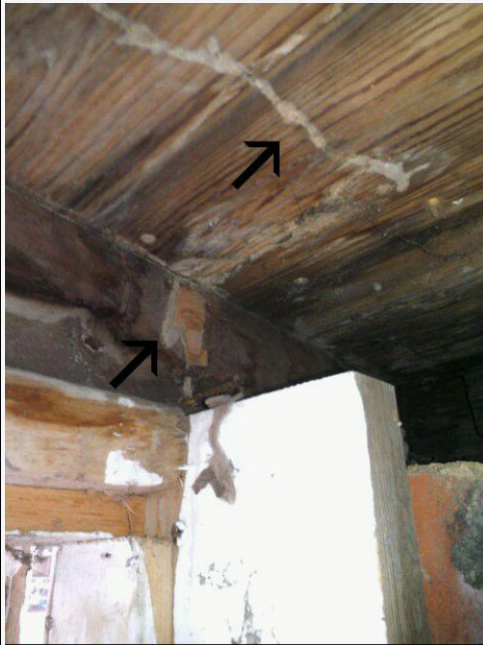
Termite shelter tubes / damaged wood

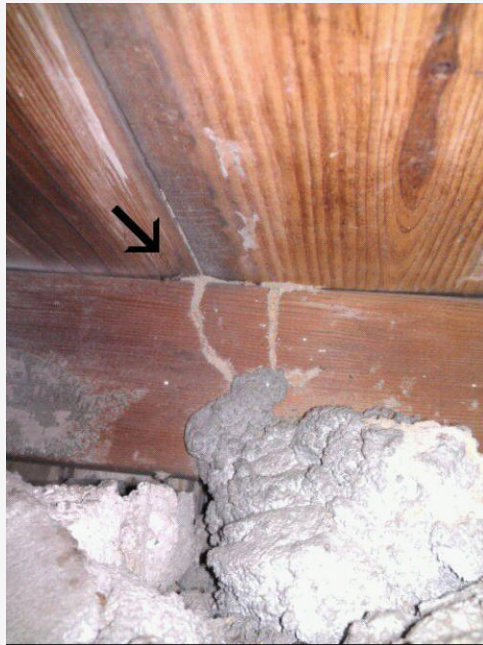
Termite shelter tubes

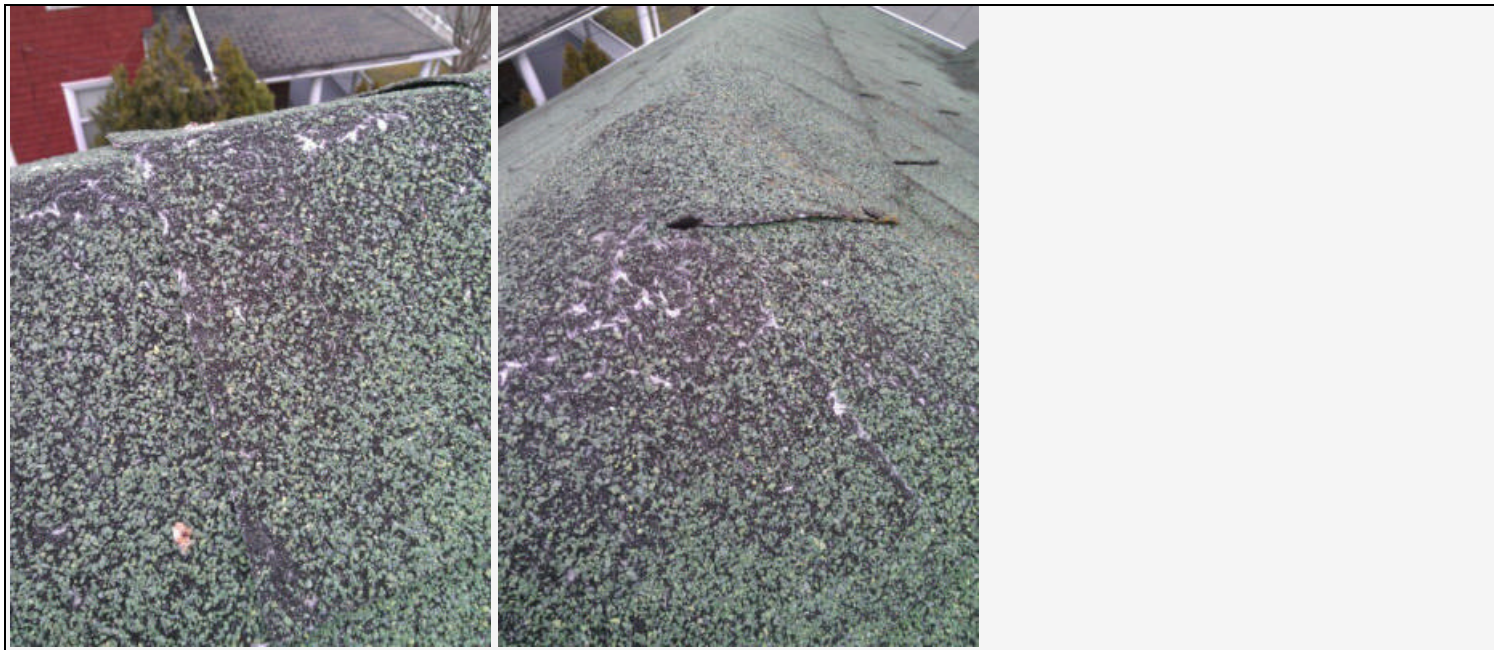
ROOF COVERING STATUS:

Moderate to heavy wear present.

REPAIRS RECOMMENDED:

There are a few damaged asphalt shingles which should be repaired to prevent potential leakage. Repairs recommended by a qualified roofing contractor.

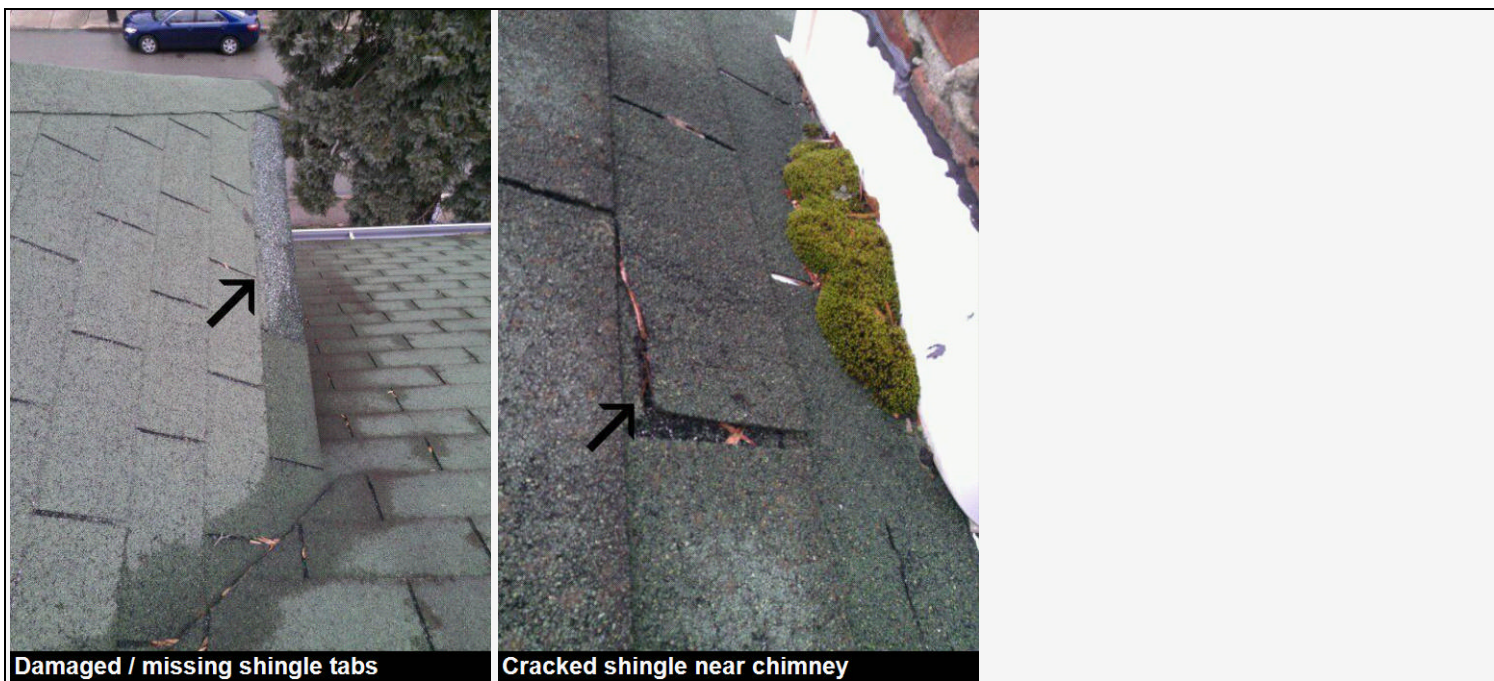
Damaged / missing shingle tabs

Cracked shingle near chimney

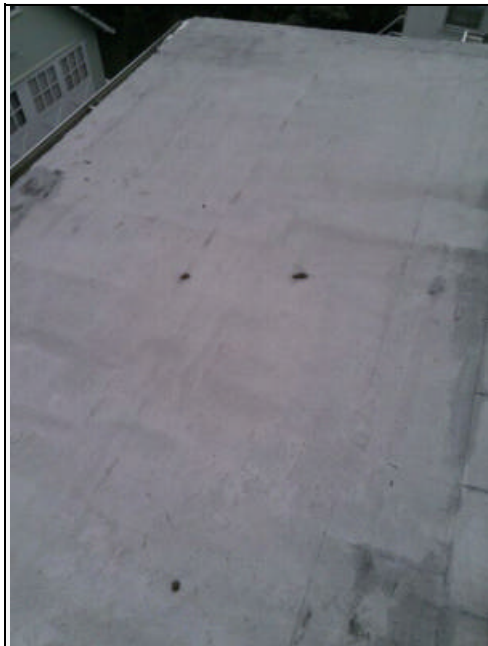
FLAT ROOF COVERING STATUS:

Appears serviceable/within useful life. Signs of typical weathering and aging observed.

Pitched roof maintenance: TYPICAL MAINTENANCE RECOMMENDED. This usually consists of repair/replacement of damaged/missing shingles and sealing any exposed nails and flashings. This maintenance should help insure the weather tightness of the building and should be performed on a regular basis.

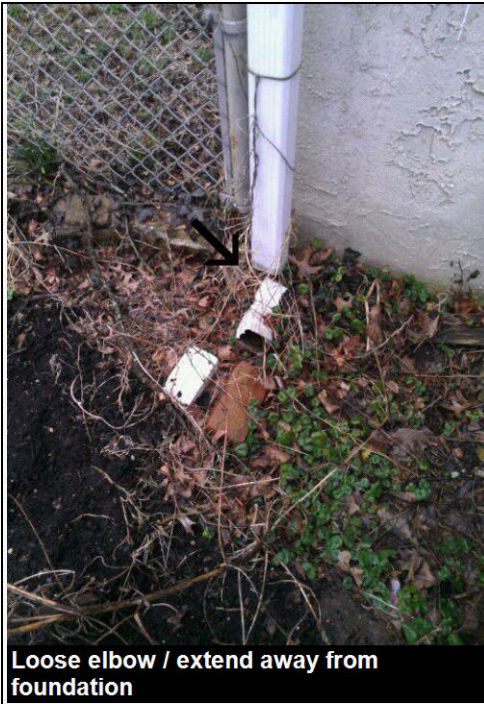
Appears serviceable. Loose downspout noted at left side porch area. Loose downspout should be secured with proper straps and screws. **Route downspouts away from the building with proper splash blocks or downspout extensions. The further water is taken away from the foundation, the less the risk of water infiltrating through the foundation.**

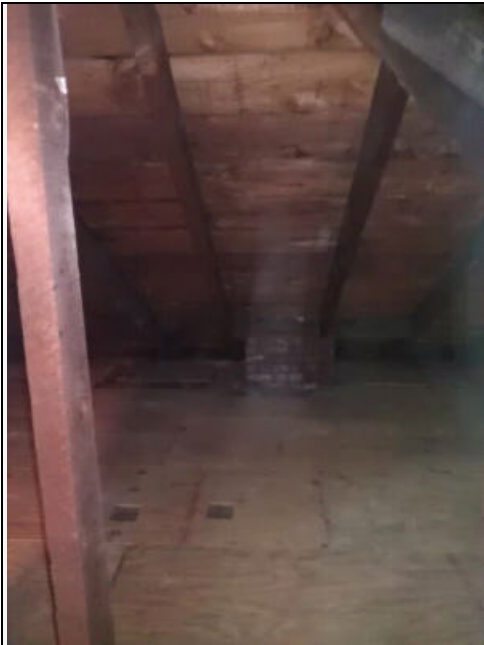
MOISTURE RELATED FINDINGS:

Stains observed on wood in attic area indicate previous leakage. Stains observed were dry at the time of the inspection. Stains were checked with a moisture meter where accessible at the time of the inspection and levels were normal. Wood and insulation was dry in the surrounding area. The stains may be from prior to having the roof replaced. *Determining the condition of staining whether it be active or previous is beyond the scope of the inspection. Conditions for*

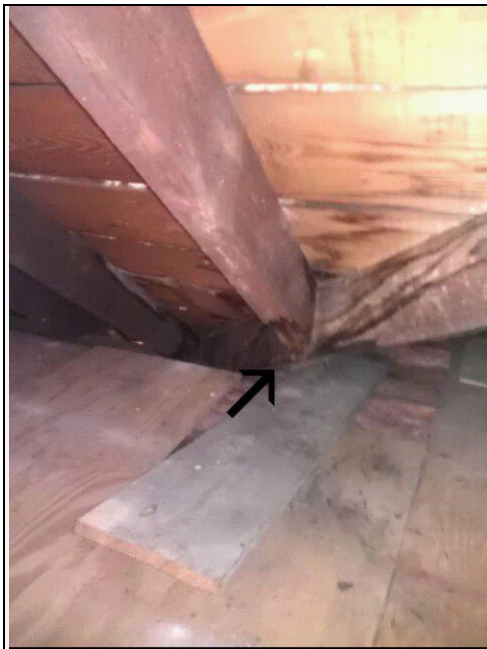
Evidence of previous leakage.

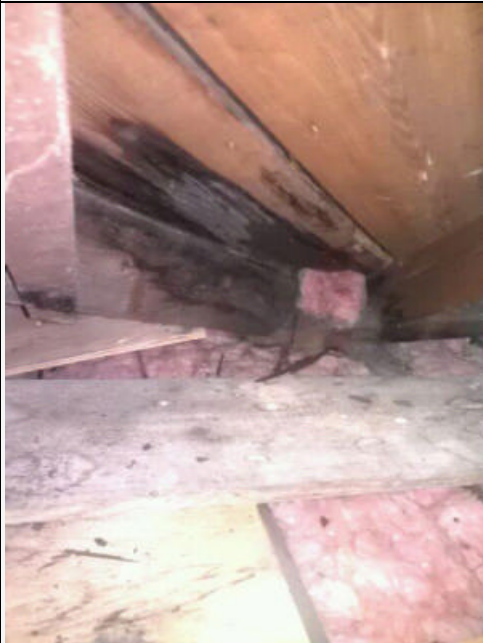
No problems were observed at the time of the inspection. Damaged sheathing is present in some locations and should be replaced at the time of roof replacement.

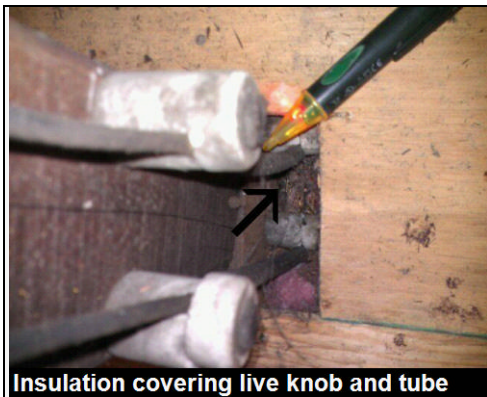
Insulation is in contact or covering knob and tube wiring in attic area in some areas. Insulation

should not come in contact with knob and tube wiring in attic area. See electrical section regarding upgrades to wiring in attic area.

Insulation covering live knob and tube

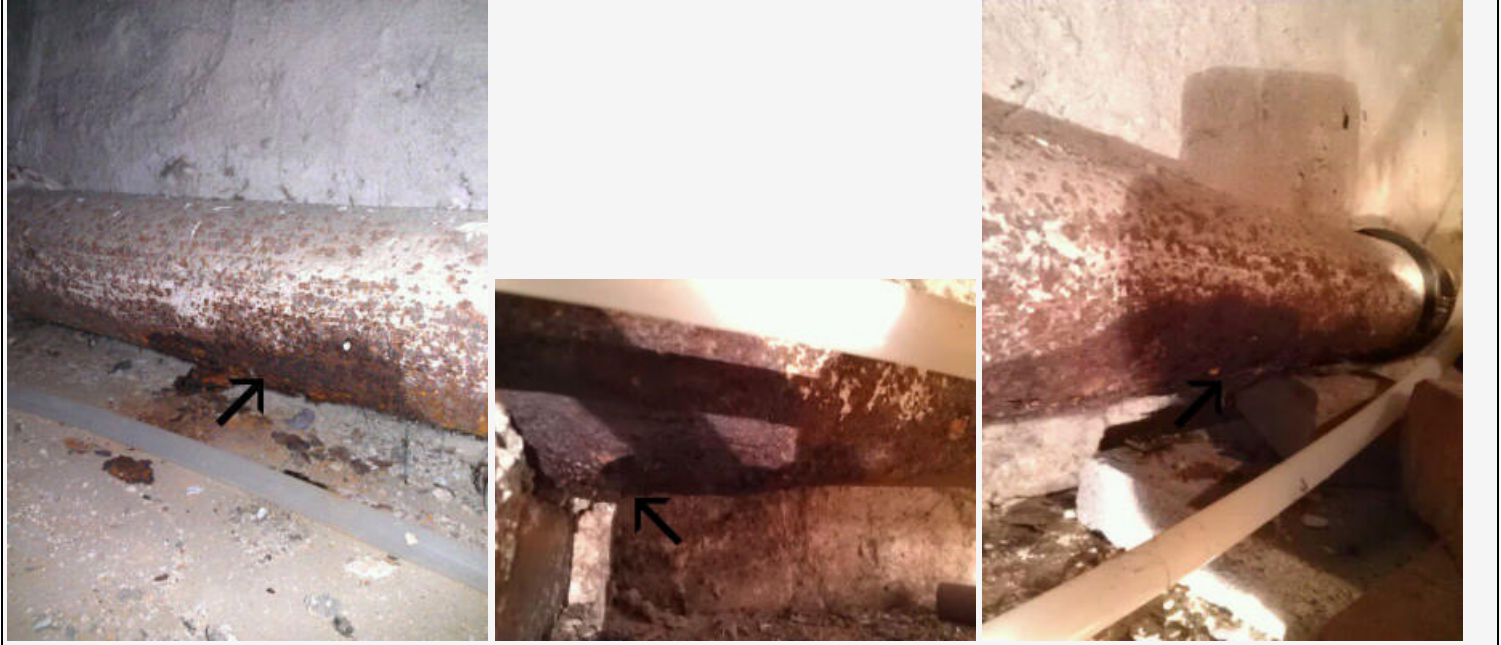
Cast iron pipe is rusted and deteriorated along the base of the main drain prior to exiting foundation. Repairs are needed by a qualified plumber.

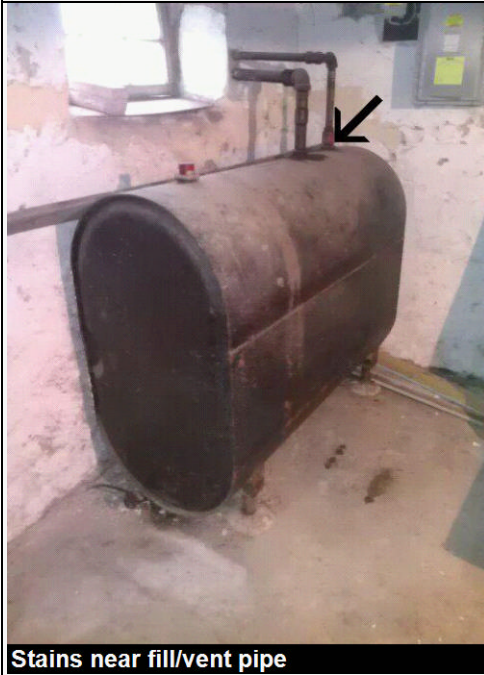
Oil tank is an older tank (most likely older than 30 years). No signs of active leakage was present at the time of the inspection however due to the age of the tank, anticipate on replacement in the not to distant future. Consider contacting a heating oil company that is affiliated with the "Tanksure" program. These companies can further evaluate and test the tank. If the tank passes an ultrasonic test, it can qualify for a warranty which will credit \$1000.00 towards a new tank should the tank fail after qualifying for program. If the tank does not qualify for the program, you will know it needs to be replaced in the near future.

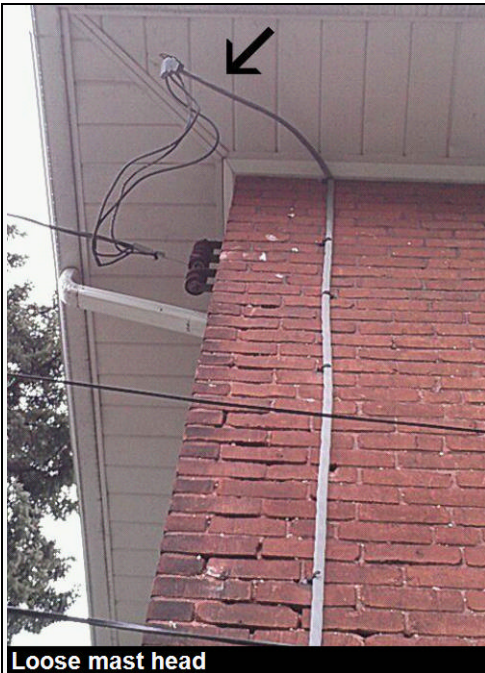
The mast head is loose and should be secured as needed. Overhead, 120/240 Volt, Circuit breakers, Appears serviceable. Meter is rusted and should be painted in the future.

Loose mast head

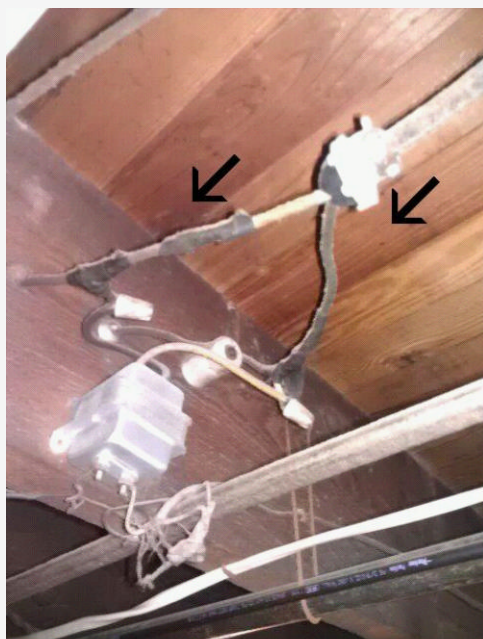
Knob and tube wiring / improper splices

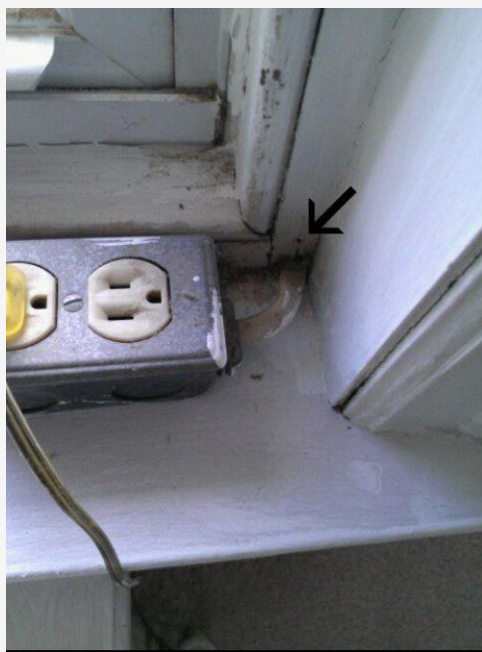
Improper wiring

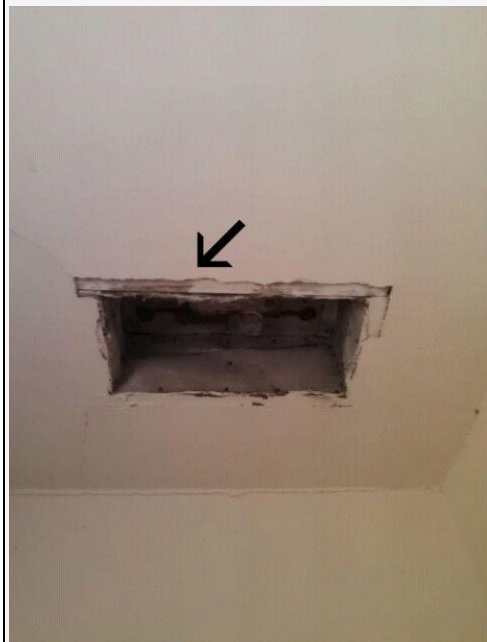
Unable to determine if fuse box in attic is active with knob and tube wiring. Upgrade as needed.

Knob and tube wiring at fuse box in closet

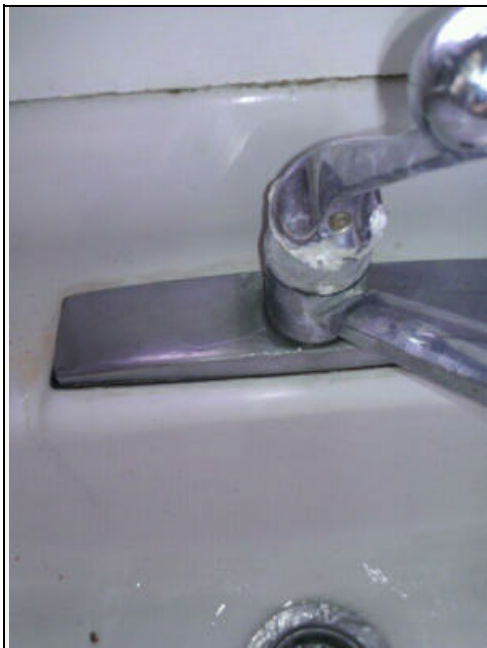
Porcelain, Sink appears serviceable, Minor leaks were observed from the faucet spout. This is possibly due to worn o-rings or cartridge which can be replaced. Repairs recommended by a licensed plumber or qualified individual. Faucet drips when off. Replacement of o-rings needed. Drain appears serviceable with no leaks detected.

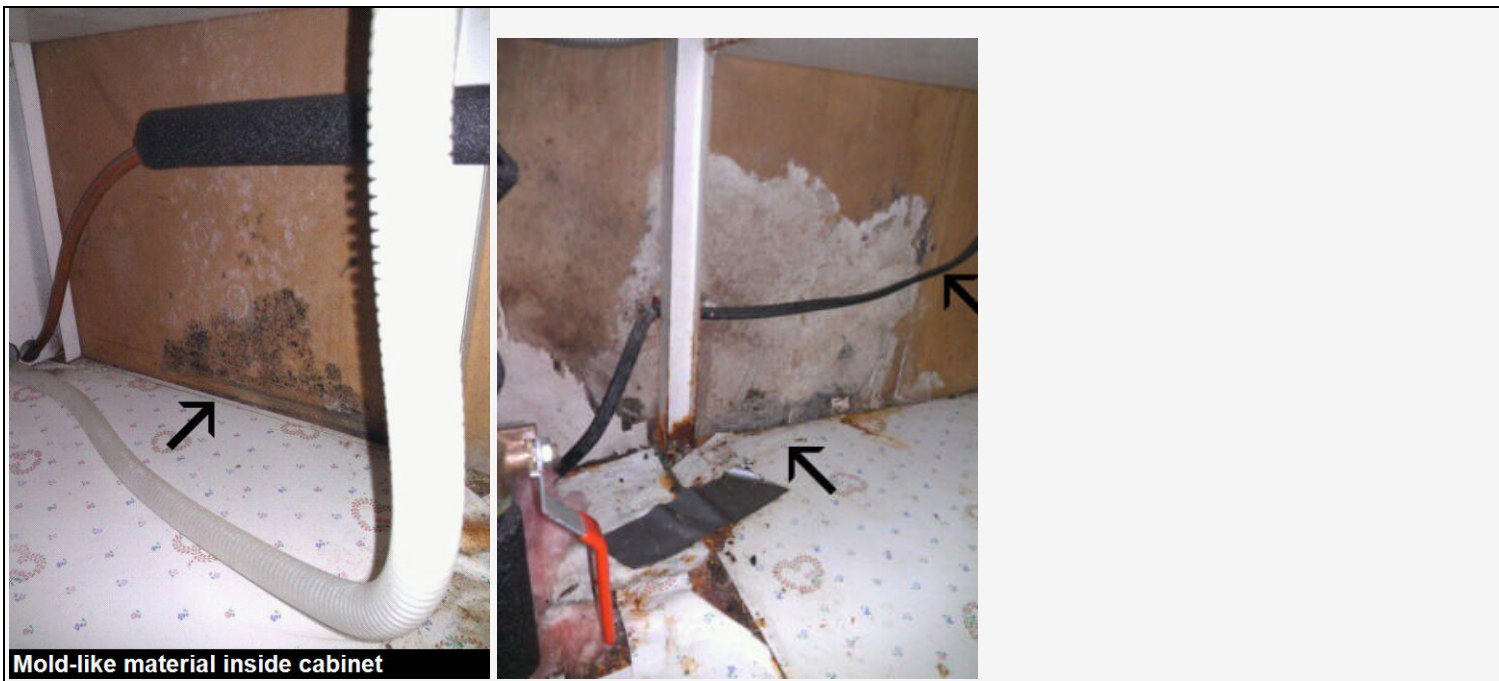
Cabinets appear serviceable with moderate to heavy wear noted. Upgrades or replacement is recommended in the future. Mold-like material observed behind sink cabinet. Evidence of a previous or present leak in this location. Certain types of mold prevalent in housing can cause adverse health effects to certain individuals. Further evaluation/testing and cleanup recommended by a qualified mold remediation contractor.

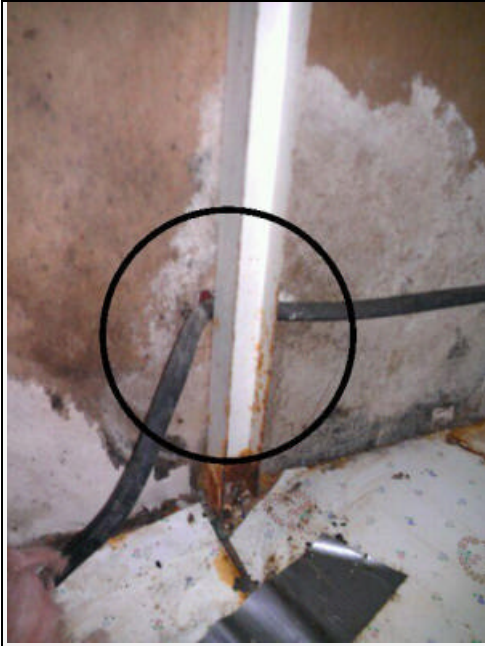
Tested receptacles are in serviceable condition. Substandard wiring is present below sink. Further evaluation and repairs are recommended by a qualified and licensed electrical contractor.
