Confidential Inspection Report
999 Main St.
Fort Myers, FL 33903

Prepared by: 3D Inspection Systems, Inc.
3D Inspection Systems
Fort Myers, FL 33907
800-745-6126 info@3dinspection.com

GENERAL INFORMATION

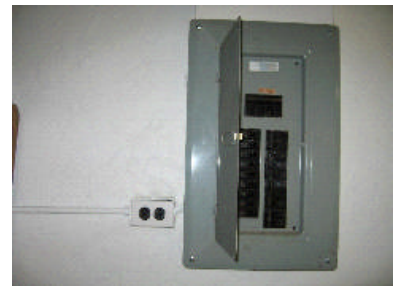
| | | <i>Main Panel Observations:</i> | Circuit and wire sizing correct so far as visible, Grounding system is present, Multiple wires are connected to a single lug on a circuit breaker where only one wire should be connected, Missing strain relief at panel, Have a licensed electrician make further evaluation and corrections as needed. |
| ☐ | ☐ | <i>Subpanel #1:</i> | Located in the Air conditioner. |
| ☐ | ☐ | <i>Subpanel #2:</i> | Located in the Utility room. |

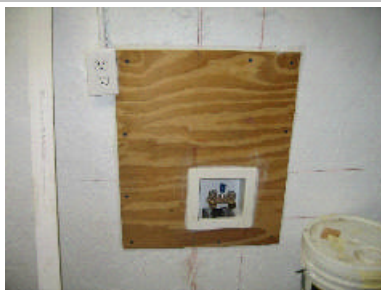
Laundry:

Plumbing appears serviceable, but also appears handyman installed.

There is no trap on the drain line. Drain line empties into the rear yard and is considered a sanitary nuisance by local officials. Consider connecting this drain lin to the main drain system serving the house.

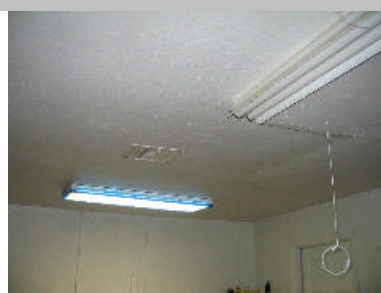
Condition: Blemishes noted. Cosmetic repairs and trim needed to improve appearance.

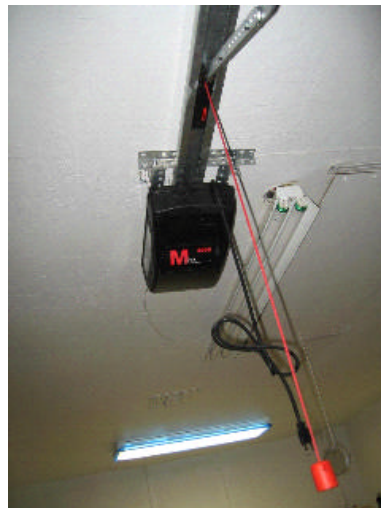
Door Operator: Automatic door opener(s)- not operational, due to a lack of power. An electrical outlet should be installed in the ceiling.
