Confidential Inspection Report
999 Main St.
Fort Myers, FL 33903

Prepared by: 3D Inspection Systems, Inc.
3D Inspection Systems
Fort Myers, FL 33907
800-745-6126 info@3dinspection.com

GENERAL INFORMATION

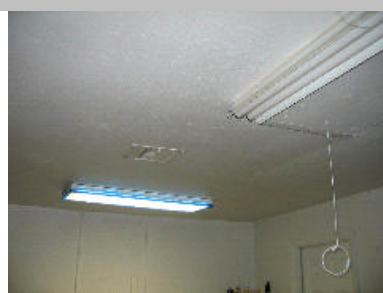
Condition: Blemishes noted. Cosmetic repairs and trim needed to improve appearance.

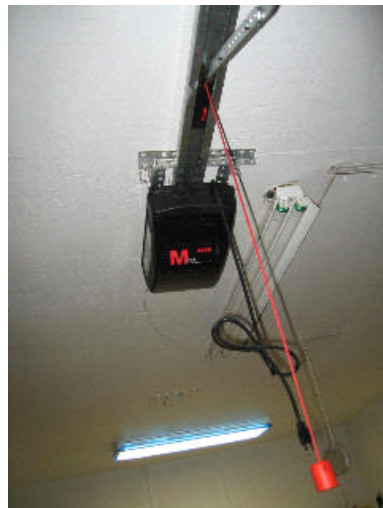
Door Operator: Automatic door opener(s)- not operational, due to a lack of power. An electrical outlet should be installed in the ceiling.
