Confidential Inspection Report
999 Main St.
Fort Myers, FL 33903

Prepared by: 3D Inspection Systems, Inc.
3D Inspection Systems
Fort Myers, FL 33907
800-745-6126 info@3dinspection.com

GENERAL INFORMATION

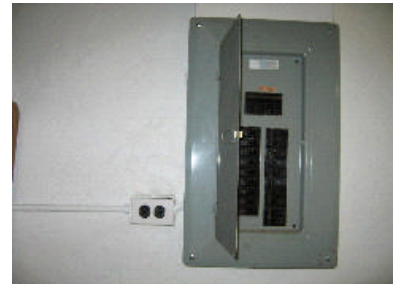
| | | Main Panel Observations: | Circuit and wire sizing correct so far as visible, Grounding system is present, Multiple wires are connected to a single lug on a circuit breaker where only one wire should be connected, Missing strain relief at panel, Have a licensed electrician make further evaluation and corrections as needed. |

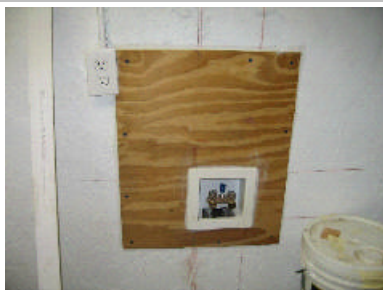
Plumbing appears serviceable, but also appears handyman installed.

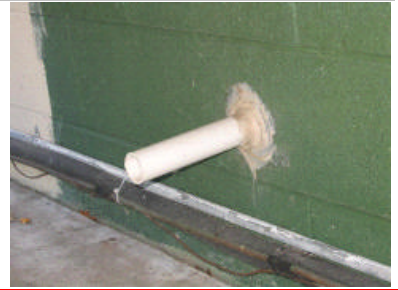
There is no trap on the drain line.
Drain line empties into the rear yard and is considered a sanitary nuisance by local officials.
Consider connecting this drain lin to the main drain system serving the house.

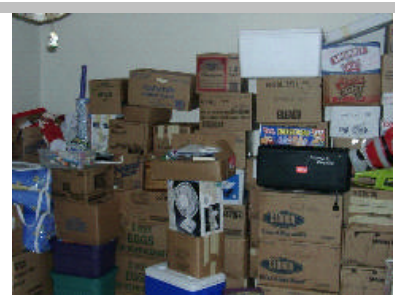
<i>Kitchen Interior:</i>	Due to stored items in the closet, it is not possible to determine the condition of the walls and the ceiling that are not visible.
--------------------------	---
