# Home Inspection Report

**456 Castle Avenue  
West Simsbury, CT 06092  
Prepared exclusively for:  
Mary Brown**

**Prepared by: Cedar Hill Home Inspection  
PO Box 537  
West Simsbury, CT 06092  
860-217-0060  
Web: [www.CedarHillInspect.com](http://www.CedarHillInspect.com)**

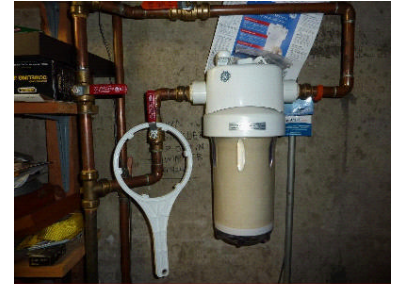
Whole house filter

A whole house filter was noted attached to supply lines in basement. These filters require regular maintenance. *Follow manufacturers maintenance schedule or contact a plumber or home improvement contractor for further information.*

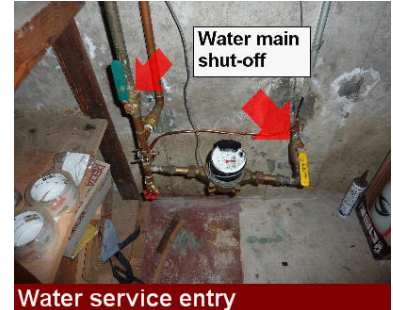
Water service entry

**Location of Entry:** Basement: front, center.  
Water meter and main shut off located at water entry to home.  
Main entry pipes: Copper.

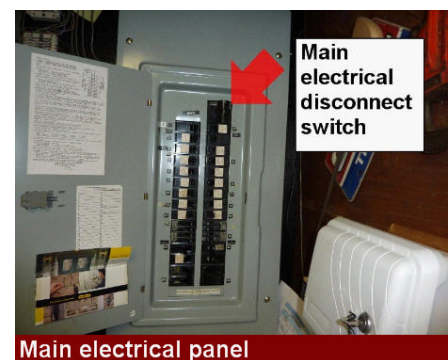
**Main Electrical Disconnect:** Main disconnect type: Circuit breaker  
Main disconnect rating: 200 Amps  
Main disconnect located in main panel box.  
Main disconnect located in the basement, right/front.

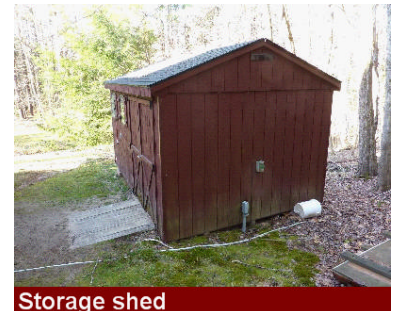
Storage shed

A storage shed was noted on the property. Construction of the shed was of wood material. Shed appeared to be in serviceable condition at time of inspection.

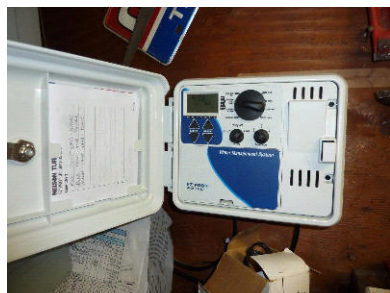
Irrigation control

An irrigation and/or lawn sprinkler system was noted by a control panel. As observed in the basement, garage, and/or exterior.

*Irrigation/sprinkler systems are beyond the scope of this inspection and were not inspected or operated. These systems require seasonal maintenance and settings. Recommend having system inspected and tested by an irrigation contractor. At this time have contractor explain system operation and maintenance.*
