# Home Inspection Report

456 Castle Avenue  
West Simsbury, CT 06092  
Prepared exclusively for:  
Mary Brown

Prepared by: Cedar Hill Home Inspection  
PO Box 537  
West Simsbury, CT 06092  
860-217-0060  
Web: [www.CedarHillInspect.com](http://www.CedarHillInspect.com)

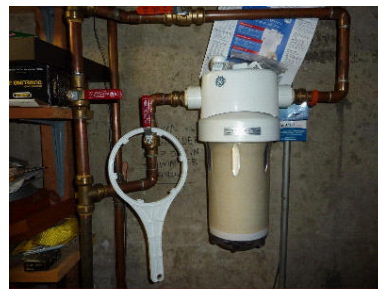
**Whole house filter**

A whole house filter was noted attached to supply lines in basement. These filters require regular maintenance.  
*Follow manufacturers maintenance schedule or contact a plumber or home improvement contractor for further information.*

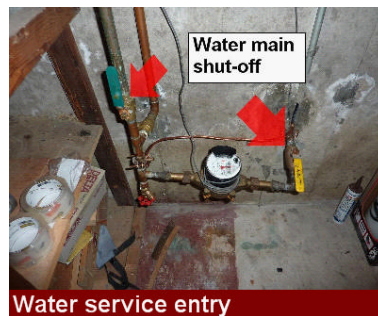
**Water service entry**

**Location of Entry:** Basement: front, center.  
Water meter and main shut off located at water entry to home.  
Main entry pipes: Copper.

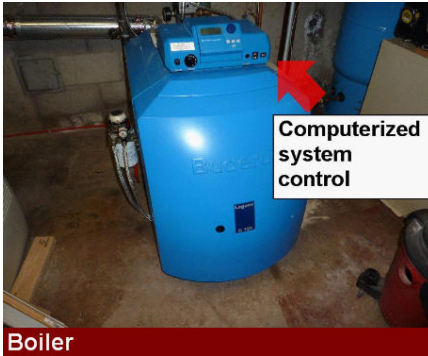
<b>System Operation:</b>	<p>Combustion air from: Exterior.          When system was turned on by operating thermostat(s) or control(s), unit: fired and gave heat as expected.          Heating system was in use during inspection.</p> <p><b>Note: a computerized system control was observed. Be sure to read and understand the manufacturer's instructions for operating this control. If further instruction is needed, contact a heating contractor familiar with this brand of system.</b></p>

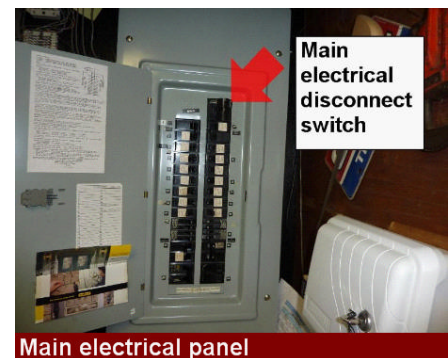
**Main Electrical Disconnect:** Main disconnect type: Circuit breaker  
 Main disconnect rating: 200 Amps  
 Main disconnect located in main panel box.  
 Main disconnect located in the basement, right/front.

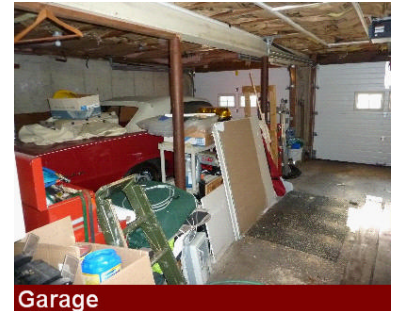
Garage

Visibility in garage: View of garage was blocked extensively by stored items and/or parked car(s). The garage was only randomly inspected.

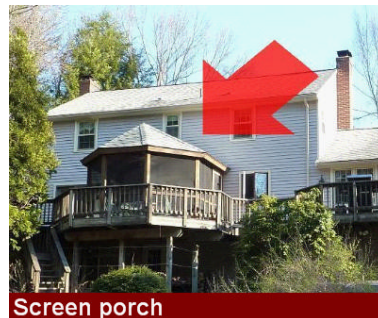
<b>Entry Porch:</b>	Entry located: front/center. Entry Construction: Porch of slate or slate and concrete. Porch deck surface appears to be generally in good condition. Entry porch balusters and guardrails: No porch guardrails observed. <i>Recommend adding guard rail(s) for safety.</i> Number of steps to grade: 1. Stairs appear to be in generally good condition.
<b>Landing:</b>	Landing located: rear/right. Deck surface appears to be generally in good condition.
<b>Enclosed Porch:</b>	Enclosed porch style: Enclosed deck located rear. Enclosed porch construction: Deck style framing, built on columns. Roof over porch: With wood support columns. Walls: Screened in porch or sliding doors.
<b>Windows:</b>	No windows, screens only, <b>screens torn, missing and/or generally in poor condition.</b>

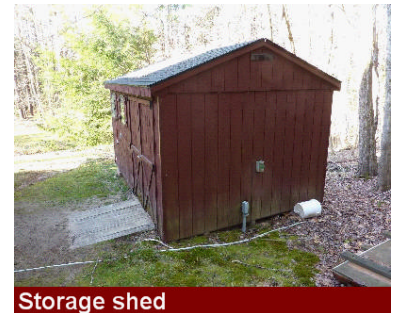
A storage shed was noted on the property. Construction of the shed was of wood material. Shed appeared to be in serviceable condition at time of inspection.  
*Generally storage sheds are beyond the scope of this inspection. The shed was only randomly inspected.*

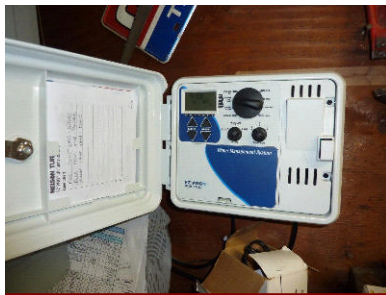
Irrigation control

An irrigation and/or lawn sprinkler system was noted by a control panel. As observed in the basement, garage, and/or exterior.  
*Irrigation/sprinkler systems are beyond the scope of this inspection and were not inspected or operated. These systems require seasonal maintenance and settings. Recommend having system inspected and tested by an irrigation contractor. At this time have contractor explain system operation and maintenance.*
