Report: 0200; 3d sample **Address:** 123 Anystreet

Confidential Inspection Report

123 Anystreet
Anytown, PA 12345

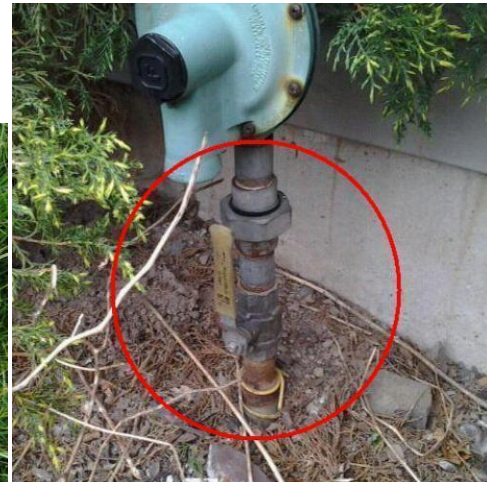
Gas service shutoff valve

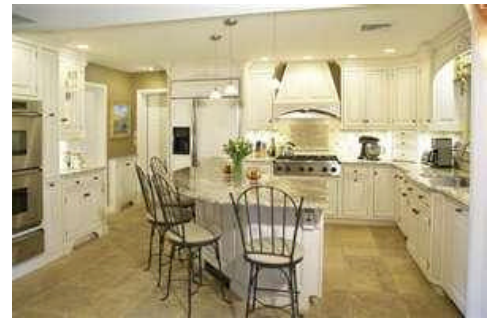
Kitchen Interior:

[OK] MR RR SC NI **Counters & Cabinets:**
Corian countertops installed. Counters tops are in good condition. With normal wear. Cabinets appear in good condition.

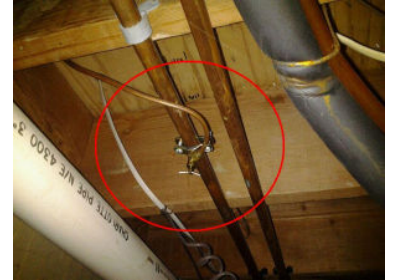
Refrigerator:

[OK] MR RR SC NI **Condition:**
This inspection determines only if the unit is currently keeping food cold. The freezer portion of the refrigerator is required to freeze water. The refrigerator appears to pass this minimum inspection. An automatic ice making option was installed. The ice maker was operational. A shut off valve was installed. It is located in the basement under the kitchen location.
