REPORT OF MARINE SURVEY

PRE-PURCHASE CONDITION & VALUE
of the vessel

1998 Sea Ray 33' Sundancer 330

Bob Ptak, AMS #842 - S.A.M.S.
Society of Accredited Marine Surveyors
on
8/26/2010

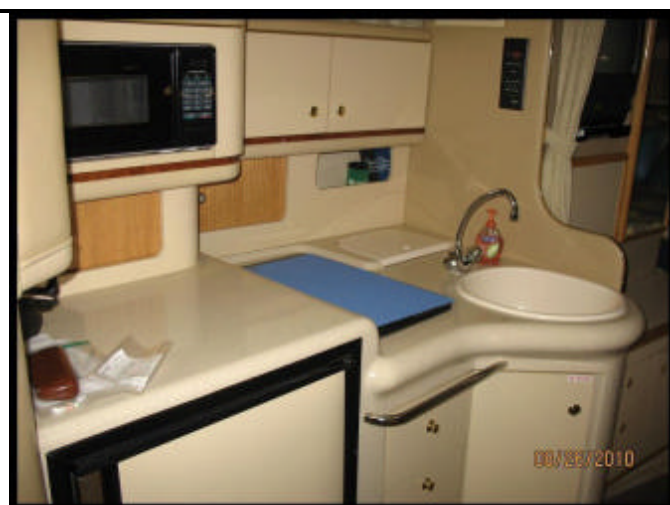
Stove: Kenyon, two burner, alcohol/electric. Electric burners tested and are functional. Alcohol function not tested. Power indicator lights are functional. **Safety switch is functional but sticks in down position.---- Switch may need some light lube so it comes up when glass top cover is raised.**

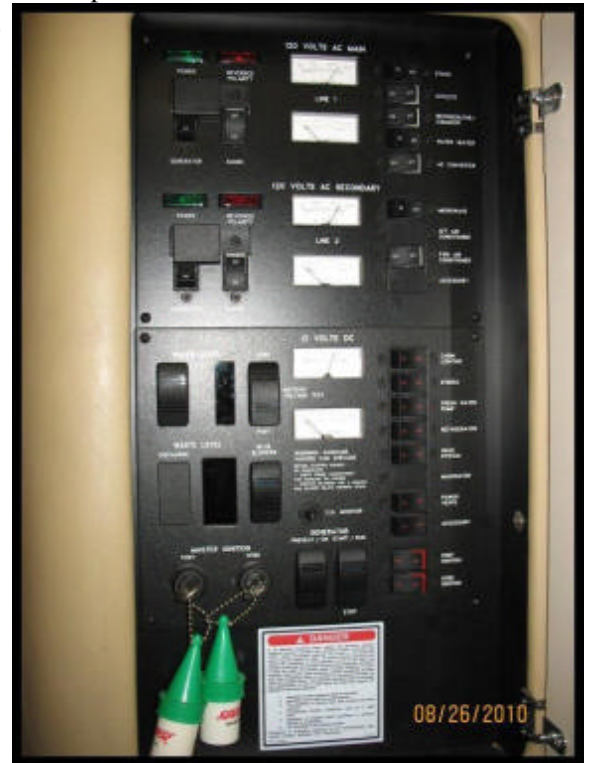
Distribution panel: Yes located in main salon, combined with AC Power panel.

Breaker(s)/fuse(s): All D.C. circuits are adequately protected by branch or switched breakers.

D.C. wiring: All wiring runs are properly secured every 18" per ABYC E-11 recommendations. Ring spade or crimp on connectors sighted for wiring connections per ABYC recommendations.

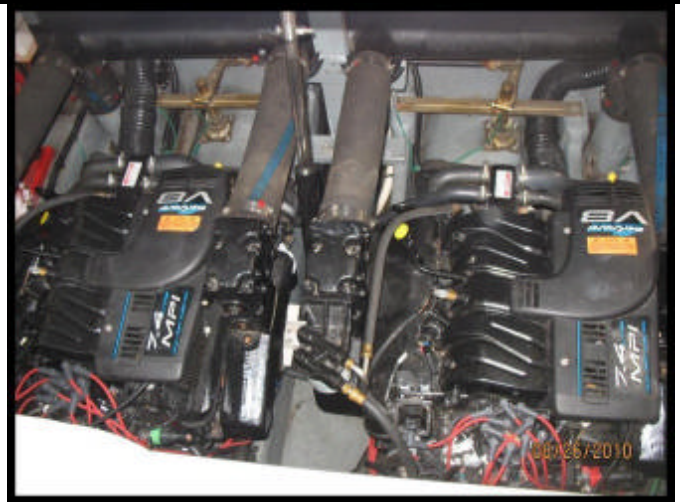
No./Type/Cylinders Two, MerCruiser, 7.4 Litre
Inboard Gasoline, V8,
Naturally aspirated Multi
Port Fuel injection.

Serial no(s): Port engine: Tag not sighted on engine. Starboard engine: 0L00 ____.
Engine(s) hours: Port: 491.5 Starboard: 498.2.
Raw water hoses: Good condition-No cracks, soft spots or leakage sighted.
Belts and pulleys: Belts condition are serviceable. No cracks or splits sighted. Pulleys/belts appear to be in line.
Cooling system(s): Raw water cooled, Raw water strainer(s) installed and clear.
Oil level and condition: Clean & full on dipstick(s). No evidence of water or cuttings in lube oil as sighted on dipstick(s).
Flame arrestor(s): Yes- USCG approved.
Ignition protection: Yes -Alternator and Starter are OEM and ignition protected.
Engine ventilation: Natural ventilation for engine space is provided. Power exhaust ventilation blower(s) are installed. Power vents are fully operational.

Fuel pump(s): Engine mounted. No leaks sighted.
Fuel supply lines: USCG A1 flex. No leaks, cracks or soft spots sighted.
Fuel filter(s): Engine mounted. No leaks sighted at fuel filters.
Drip pad(s) : No Pads in place beneath engine(s). Fluids and debris fall into bilge area. -----
 Consider installing drip pads beneath engine(s) to catch fluid drippings and rapidly identify leaks of any kind.
