Inspection Report Compiled For:

Tuesday February 21, 2012

Report 8654

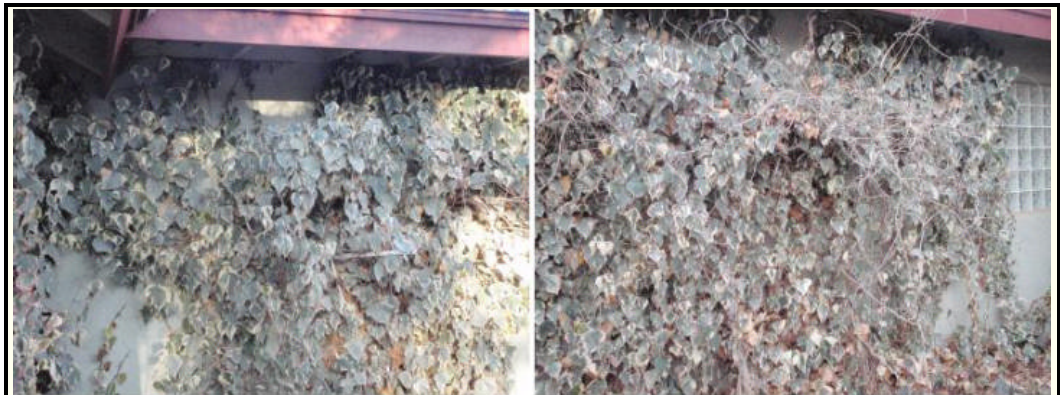
Exterior walls of the house are stucco over frame, with no signs of significant structural settlement. Small cracks in the stucco will sometimes appear as a house ages. These cracks are not structural in nature and are a result of shrinkage and/or settlement. In this area cracks are also caused by the rapid expansion and contraction from rapid temperature swings. These will be most evident on west walls and radiating out from window and door corners. Any significant wall cracks that may allow moisture entry should be caulked or patched.

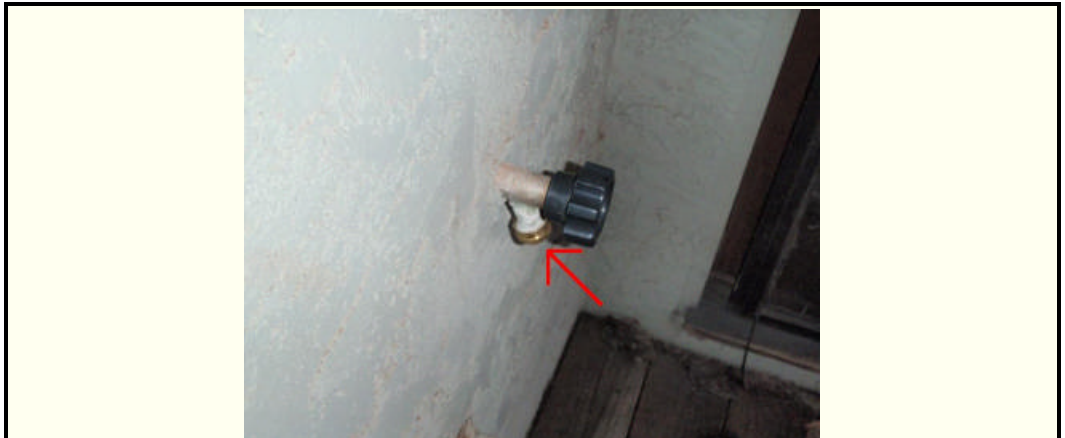
Most hose faucets located are operational. Frost proof type noted. Disconnect hoses in the winter or the valve will not properly drain and could freeze.

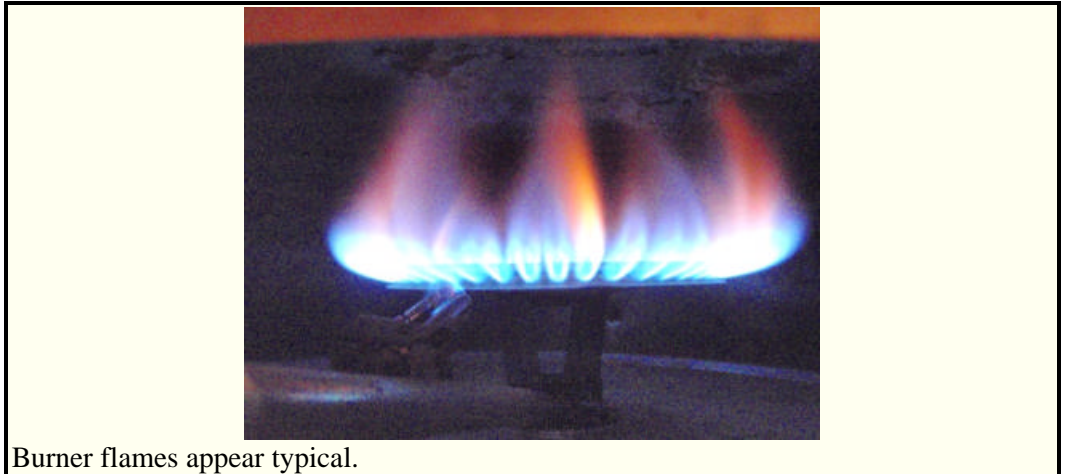
Burner flames appear typical.

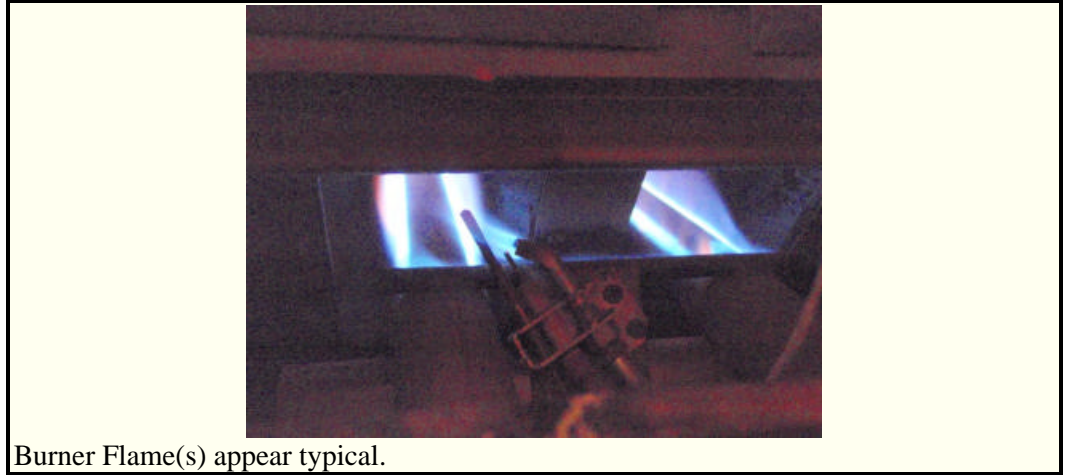
Burner Flame(s) appear typical.

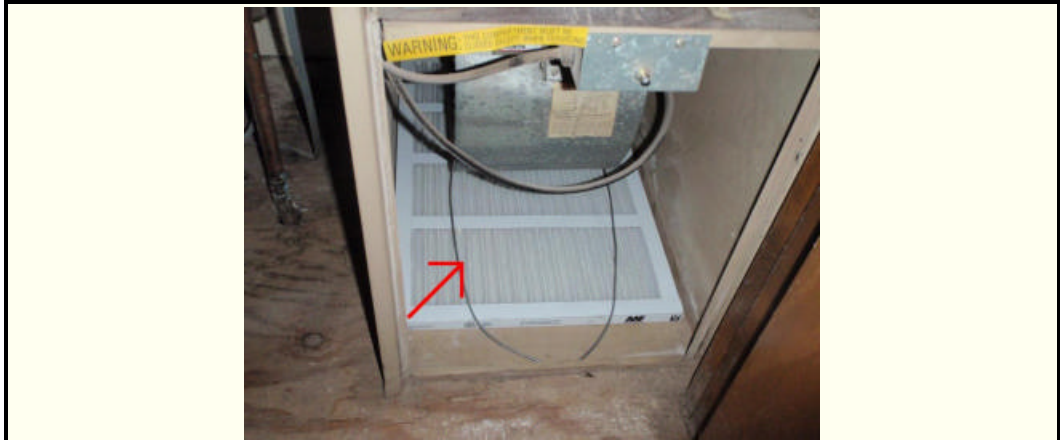
The filter for this unit is located at the return air duct in the blower compartment of the furnace. Filter is in serviceable condition.

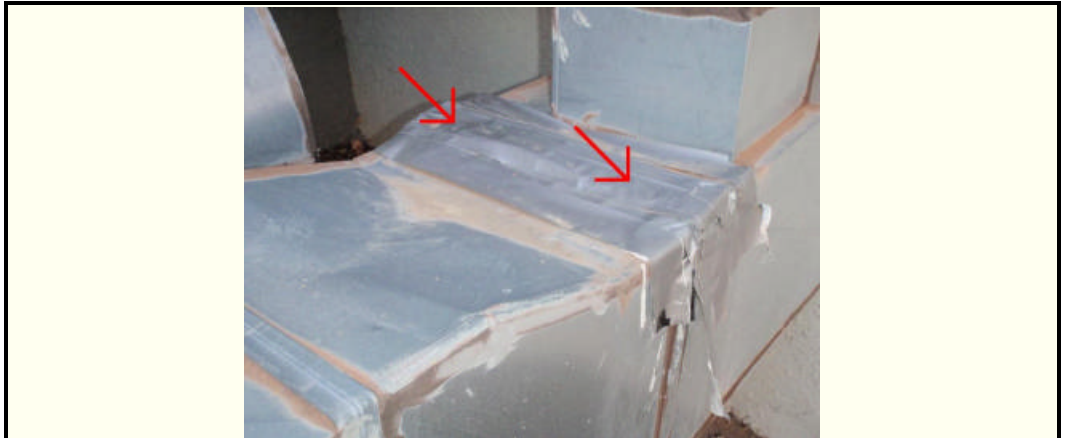
Due to the type of construction, most of the heating supply and return ducts including duct insulation are not visible to inspect. Air flow is noted from all registers. All living areas are heated and cooled.

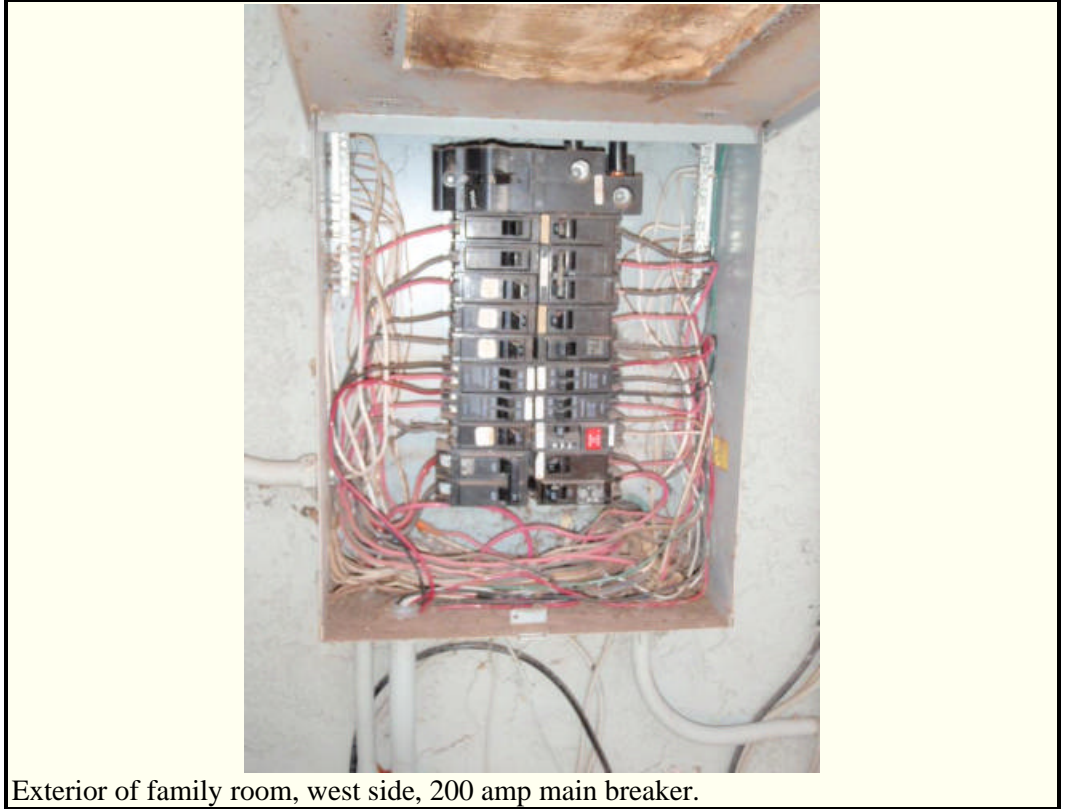
Exterior of family room, west side, 200 amp main breaker.

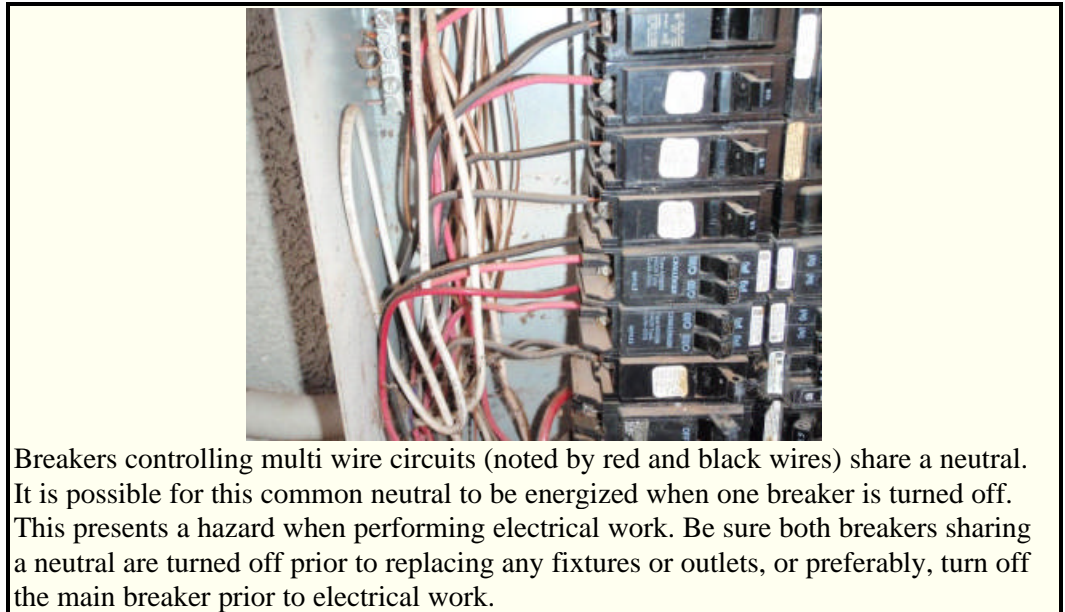
Breakers controlling multi wire circuits (noted by red and black wires) share a neutral. It is possible for this common neutral to be energized when one breaker is turned off. This presents a hazard when performing electrical work. Be sure both breakers sharing a neutral are turned off prior to replacing any fixtures or outlets, or preferably, turn off the main breaker prior to electrical work.

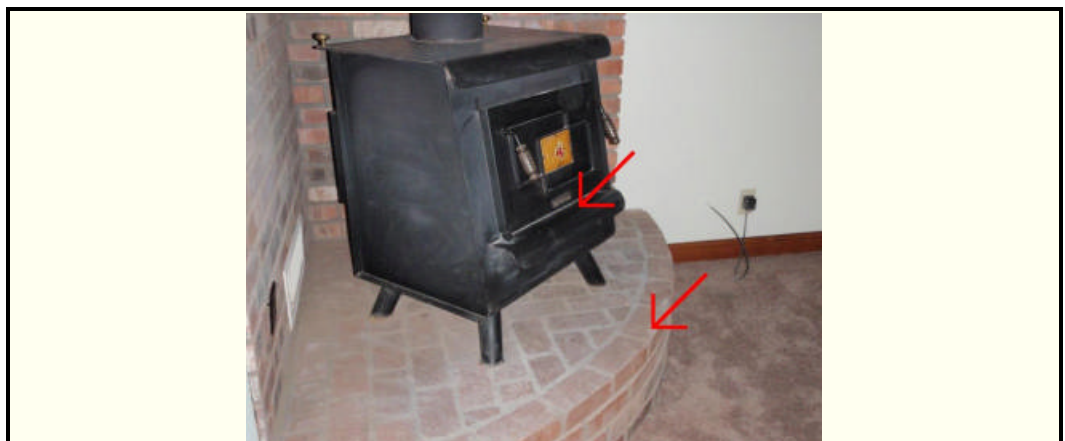
Woodstove hearth is too short, I recommend extending the hearth to 16 inches from the door opening for safety.

Family room woodstove is the free standing type and appears in serviceable condition.

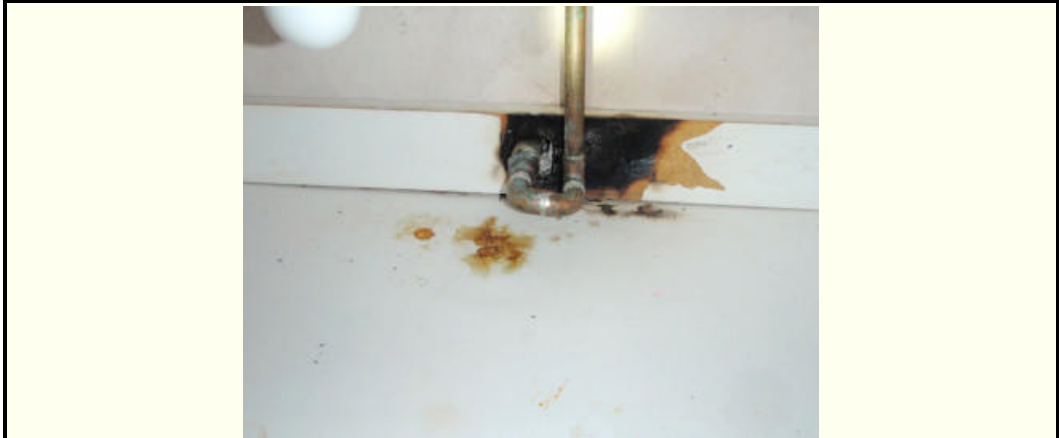
Sink bowl is serviceable, Drain is serviceable. A proper "P" trap is installed. Sink drainage appears normal. ("Normal" drainage means that when the faucet was on, the sink drained at the same rate or faster than it filled). Counters/cabinets are serviceable with normal wear.

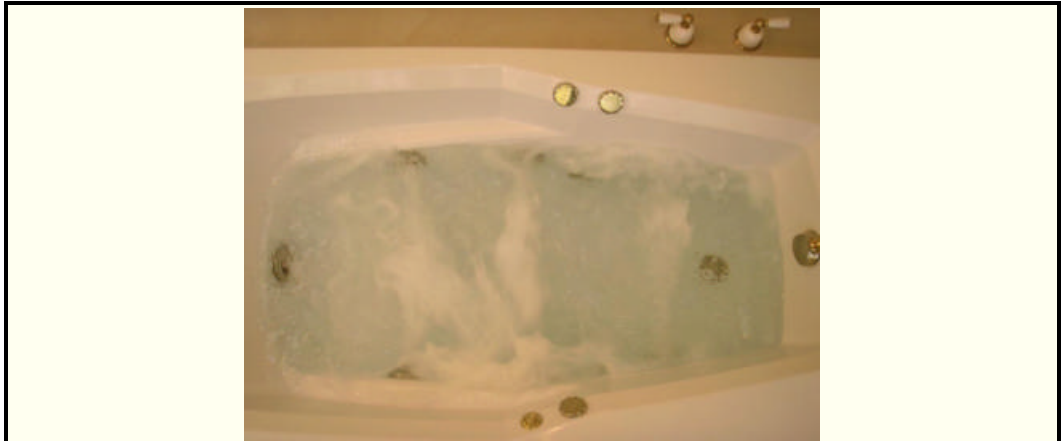
Faucets are serviceable, Drainage time is normal. Drain trap cannot be viewed or evaluated. Jetted tub pump is properly operational. Enclosure is serviceable. No pump access was located.
