Inspection Report Compiled For:

Tuesday February 21, 2012

Report 8654

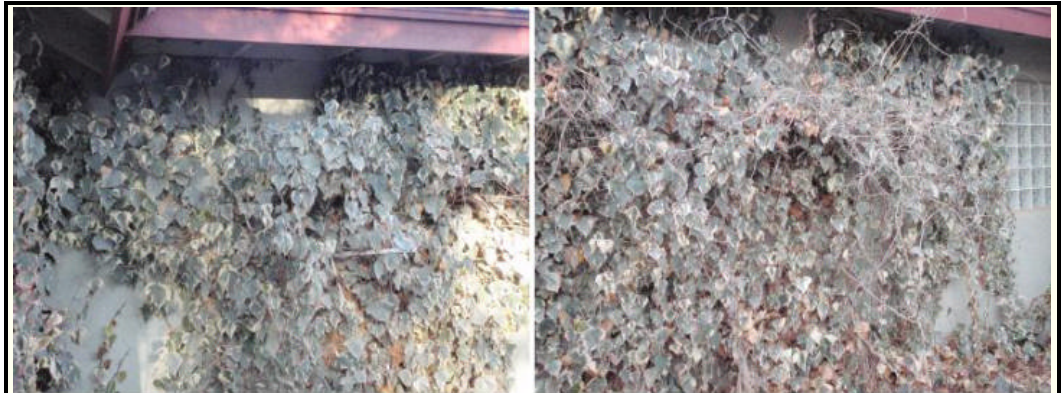
Stucco.

Exterior walls of the house are stucco over frame, with no signs of significant structural settlement. Small cracks in the stucco will sometimes appear as a house ages. These cracks are not structural in nature and are a result of shrinkage and/or settlement. In this area cracks are also caused by the rapid expansion and contraction from rapid temperature swings. These will be most evident on west walls and radiating out from window and door corners. Any significant wall cracks that may allow moisture entry should be caulked or patched.

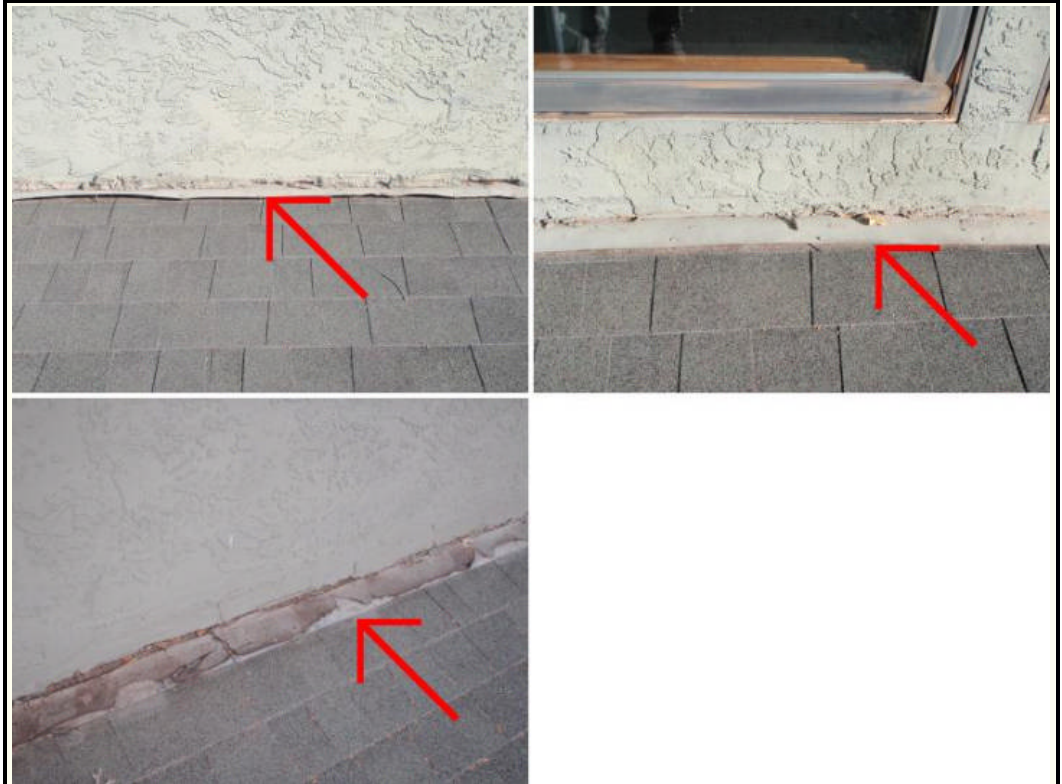
EXPOSED FLASHINGS:

Metal.

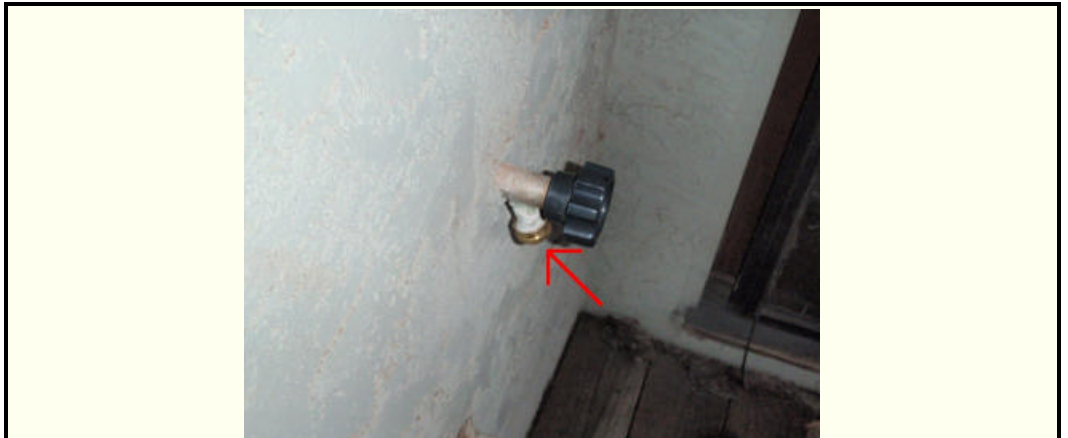
HOSE FAUCETS:

Most hose faucets located are operational. Frost proof type noted. Disconnect hoses in the winter or the valve will not properly drain and could freeze.

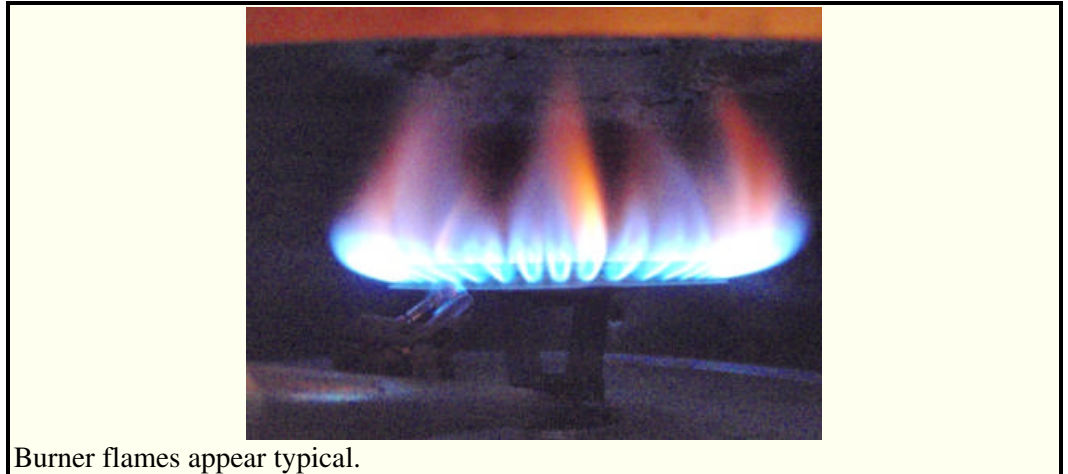
GENERAL COMMENTS:

Burner flames appear typical.

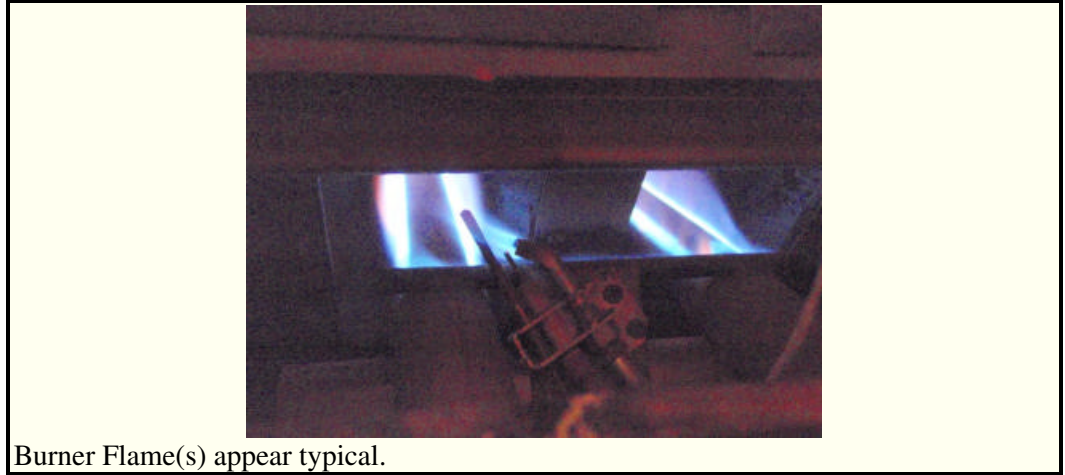
BURNERS/HEAT EXCHANGERS:

Burner Flame(s) appear typical.

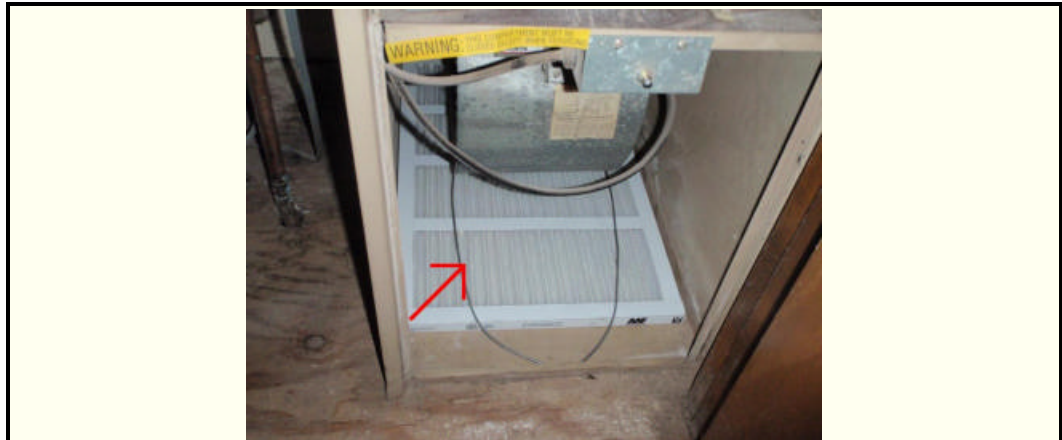
AIR FILTERS:

The filter for this unit is located at the return air duct in the blower compartment of the furnace. Filter is in serviceable condition.

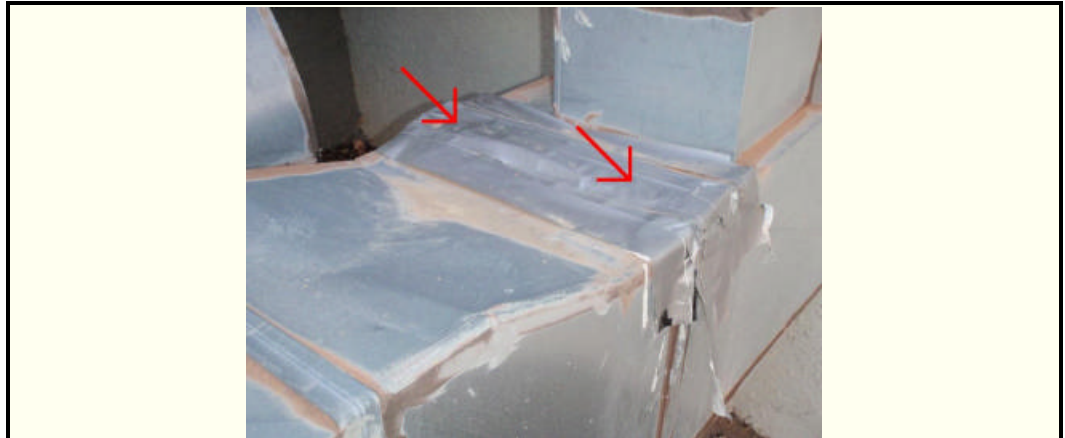
DUCTS/AIR SUPPLY:

Due to the type of construction, most of the heating supply and return ducts including duct insulation are not visible to inspect. Air flow is noted from all registers. All living areas are heated and cooled.

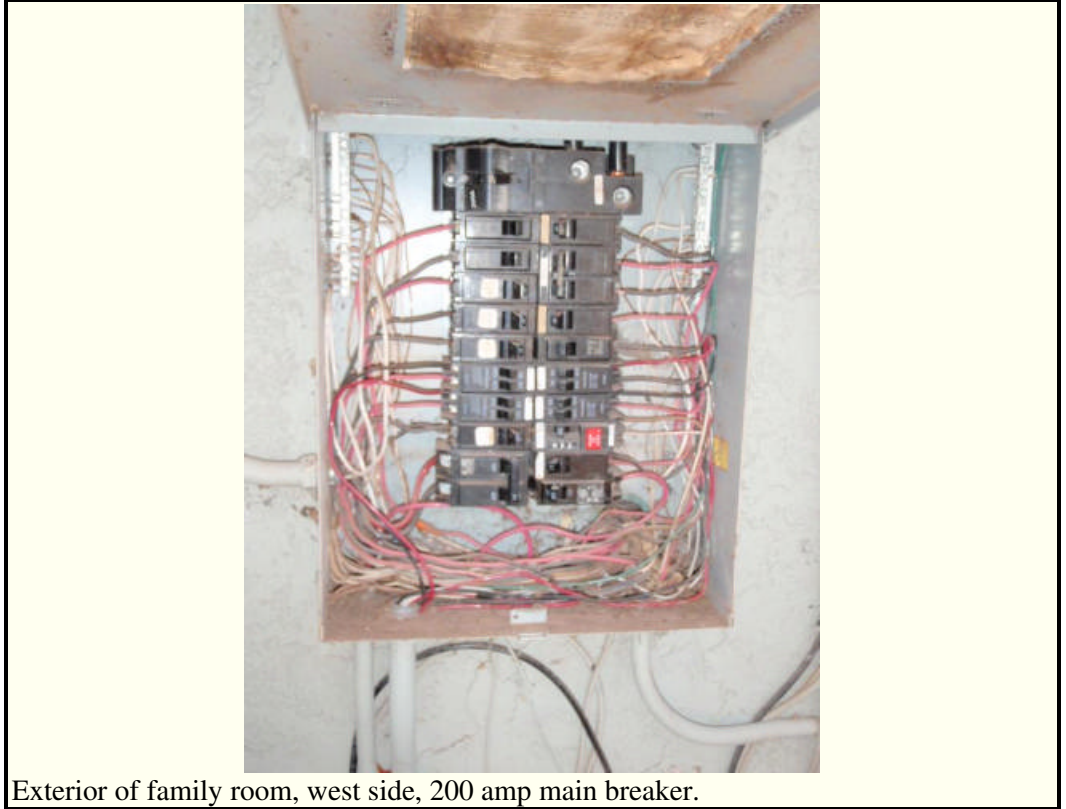
MAIN SERVICE PANEL:

Exterior of family room, west side, 200 amp main breaker.

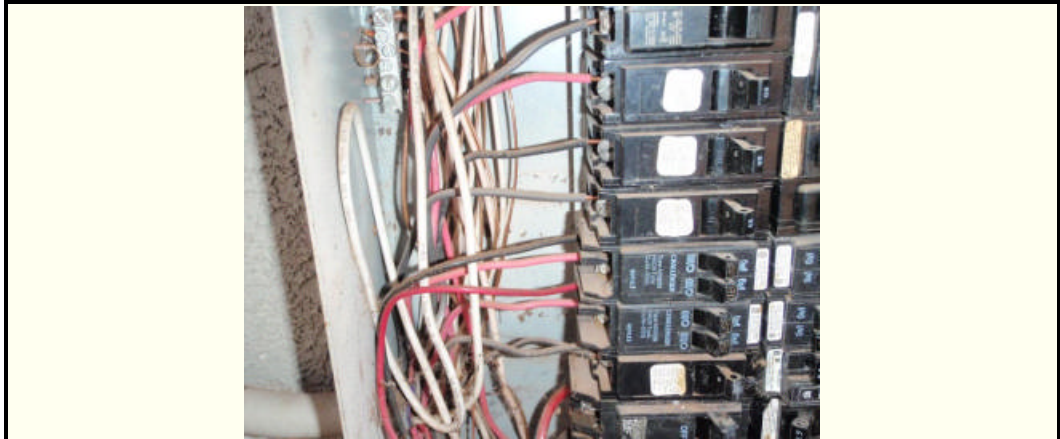
GENERAL COMMENTS:

Breakers controlling multi wire circuits (noted by red and black wires) share a neutral. It is possible for this common neutral to be energized when one breaker is turned off. This presents a hazard when performing electrical work. Be sure both breakers sharing a neutral are turned off prior to replacing any fixtures or outlets, or preferably, turn off the main breaker prior to electrical work.

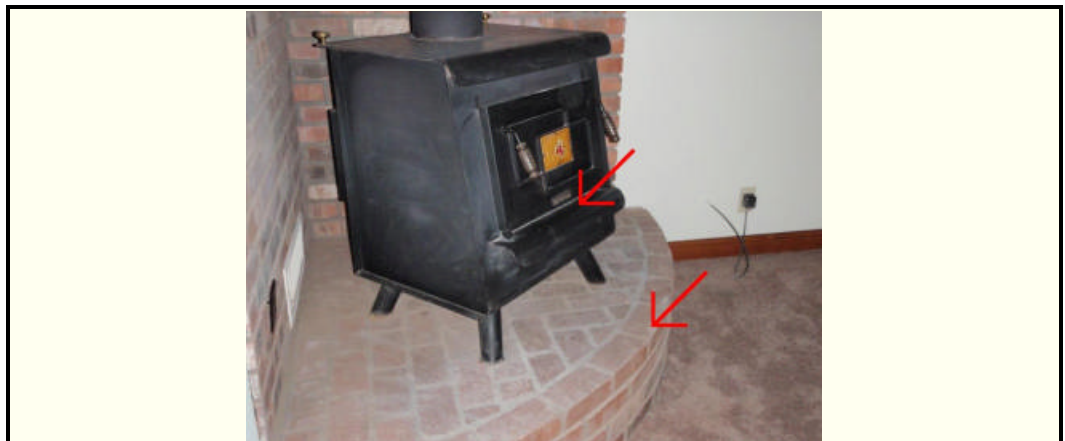
FAMILY ROOM:

Family room woodstove is the free standing type and appears in serviceable condition.

Woodstove hearth is too short, I recommend extending the hearth to 16 inches from the door opening for safety.

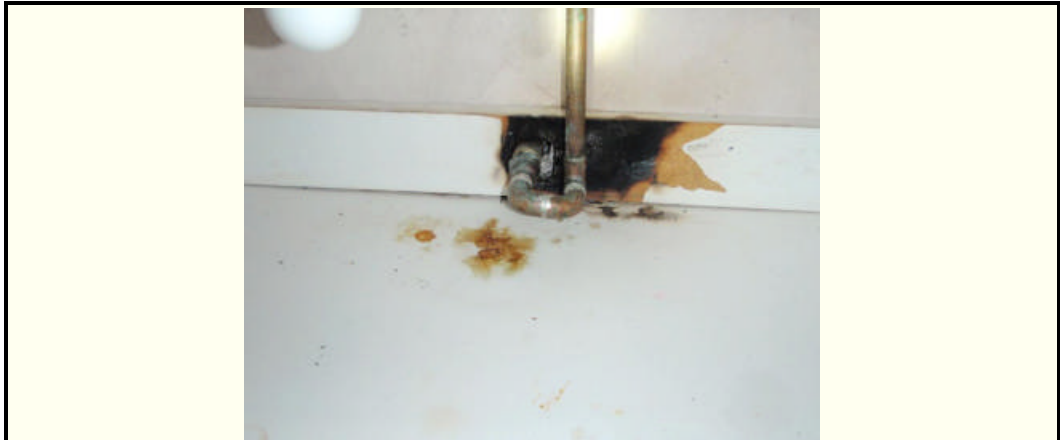
CONDITION OF SINK:

Sink bowl is serviceable, Drain is serviceable. A proper "P" trap is installed. Sink drainage appears normal. ("Normal" drainage means that when the faucet was on, the sink drained at the same rate or faster than it filled). Counters/cabinets are serviceable with normal wear.

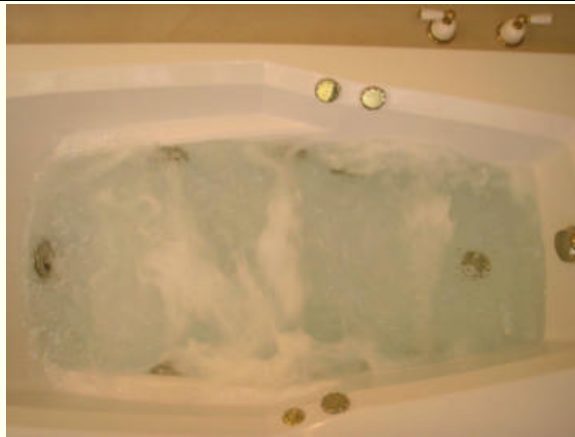
TUB AREA AND FIXTURES:

Faucets are serviceable, Drainage time is normal. Drain trap cannot be viewed or evaluated. Jetted tub pump is properly operational. Enclosure is serviceable. No pump access was located.

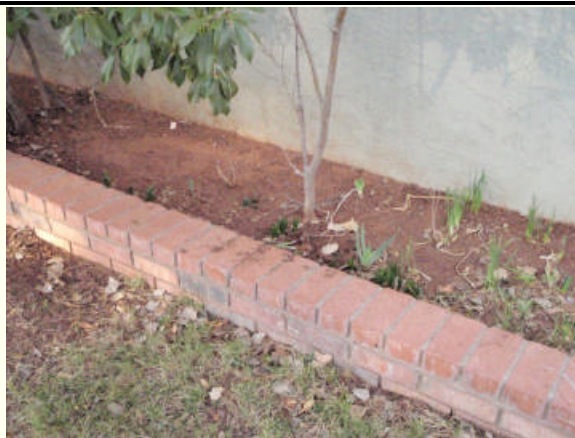
LANDSCAPING:

Not inspected.
