## INTERIOR ROOMS

#### 7.1 Main Entry Door:

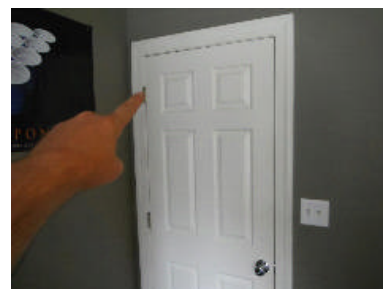
#### 7.3 Overall Interior Door Condition: Location: Upper, front, middle bedroom - entry door, The following item(s) are in need of repair:

- (a) The upper hinge screws are stripped out and the door does not close properly. Adjustments/repairs are needed
- (b,c) There were two holes in the rear side of the door.
